Asbestos Assessment

Our Lady of the Assumption
20 Highway 55, Stoney Creek,
Ontario

**Hamilton-Wentworth Catholic
District School Board**

July 23, 2021

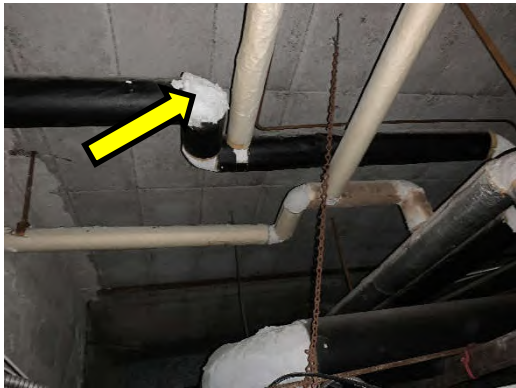
Material and Application	Asbestos Type/Friability	Photo
Parging cement is present on pipe fittings (elbows, valves, tees, hangers etc.)	Chrysotile/Friable

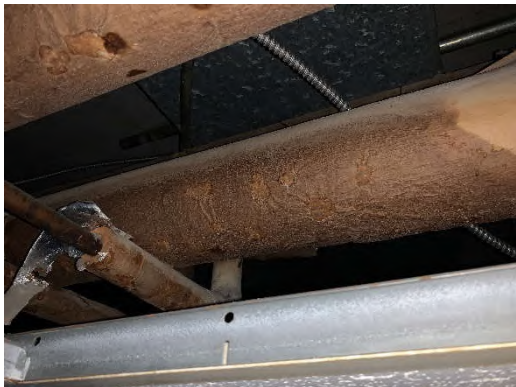
Sweatwrap insulation (brown layered paper) is present on straight sections of pipes.	None

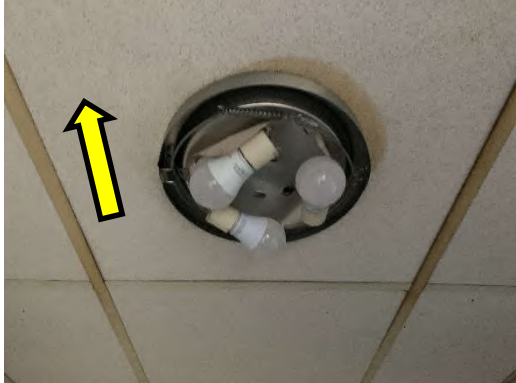
Material and Application	Asbestos Type/Friability	Photo
<p>24"x48" lay-in ceiling tiles, with a short fissure random pattern are present.</p>	<p>Presumed/Non-friable</p>

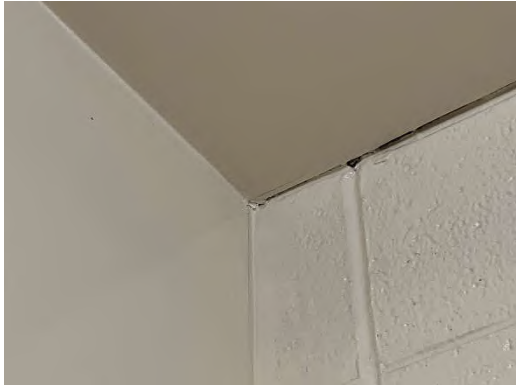
<p>Remaining ceiling tiles are presumed to be non-asbestos based on previous sampling or the material of manufacture (fibreglass).</p>	<p>None</p>	
<p>Plaster present on walls and ceilings does not contain asbestos.</p>	<p>None</p>	
<p>Drywall joint compound is present on wall and ceiling finishes.</p>	<p>Chrysotile/Non-friable</p>

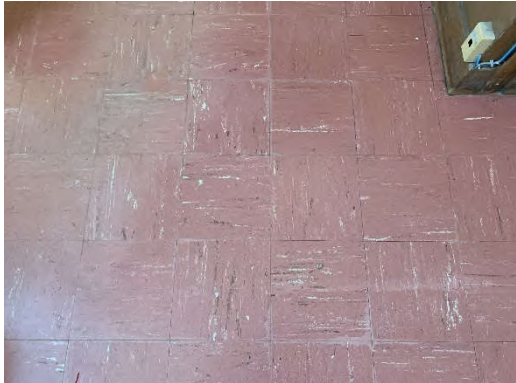
<p>Vinyl floor tiles, 9"x9" red with white streak are present.</p>	<p>Chrysotile/Non-friable (tile) Presumed/Non-friable (mastic)</p>

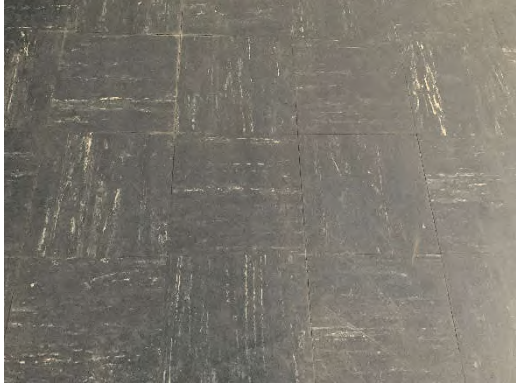
Material and Application	Asbestos Type/Friability	Photo
<p>Vinyl floor tiles, 9"x9" brown with white fleck are present.</p>	<p>Presumed/Non-friable (tile) Presumed/Non-friable (mastic)</p>

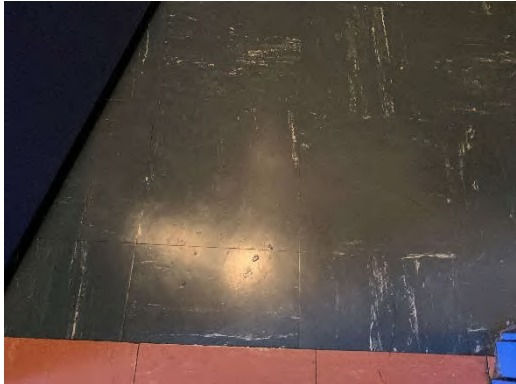
<p>Vinyl floor tiles, 9"x9" blue with white streak are present.</p>	<p>Presumed/Non-friable (tile) Presumed/Non-friable (mastic)</p>

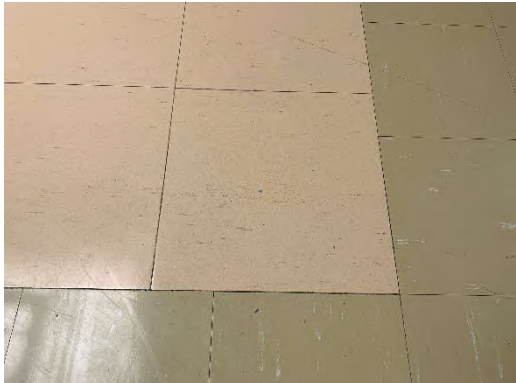
<p>Vinyl floor tiles, 9"x9" tan with white streak are present.</p>	<p>Presumed/Non-friable (tile) Presumed/Non-friable (mastic)</p>

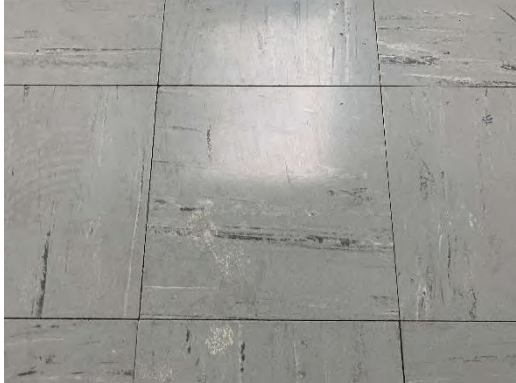
Material and Application	Asbestos Type/Friability	Photo
Vinyl floor tiles, 9"x9" grey with white and black fleck are present.	Presumed/Non-friable (tile) Presumed/Non-friable (mastic)

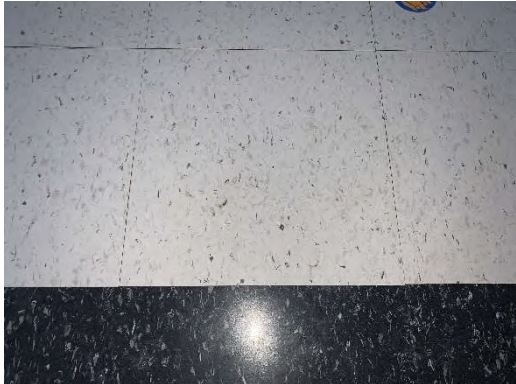
Vinyl floor tiles, 12"x12" cream with rose fleck are present.	Presumed/Non-friable (tile) Presumed/Non-friable (mastic)

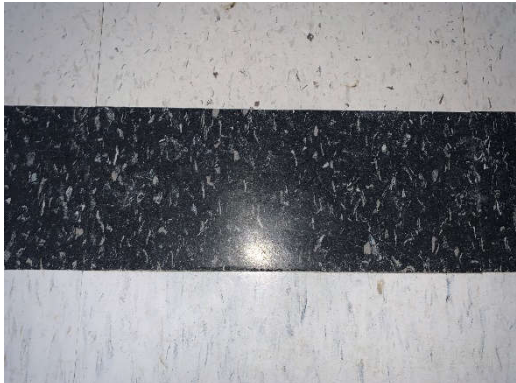
Vinyl floor tiles, 12"x12" black dense fleck are present.	Presumed/Non-friable (tile) Presumed/Non-friable (mastic)

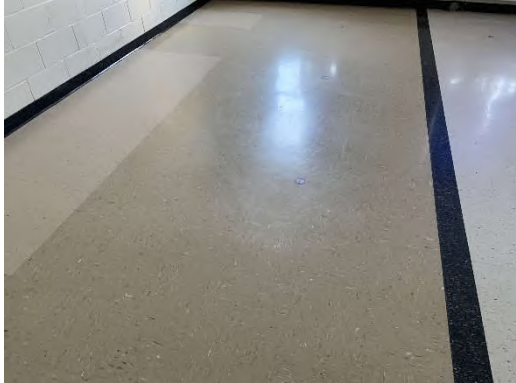
Material and Application	Asbestos Type/Friability	Photo
<p>Vinyl floor tiles, 12"x12" beige with brown and white streak are present.</p>	<p>Presumed/Non-friable (tile) Presumed/Non-friable (mastic)</p>

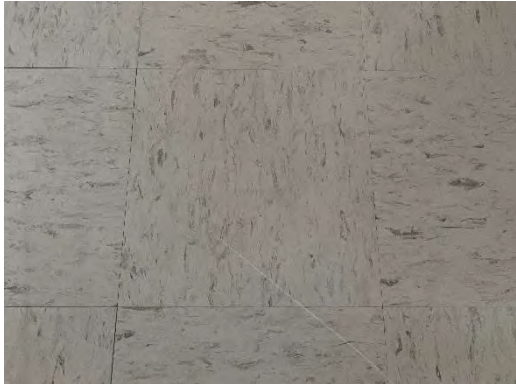
<p>Vinyl floor tiles, 12"x12" white with black streak are present.</p>	<p>Presumed/Non-friable (tile) Presumed/Non-friable (mastic)</p>

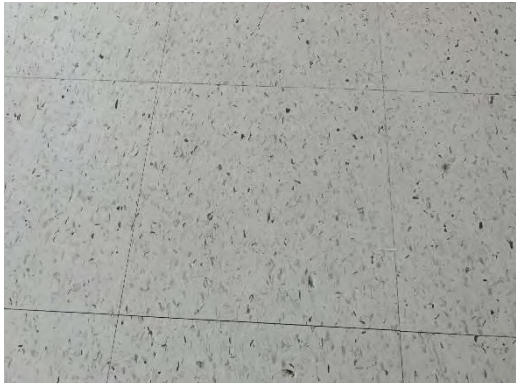
<p>Vinyl floor tiles, 12"x12" white with black and grey fleck are present.</p>	<p>Presumed/Non-friable (tile) Presumed/Non-friable (mastic)</p>

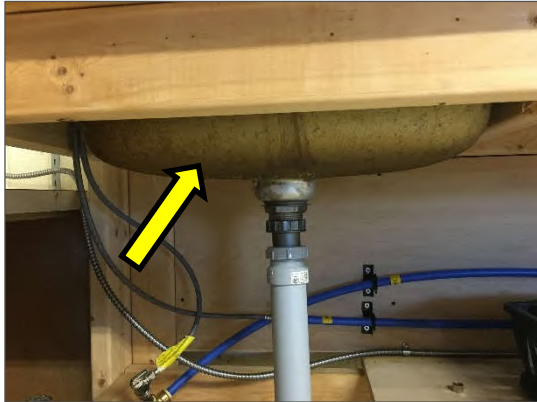
Material and Application	Asbestos Type/Friability	Photo
Gold mastic is present as a sink undercoating.	Presumed/Non-friable

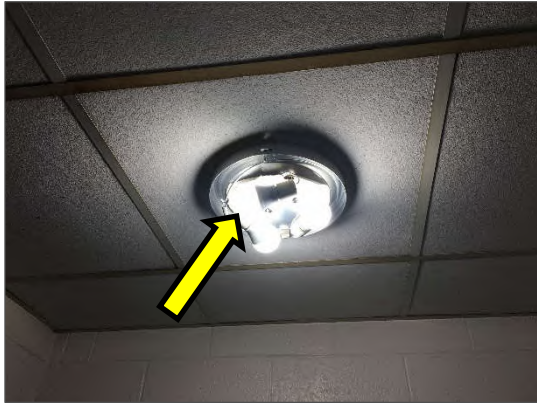
Paper heat shields are present in light fixtures.	Presumed/Non-friable

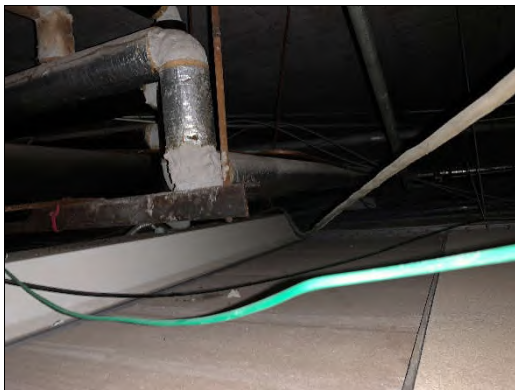
Photo 1

Material, Quantity, Condition and Photo #	Location Name (Location #)	Recommended Procedure
Pipe insulation, 9 fittings (and debris on ceiling tiles), poor condition, Photos 1 & 2	Corridor (Location 102)	Type 2 clean-up and repair.
