Asbestos Assessment

Blessed Sacrament
315 East 37th Street, Hamilton, ON,
L8V 4B5

August 31, 2023

Pinchin File: 320582.004

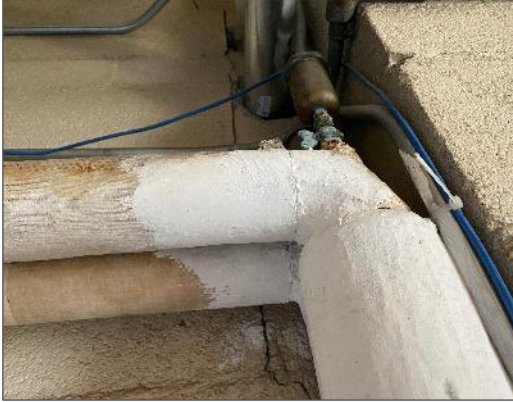
Material and Application	Asbestos Type	Photo
<p>Parging cement is present on pipe fittings (elbows, valves, tees, hangers etc.).</p>	<p>Chrysotile</p>

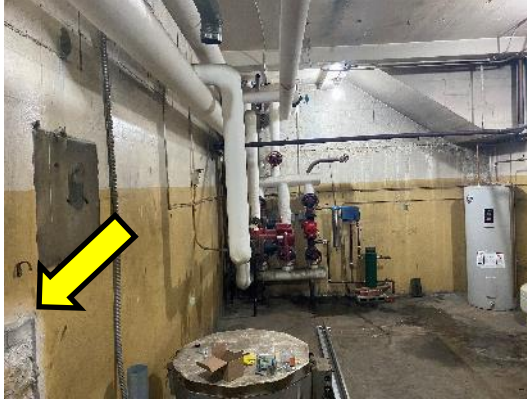
Material and Application	Asbestos Type	Photo
<p>Parging cement is present as firestopping at outer perimeter hatch penetration in the Boiler Room (Location 1001).</p>	<p>Presumed</p>

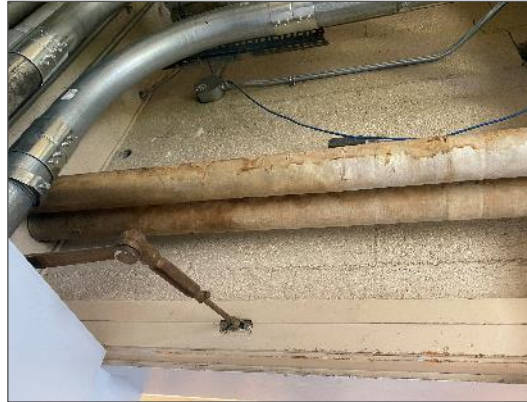
<p>A white corrugated paper insulation (trade name Aircell) is present on pipes.</p>	<p>Chrysotile</p>

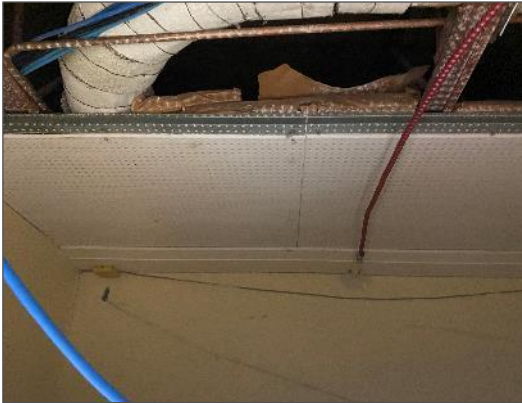
Material and Application	Asbestos Type	Photo
Transite board is present as acoustic ceiling tiles.	Presumed

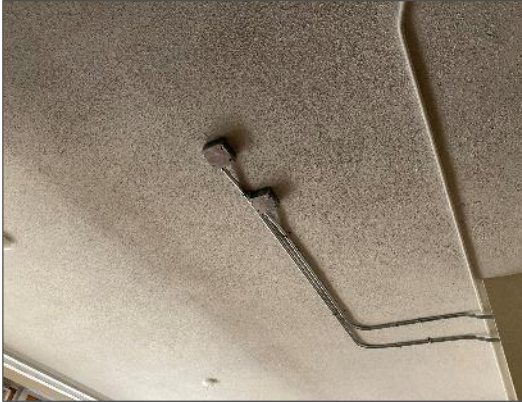
24"x48" lay-in ceiling tiles, with a right-angled fissure and pinhole pattern are present.	Presumed	
Remaining ceiling tiles are non-asbestos from previous sampling, presumed to be non-asbestos based on the date of manufacture determined from the date stamp applied to the top of the tiles and the age of the materials determined from the age of the building.	None	
Smooth plaster is present on walls and ceilings.	None	
Textured plaster is present on bulkheads and ceilings in the Classrooms (Locations 1011-1021).	None	
Textured plaster is present on ceilings of the Kindergarten (Location 1042).	Chrysotile

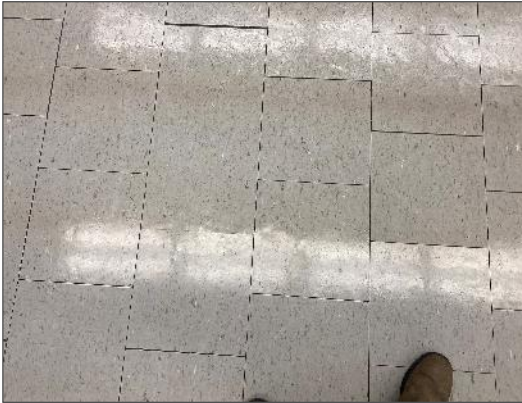
Material and Application	Asbestos Type	Photo
<p>Asbestos in drywall joint compound was banned in Canada in 1980. Any drywall joint compound installed in the building was installed after 1986 (1980 plus a reasonable non-compliance period based on our experience) and is assumed to contain no asbestos.</p>	<p>None</p>	
<p>Vinyl floor tiles (12"x12", various colours) and mastic present throughout the building are presumed to contain asbestos until sampling is performed.</p>	<p>Presumed (tile) Presumed (mastic)</p>

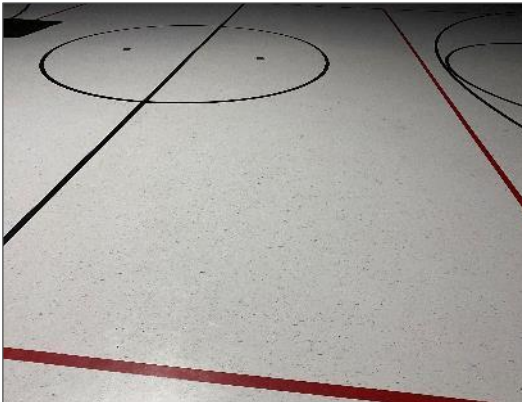
<p>Mastic present under new non-asbestos vinyl floor tiles contains asbestos.</p>	<p>None (tile) Chrysotile (mastic)</p>

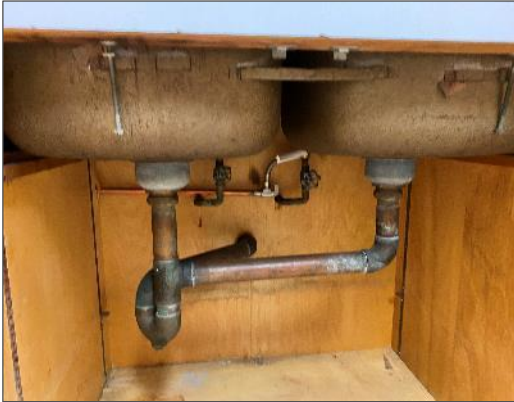
Material and Application	Asbestos Type	Photo
Gold sink undercoating is present.	Presumed

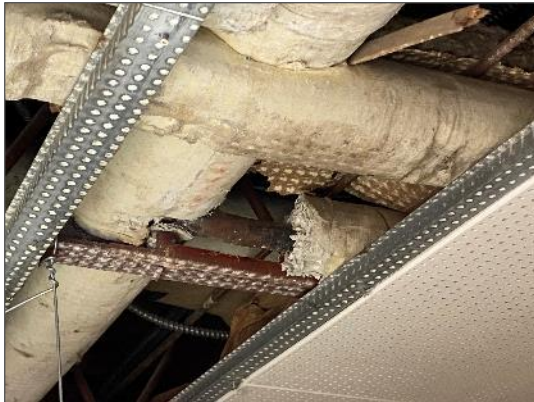
Material, Quantity, Condition, Photo #	Location (Location #)	Recommended Procedure
Aicell pipe insulation, poor, 2 LF, Photo 1	Corridor (Location 1005)	Precautions for work above ceiling which may disturb asbestos in poor condition.
Aicell pipe insulation, poor, 1 LF, Photo 2	Corridor (Location 1006)	Precautions for work above ceiling which may disturb asbestos in poor condition.
