Asbestos Assessment

Canadian Martyrs
1355 Main Street West, Hamilton,
ON, L8S 4M7

**Hamilton-Wentworth Catholic
District School Board**

August 31, 2023

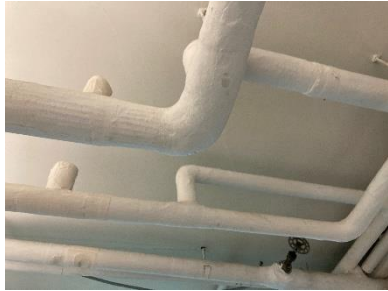
Material and Application	Asbestos Type	Photo
Parging cement is present on pipe fittings (elbows, valves, tees, hangers etc.).	Chrysotile

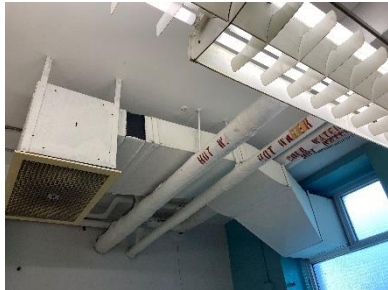
A white corrugated paper insulation (trade name Aircell), containing chrysotile asbestos, is present on straight sections of pipes.	Chrysotile

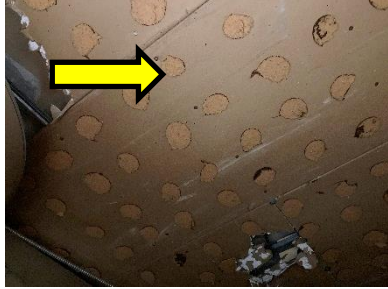
Material and Application	Asbestos Type	Photo
Puck adhesive, formerly above glue-on ceiling tiles is present.	Presumed

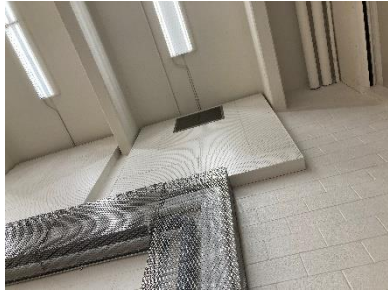
All ceiling tiles are presumed to be non-asbestos based on sample analysis, the date of manufacture determined from the date stamp applied to the top of the tiles, or the age of the materials determined from the age of the building renovation.	None	N/A
Textured plaster present on walls throughout the building does not contain asbestos. Textured plaster soffit in the Vestibule (Location 1025) does not contain asbestos.	None	N/A
Textured plaster ceiling in the Gymnasium (Location 1010) is presumed to contain asbestos	Presumed

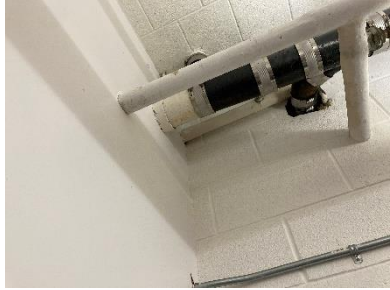
Material and Application	Asbestos Type	Photo
Transite pipe is present as a rainwater leader	Presumed

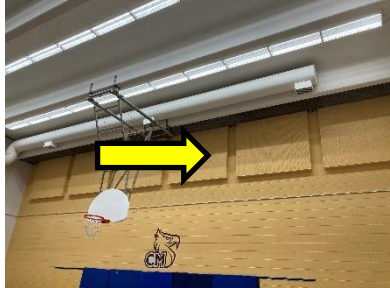
Acoustic Transite panels are present in the Gymnasium (Location 1010)	Presumed

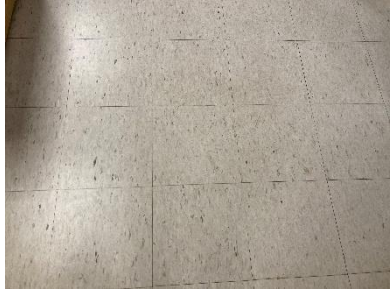
Vinyl floor tiles, 12"x12", beige with brown and white streaks, are present.	Chrysotile (tile) None (mastic)

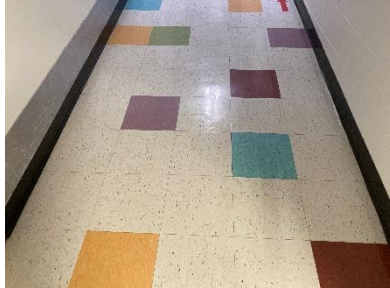
Vinyl floor tiles, 12"x12", white with grey flecks, are present.	Presumed (tile) Presumed (mastic)

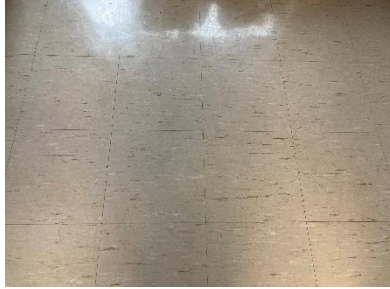
Material and Application	Asbestos Type	Photo
<p>Vinyl floor tiles, 12"x12", brown with brown streaks, are present.</p>	<p>Presumed (tile) Presumed (mastic)</p>

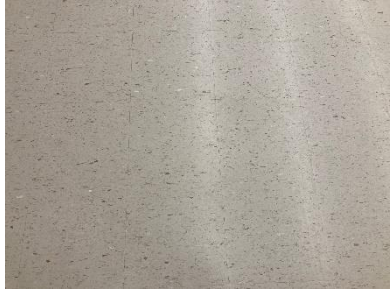
<p>Vinyl floor tiles, 12"x12", cream with brown streaks, are present.</p>	<p>Presumed (tile) Presumed (mastic)</p>

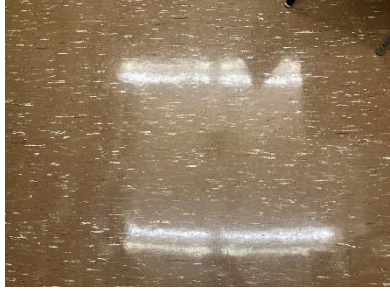
<p>Vinyl floor tiles, 12"x12", brown with white and black streaks, are present.</p>	<p>Presumed (tile) Presumed (mastic)</p>

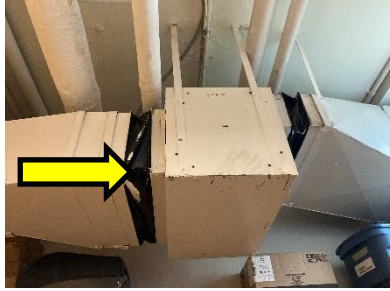
<p>Remaining vinyl floor tiles were presumed to be non-asbestos based on sample analysis or historical knowledge of the date of installation.</p> <p>Mastic underneath new flooring is presumed to contain asbestos until further sampling can prove otherwise.</p>	<p>None (tile) Presumed (mastic)</p>	<p>N/A</p>
<p>Vibration dampener is present on ductwork in the Kiln Room (Location 1020).</p>	<p>Presumed</p>
