Asbestos Assessment

Cathedral Annex
685 King Street East, Hamilton,
Ontario

August 31, 2023

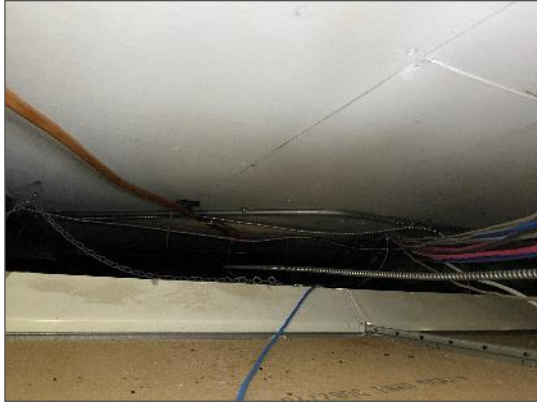
Material and Application	Asbestos Type	Photo
<p>Pipes are either uninsulated or insulated with non-asbestos fibreglass or elastomeric insulation (Armaflex).</p> <p>Due to the age of the building, pipes may be insulated with asbestos-containing insulations in inaccessible spaces such as above solid ceilings, in chases, in column enclosures and within shafts.</p>	None	
<p>Ducts are either uninsulated or insulated with non-asbestos fibreglass (foil-faced or canvas).</p>	None	
<p>Mechanical equipment is either uninsulated or insulated with non-asbestos fibreglass.</p>	None	
<p>All ceiling tiles are non-asbestos from previous sampling.</p>	None	
<p>Drywall joint compound is present on wall and ceiling finishes.</p>	None

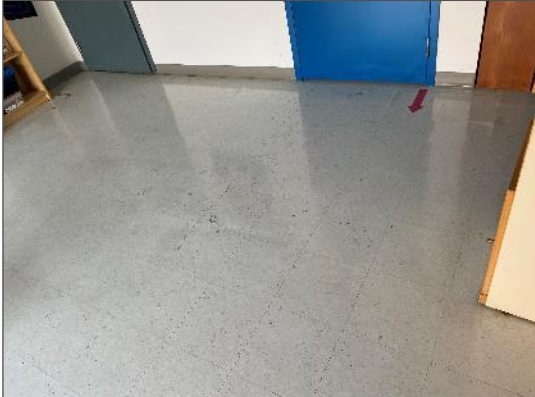
Vinyl floor tiles, 12"x12", white with faint black specks, are present.	None (tile) None (mastic)
