# Asbestos Assessment

Cathedral High School  
30 Wentworth Street North,  
Hamilton, ON, L8L 8H5

**Hamilton-Wentworth Catholic  
District School Board**

August 31, 2023

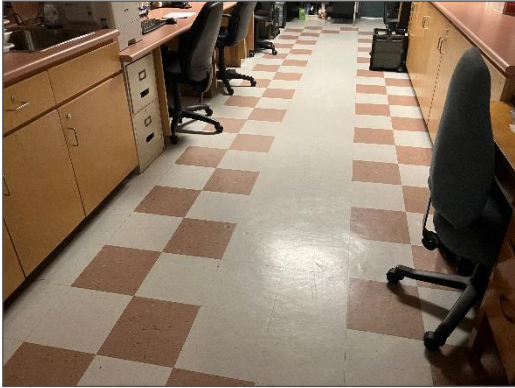
Material and Application	Asbestos Type	Photo
<p>Vinyl floor tiles and mastic are presumed to be non-asbestos based on historical knowledge of the date of installation.</p>	<p>None</p>

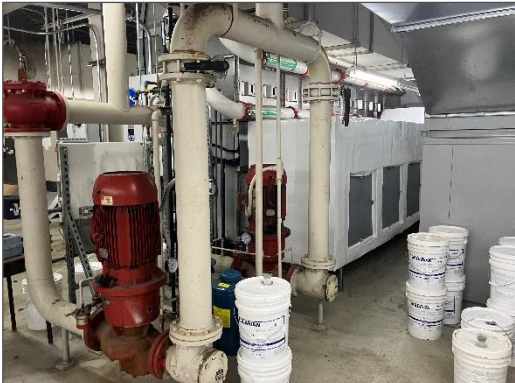
<p>Gaskets are present in the Mechanical Penthouses.</p>	<p>Chrysotile</p>
