Asbestos Reassessment

Corpus Christi
25 Alderson Drive, Hamilton,
Ontario

May 15, 2023

Pinchin File: 320582.001

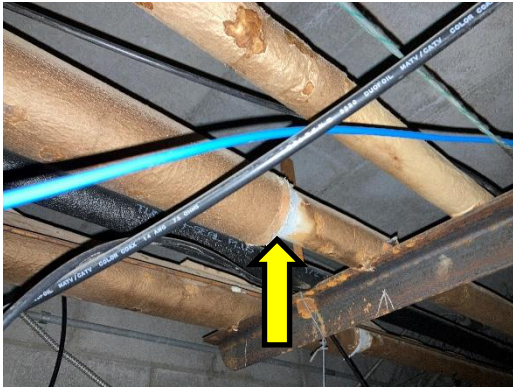
| Material and Application | Asbestos Type | Photo |
|--|---|--|
| <p>Parging cement is present on pipe fittings and seams of fibreglass insulation on pipe straights in the Corridor (Location 1020).</p> | <p>Chrysotile</p> | |

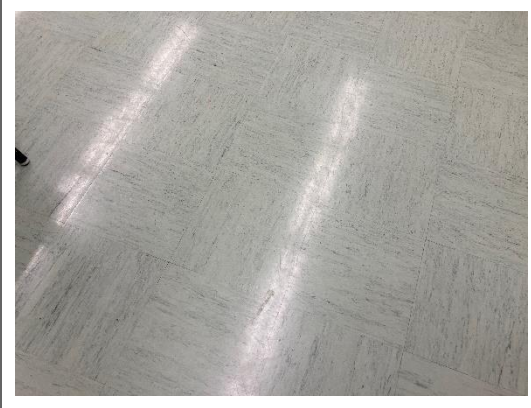
| Material and Application | Asbestos Type | Photo |
|--|--|--|
| <p>Vinyl floor tiles, 12"x12", green with green streaks, are present.</p> | <p>Presumed (tile) Presumed (mastic)</p> | |

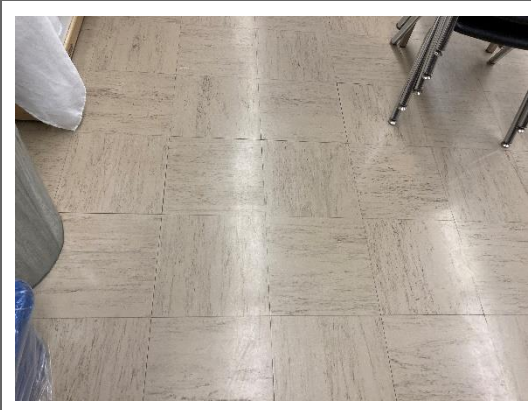
| Material and Application | Asbestos Type | Photo |
|--|--|--|
| <p>Vinyl floor tiles, 12"x12", beige with dark streaks, are present.</p> | <p>Presumed (tile) Presumed (mastic)</p> | |

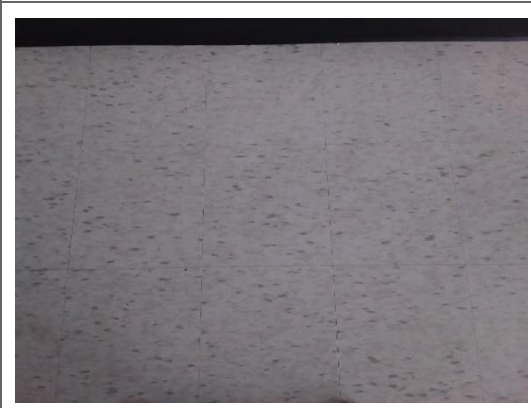
| Material and Application | Asbestos Type | Photo |
|--|--|--|
| <p>Vinyl floor tiles, 12"x12", light grey with dark streaks, are present.</p> | <p>Presumed (tile) Presumed (mastic)</p> | |

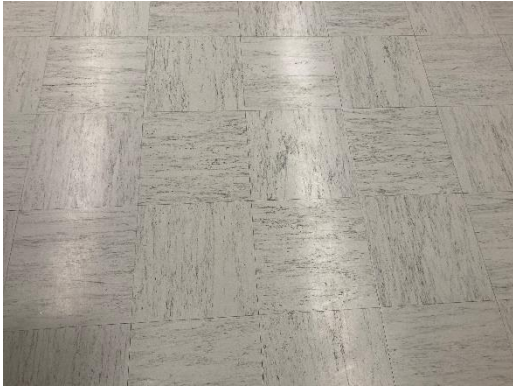
| Material and Application | Asbestos Type | Photo |
|--|---|--|
| Vinyl floor tiles, 12"x12", cream with dark streaks, are present. | Presumed (tile) Presumed (mastic) | |
