## **Asbestos Assessment**

Father Kryan Kennedy  
90 Mulberry Street, Hamilton, ON,  
L8L 1B5

**Hamilton-Wentworth Catholic  
District School Board**

August 31, 2023

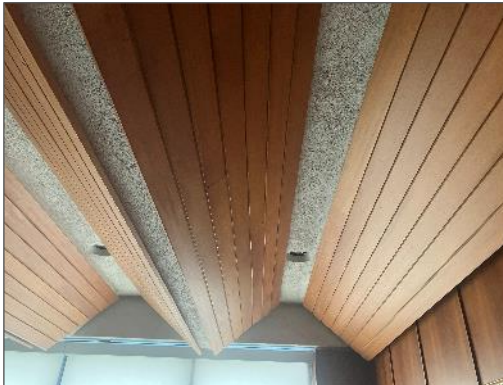
Material and Application	Asbestos Type	Photo
<p>Texture finish is present on ceilings in the Hearing Room (Location 1001) and the Boardroom (Location 1002).</p> <p>Overspray from the asbestos-containing texture coat is presumed to be present above the ceiling at light fixture openings, on the deck, ducts and within junction boxes.</p>	Chrysotile

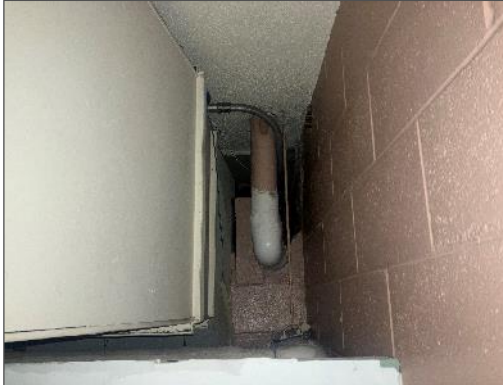
<p>Non-asbestos texture finish is present on drywall walls in the Chapel (Location 3004).</p>	None	
<p>Parging cement is present on pipe fittings (elbows, valves, tees, hangers etc.).</p> <p>Pipes insulated with asbestos-containing insulations may be present in inaccessible spaces such as above solid ceilings, in chases, in column enclosures and within shafts</p>	Chrysotile

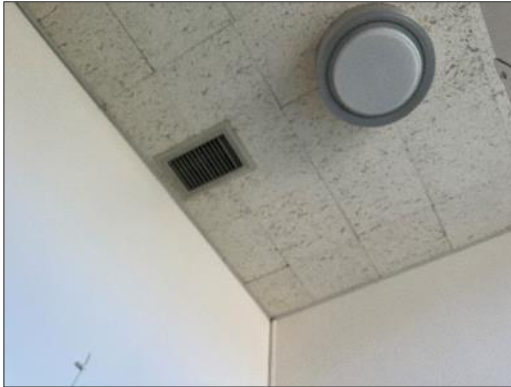
Material and Application	Asbestos Type	Photo
Ducts are either uninsulated or insulated with non-asbestos fibreglass (foil-faced or canvas).	None	
Mechanical equipment is either uninsulated or insulated with non-asbestos fibreglass.	None	
12"x12" glued-on ceiling tiles, with a fissured pattern are present.	Amosite

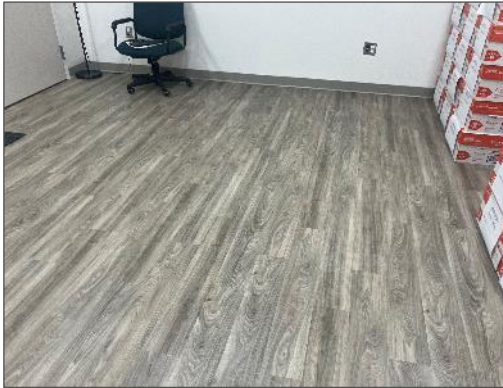
Material and Application	Asbestos Type	Photo
<p>Vinyl sheet flooring is presumed to be non-asbestos based on the date of installation (post-2020)</p> <p>Mastic under non-asbestos sheet flooring is presumed to contain asbestos until further sampling is performed.</p>	<p>None (flooring) Presumed (mastic)</p>

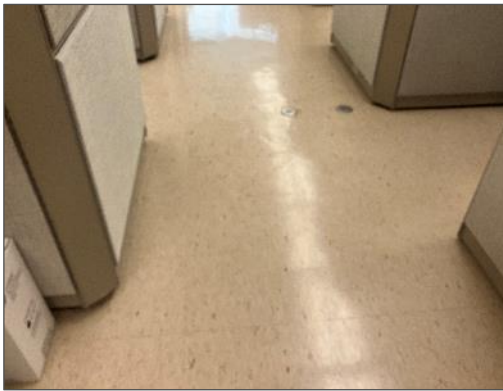
<p>Vinyl floor tiles, various colours, are present.</p>	<p>Presumed (tile) Presumed (mastic)</p>

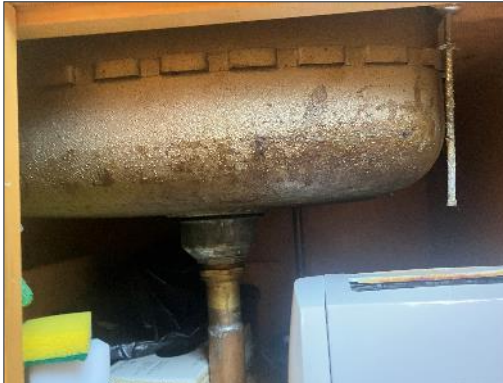
<p>Gold sink undercoating is present.</p>	<p>Presumed</p>
