Asbestos Assessment

Holy Name of Jesus
181 Belmont Ave, Hamilton, ON,
L8L 7M5

**Hamilton-Wentworth Catholic
District School Board**
90 Mulberry Street
Hamilton, Ontario, L8N 3R9

August 31, 2023

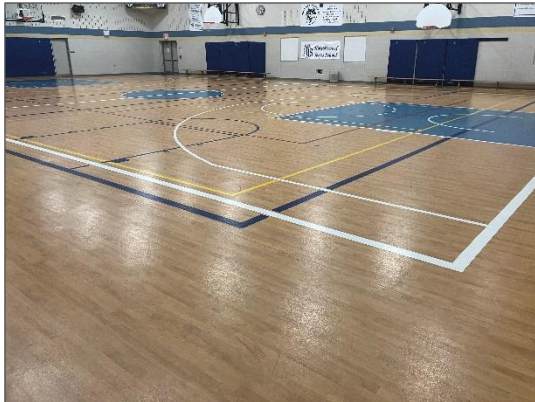
Material and Application	Asbestos Type	Photo
Pipes are either uninsulated or insulated with non-asbestos fibreglass or elastomeric insulation (Armaflex).	None	
Ducts are either uninsulated or insulated with non-asbestos fibreglass (foil-faced or canvas).	None	
Mechanical equipment is either uninsulated or insulated with non-asbestos fibreglass.	None	
All ceiling tiles are presumed to be non-asbestos based on the date of manufacture determined from the date stamp applied to the top of the tiles and the age of the materials determined from the age of the building.	None	
Asbestos in drywall joint compound was banned in Canada in 1980. The building was constructed after 1986 (1980 plus a reasonable non-compliance period based on our experience) and the drywall joint compound is assumed to contain no asbestos.	None	
Vinyl sheet flooring is presumed to be non-asbestos based on historical knowledge of the type of flooring (rubber) or based on the lack of a paper backing layer (underpad).	None

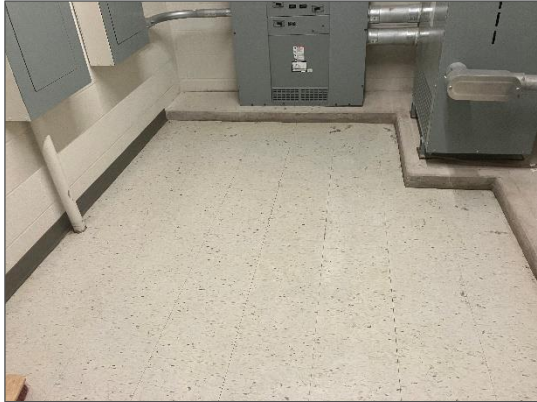
Material and Application	Asbestos Type	Photo
<p>Vinyl floor tiles and mastic were presumed to be non-asbestos based on historical knowledge of the date of installation.</p>	<p>None</p>
