# **Asbestos Assessment**

Immaculate Conception  
470 Kitty Murray Lane, Ancaster,  
ON, L9K 0C3

**Hamilton-Wentworth Catholic  
District School Board**

August 31, 2023

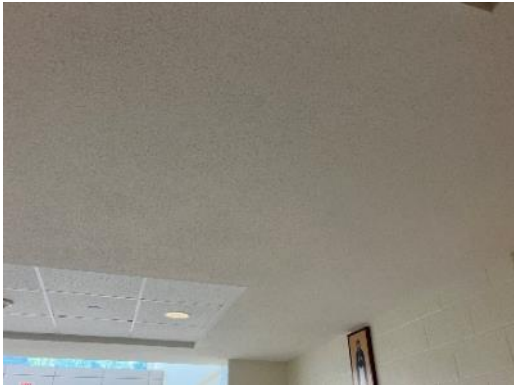
Material and Application	Asbestos Type	Photo
Texture finish is present on drywall.	None

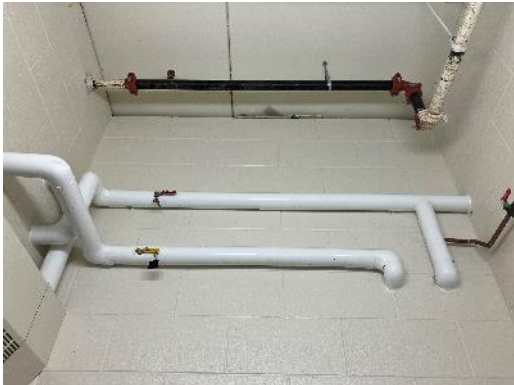
Pipes are either uninsulated or insulated with non-asbestos fibreglass or elastomeric insulation (Armaflex).	None

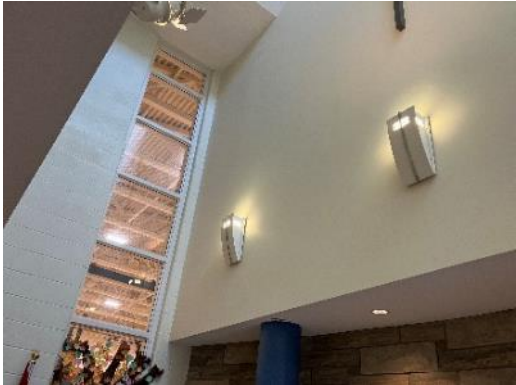
Material and Application	Asbestos Type	Photo
<p>Asbestos in drywall joint compound was banned in Canada in 1980. The building was constructed after 1986 (1980 plus a reasonable non-compliance period based on our experience) and the drywall joint compound is assumed to contain no asbestos.</p>	<p>None</p>

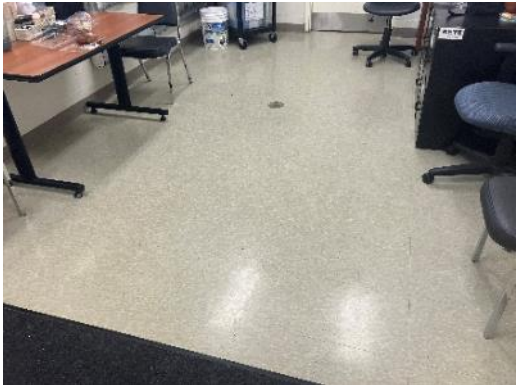
<p>Vinyl floor tiles and mastic were presumed to be non-asbestos based on historical knowledge of the date of installation.</p>	<p>None</p>
