Asbestos Assessment

Immaculate Heart of Mary
190 Glover Road, Stoney Creek,
ON, L8E 1A0

**Hamilton-Wentworth Catholic
District School Board**

August 31, 2023

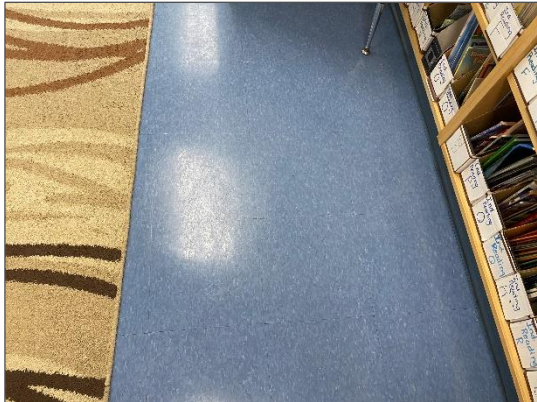
Material and Application	Asbestos Type	Photo
Pipes are either uninsulated or insulated with non-asbestos fibreglass or elastomeric insulation (Armaflex).	None	
Ducts are either uninsulated or insulated with non-asbestos fibreglass (foil-faced or canvas).	None	
Mechanical equipment is either uninsulated or insulated with non-asbestos fibreglass.	None	
All ceiling tiles are presumed to be non-asbestos based on the date of manufacture determined from the date stamp applied to the top of the tiles and the age of the materials determined from the age of the building.	None	
Asbestos in drywall joint compound was banned in Canada in 1980. The building was constructed after 1986 (1980 plus a reasonable non-compliance period based on our experience) and the drywall joint compound is assumed to contain no asbestos.	None	
Vinyl sheet flooring is presumed to be non-asbestos based on historical knowledge of the type of flooring (foam) or based on the lack of a paper backing layer (underpad) and the date of construction.	None

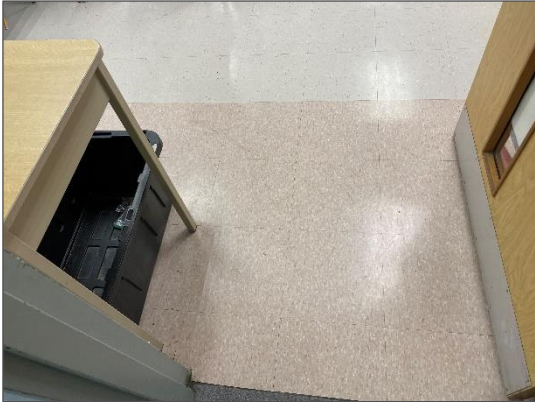
Material and Application	Asbestos Type	Photo
<p>Vinyl floor tiles and mastic were presumed to be non-asbestos based on historical knowledge of the date of installation.</p>	<p>None</p>
