## **Asbestos Assessment**

Our Lady of the Assumption  
103 Fletcher Road, Hannon,  
Ontario, L0R 1P0

August 31, 2023

Pinchin File: 320582.004

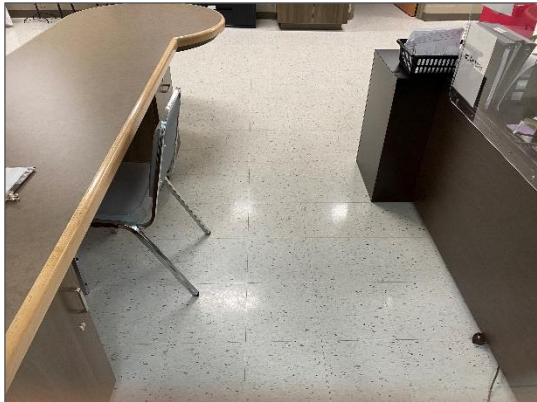
Vinyl floor tiles and mastic were presumed to be non-asbestos based on historical knowledge of the date of installation.	None
