Asbestos Assessment

Nicolas Mancini Centre
44 Hunt Street, Hamilton, ON, L8P
1C7

August 31, 2023

Pinchin File: 320582.004

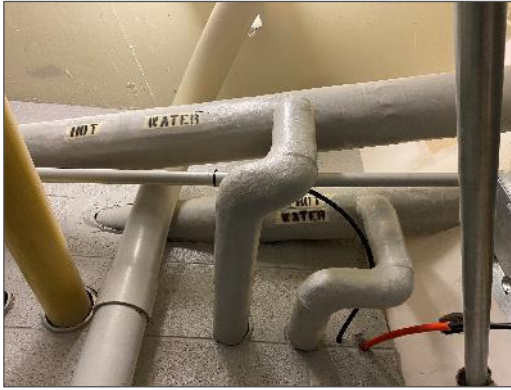
Material and Application	Asbestos Type	Photo
Fireproofing is present on structural steel including beams, trusses, joists, corrugated steel deck, concrete deck, columns.	None	
Texture finish is present on drywall.	None	
<p>Parging cement is present on pipe fittings (elbows, valves, tees, hangers etc.).</p> <p>Pipes insulated with asbestos-containing insulations may be present in inaccessible spaces such as above solid ceilings, in chases, in column enclosures and within shafts.</p>	Chrysotile

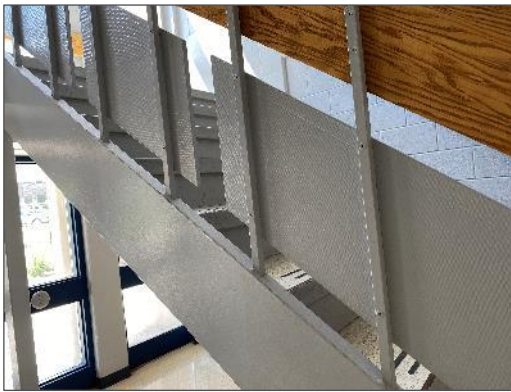
Material and Application	Asbestos Type	Photo
All ceiling tiles are presumed to be non-asbestos based on the date of manufacture determined from the date stamp applied to the top of the tiles or the materials of manufacture (fibreglass or gypsum),	None	
Drywall joint compound is present on wall and ceiling finishes.	None	
Transite board is present as panels on stair rails.	Presumed

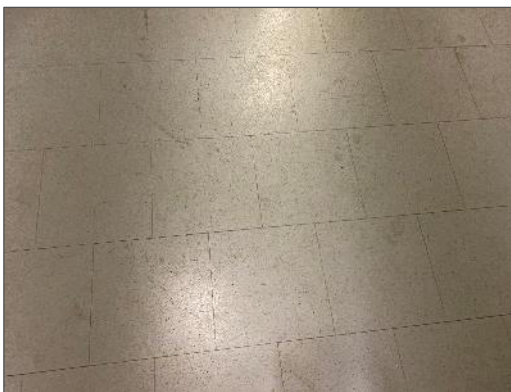
Vinyl floor tiles, 12"x12", various colours, are present.	Presumed (tile) Presumed (mastic)

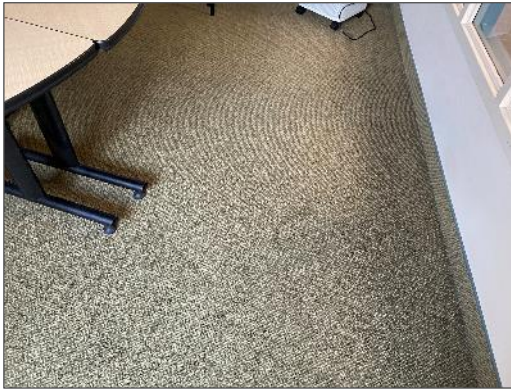
Mastic under carpet tiles in the Library (Location 1014) is presumed to contain asbestos.	Presumed (mastic)
