Asbestos Reassessment

Old Our Lady of the Assumption
20 Highway 55, Stoney Creek,
Ontario

May 15, 2023

Pinchin File: 320582.001

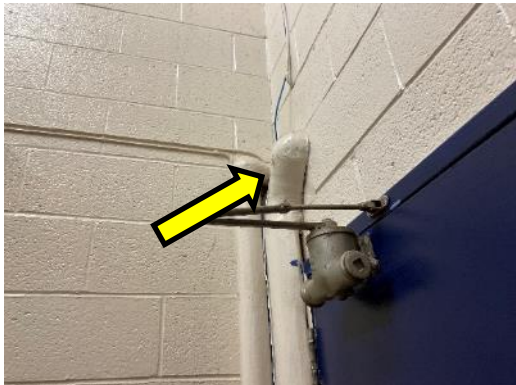
Material and Application	Asbestos Type	Photo
Parging cement is present on pipe fittings (elbows, valves, tees, hangers etc.)	Chrysotile

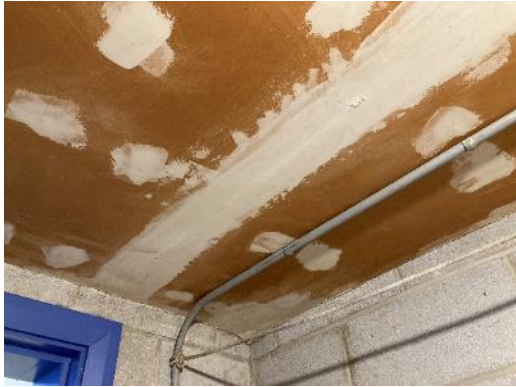
<p>Remaining ceiling tiles are presumed to be non-asbestos based on previous sampling or the material of manufacture (fibreglass).</p>	<p>None</p>	
<p>Plaster present on walls and ceilings is non-asbestos.</p>	<p>Trace Chrysotile (<0.5%)</p>	
<p>Drywall joint compound is present on wall and ceiling finishes.</p>	<p>Chrysotile</p>

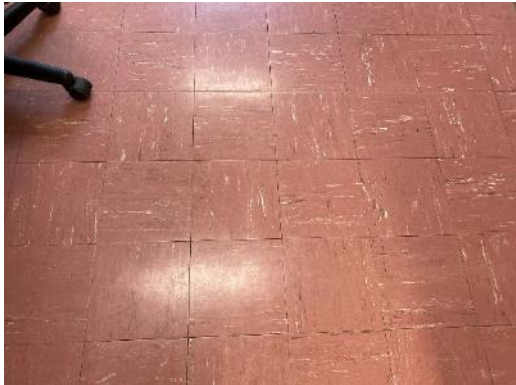
<p>Vinyl floor tiles, 9"x9" red with white streak are present.</p>	<p>Chrysotile (tile) Presumed (mastic)</p>

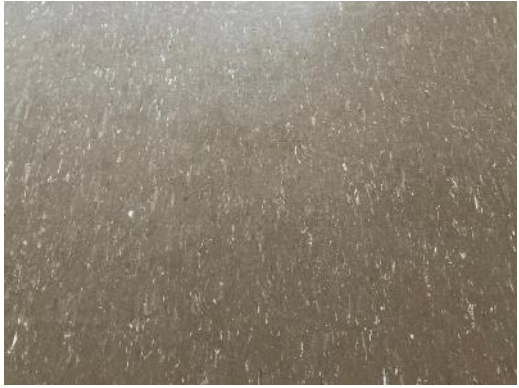
Material and Application	Asbestos Type	Photo
<p>Vinyl floor tiles, 9"x9" brown with white fleck are present.</p>	<p>Presumed (tile) Presumed (mastic)</p>

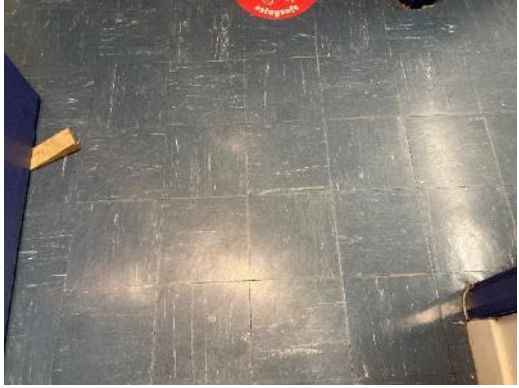
<p>Vinyl floor tiles, 9"x9" blue with white streak are present.</p>	<p>Presumed (tile) Presumed (mastic)</p>

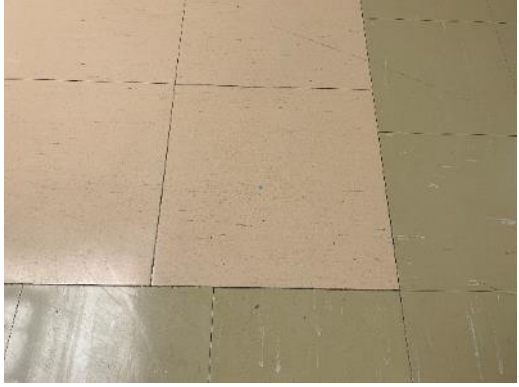
<p>Vinyl floor tiles, 9"x9" tan with white streak are present.</p>	<p>Presumed (tile) Presumed (mastic)</p>

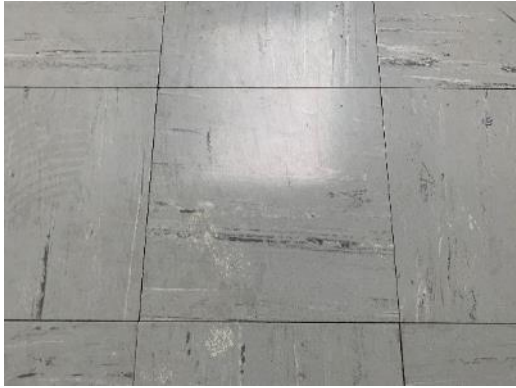
Material and Application	Asbestos Type	Photo
<p>Vinyl floor tiles, 9"x9" grey with white and black fleck are present.</p>	<p>Presumed (tile) Presumed (mastic)</p>

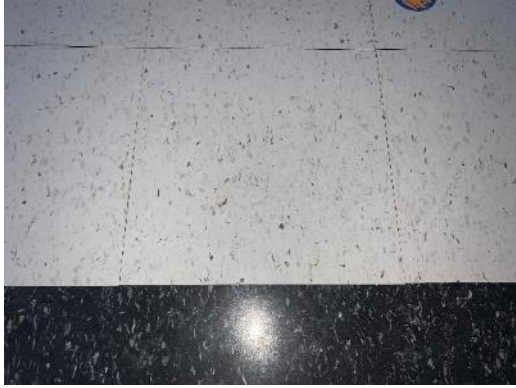
<p>Vinyl floor tiles, 12"x12" cream with rose fleck are present.</p>	<p>Presumed (tile) Presumed (mastic)</p>

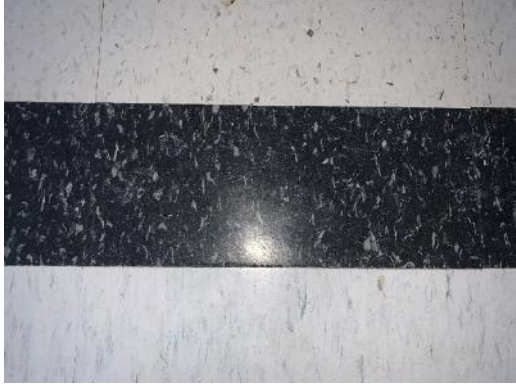
<p>Vinyl floor tiles, 12"x12" black dense fleck are present.</p>	<p>Presumed (tile) Presumed (mastic)</p>

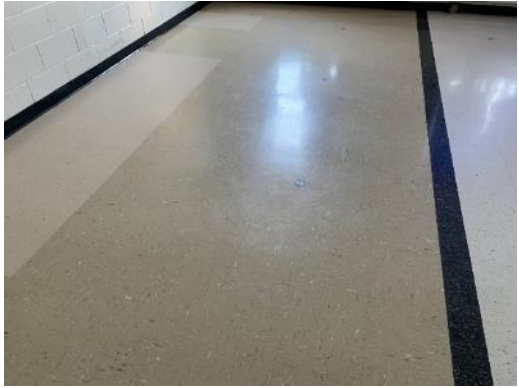
Material and Application	Asbestos Type	Photo
<p>Vinyl floor tiles, 12"x12" beige with brown and white streak are present.</p>	<p>Presumed (tile) Presumed (mastic)</p>

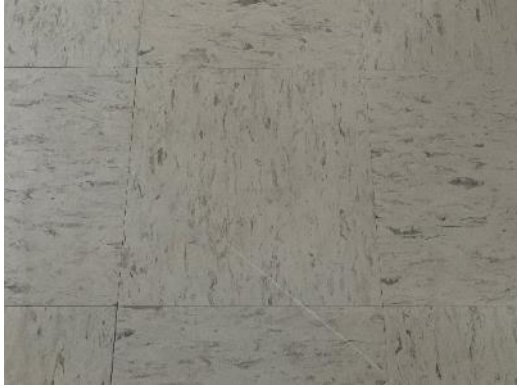
<p>Vinyl floor tiles, 12"x12" white with black streak are present.</p>	<p>Presumed (tile) Presumed (mastic)</p>

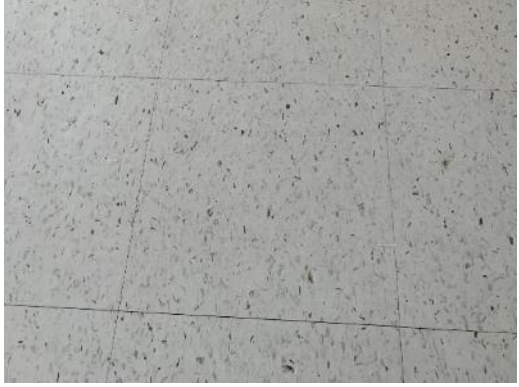
<p>Vinyl floor tiles, 12"x12" white with black and grey fleck are present.</p>	<p>Presumed (tile) Presumed (mastic)</p>

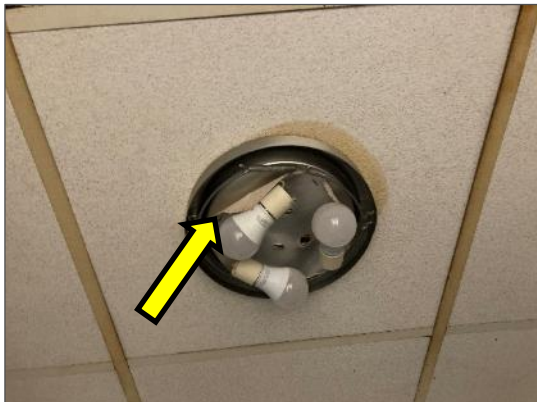
Material and Application	Asbestos Type	Photo
Paper heat shields are present in light fixtures.	Presumed

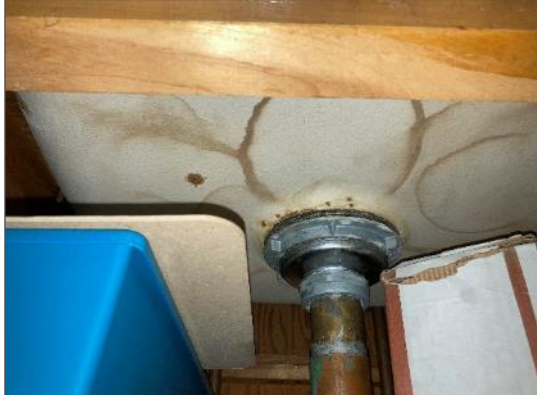
White mastic is present as a sink undercoating.	Presumed

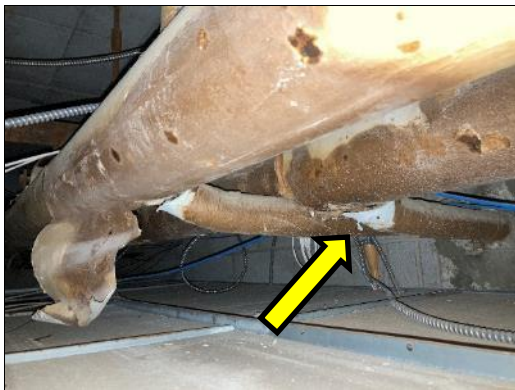
Material, Quantity, Condition and Photo #	Location Name (Location #)	Recommended Procedure
Pipe insulation, 1 fitting, poor condition, Photo 1	Corridor (Location 102)	Asbestos precautions for entry into ceiling space which may disturb asbestos in poor condition.
