Asbestos Assessment

Our Lady of Lourdes
420 Mohawk Road East, Hamilton,
ON, L8V 2H7

August 31, 2023

Pinchin File: 320582.004

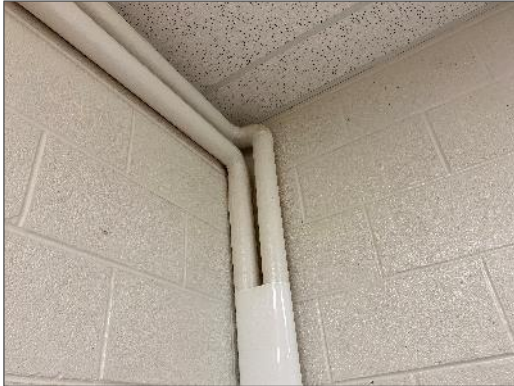
Material and Application	Asbestos Type	Photo
Parging cement is present on pipe fittings (elbows, valves, tees, hangers etc.).	Chrysotile

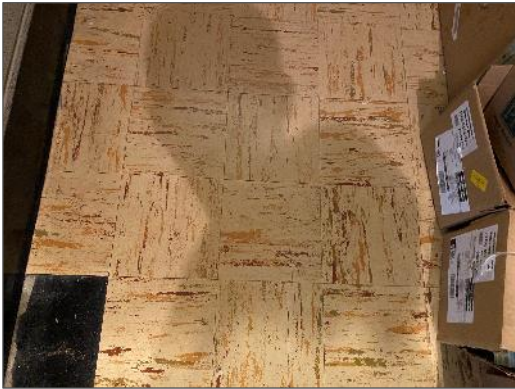
<p>Vinyl floor tiles, 9"x9", beige with grey, yellow, brown streak, are present.</p> <p>Vinyl floor tiles, 9"x9", white with black streak, are present.</p> <p>Vinyl floor tiles, 9"x9" tan with brown and white streak are present.</p> <p>Vinyl floor tiles, 9"x9" blue with white streak are present.</p>	<p>Chrysotile/Presumed (tile)</p> <p>None (mastic)</p>

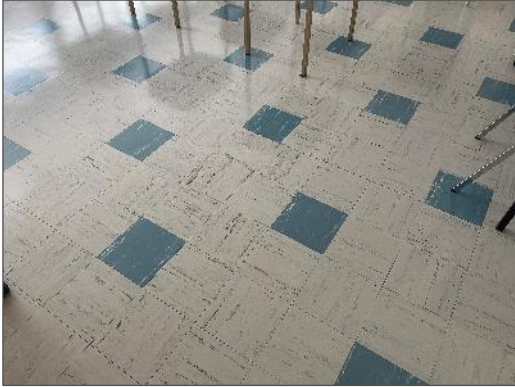
Material and Application	Asbestos Type	Photo
<p>Vinyl floor tiles, 9"x9" and 12"x12", various colours and mastic are present.</p>	<p>Presumed (tile) Presumed (mastic)</p>

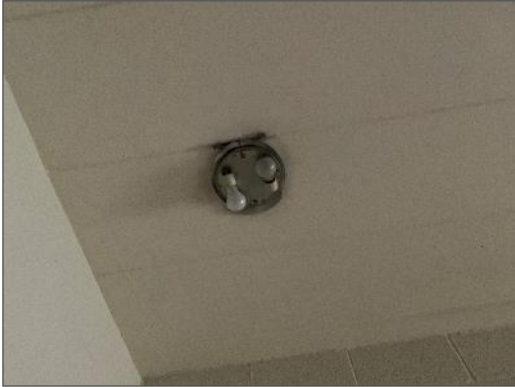
<p>Remaining vinyl floor tiles are presumed to be non-asbestos based on historical knowledge of the date of installation.</p> <p>Mastic under non-asbestos tiles is presumed to contain asbestos until further sampling is performed.</p>	<p>None (tile) Presumed (mastic)</p>	
<p>Paper heat shields are present in light fixtures.</p>	<p>Presumed</p>

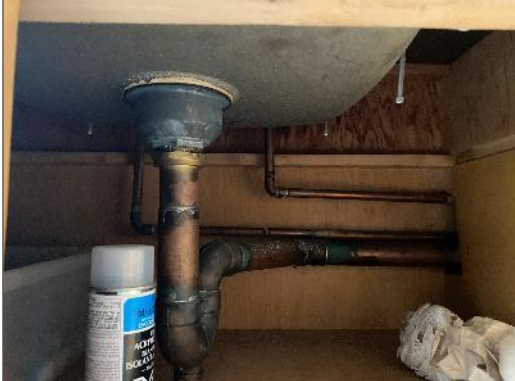
<p>Gold sink undercoating is present.</p>	<p>Presumed</p>
