Asbestos Assessment

Our Lady of Peace
252 Dewitt Road, Stoney Creek,
ON, L8E 2R1

August 31, 2023

Pinchin File: 320582.004

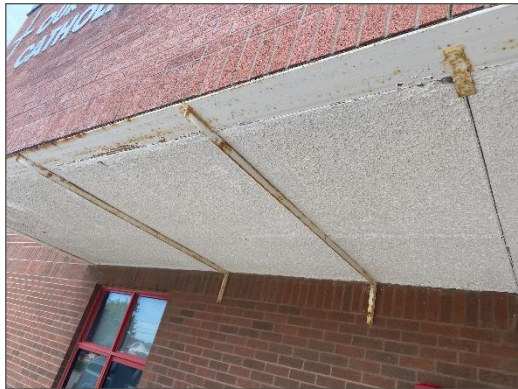
Material and Application	Asbestos Type	Photo
<p>Texture finish is present on the Transite soffit. Texture finish is presumed to be non-asbestos based on historical knowledge of the date of installation.</p>	<p>None</p>

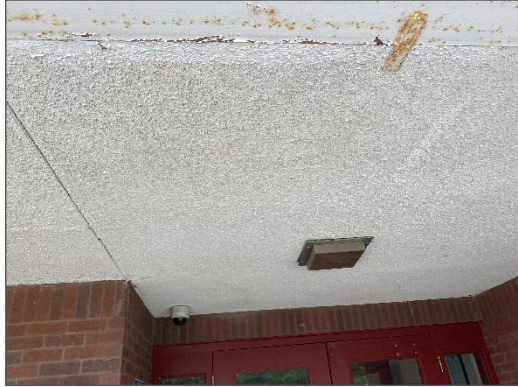
<p>Transite board is present as soffit finish.</p>	<p>Presumed</p>

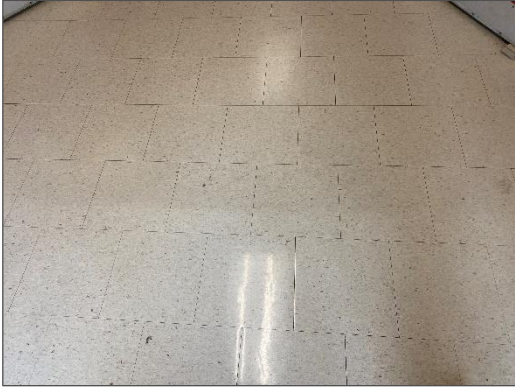
Material and Application	Asbestos Type	Photo
<p>All ceiling tiles are non-asbestos from previous sampling, presumed to be non-asbestos based on the date of manufacture determined from the date stamp applied to the top of the tiles and the age of the materials determined from the age of the building.</p>	<p>None</p>	
<p>Asbestos in drywall joint compound was banned in Canada in 1980. The building was constructed after 1986 (1980 plus a reasonable non-compliance period based on our experience) and the drywall joint compound is assumed to contain no asbestos.</p>	<p>None</p>	
<p>Vinyl floor tiles, 12"x12", beige with pink and brown fleck, are present.</p>	<p>None (tile) None (mastic)</p>

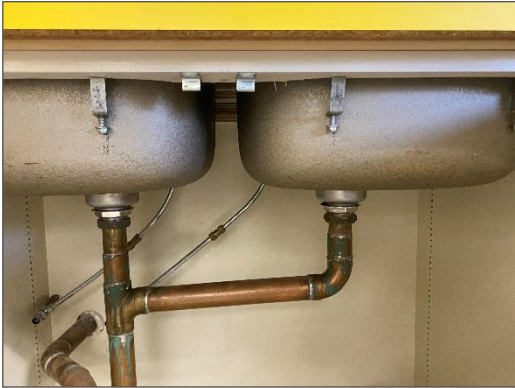
<p>Gold sink undercoating is present.</p>	<p>Chrysotile</p>

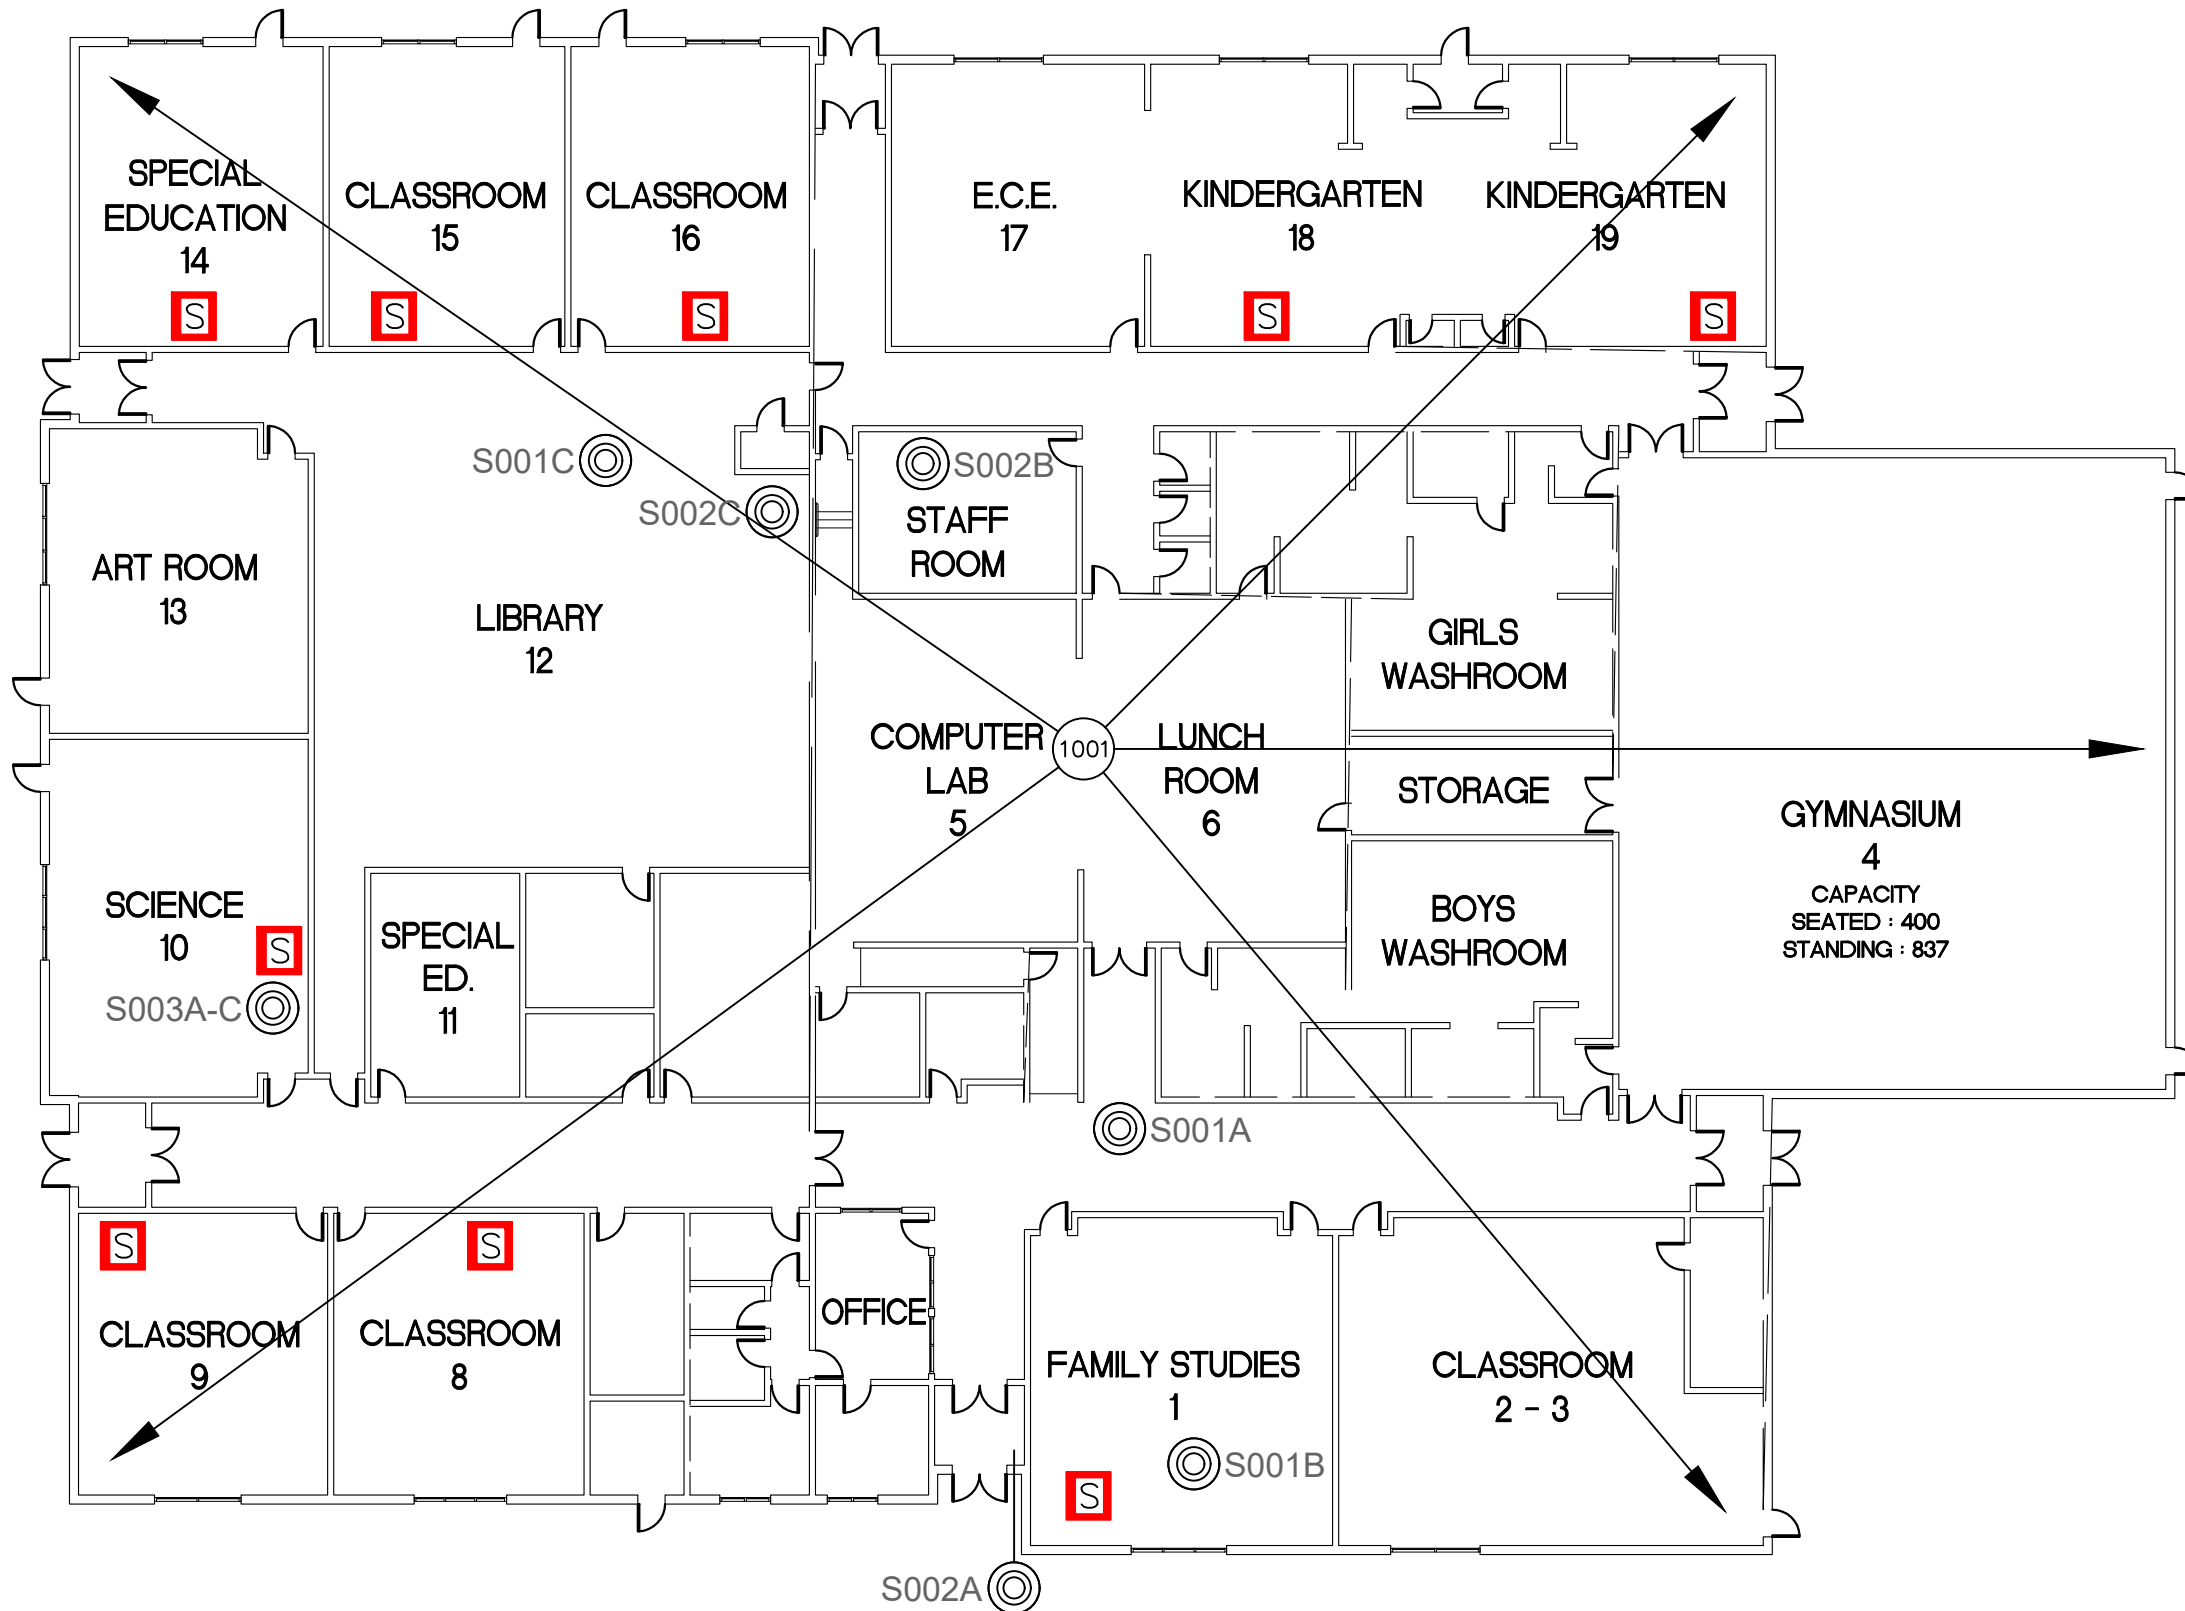
ASBESTOS REASSESSMENT
FLOOR LEVEL 1

(S) SINK UNDERCOATING
