## **Asbestos Assessment**

Regina Mundi  
675 Mohawk Road West, Hamilton,  
ON, L9C 1X7

**Hamilton-Wentworth Catholic  
District School Board**

August 31, 2023

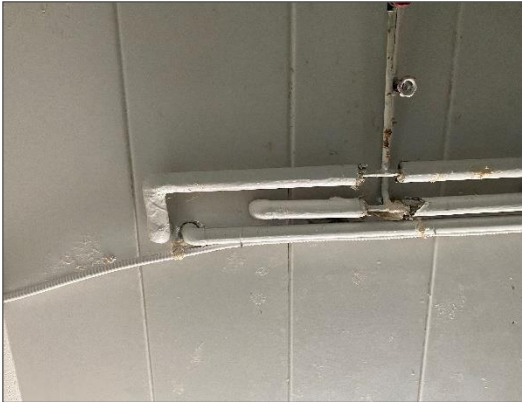
Material and Application	Asbestos Type	Photo
Parging cement is present on pipe fittings (elbows, valves, tees, hangers etc.).	Chrysotile

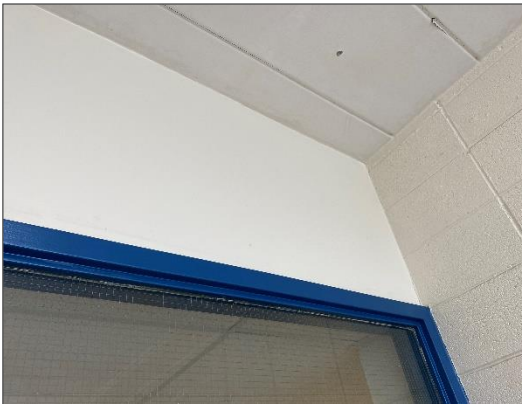
Material and Application	Asbestos Type	Photo
All ceiling tiles are non-asbestos from previous sampling, presumed to be non-asbestos based on the date of manufacture determined from the date stamp applied to the top of the tiles and the age of the materials determined from the age of the building.	None	
Textured plaster present on walls, columns, bulkheads, and ceilings does not contain asbestos.	None	
Drywall joint compound is present on wall and ceiling finishes.	Chrysotile

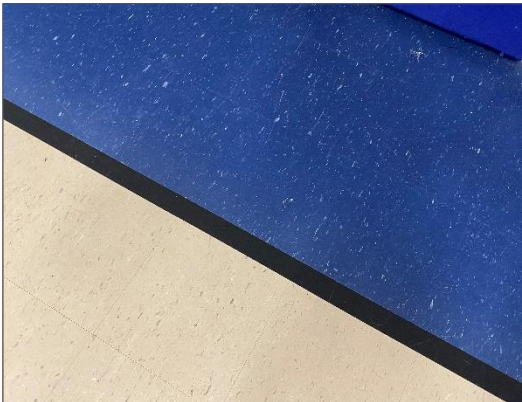
Non-asbestos drywall joint compound is present on wall and ceiling finishes.	None	
Mastic underneath new non-asbestos vinyl floor tiles in the General Purpose Room (Location 2030) contains asbestos.	None (tile) Confirmed (mastic)

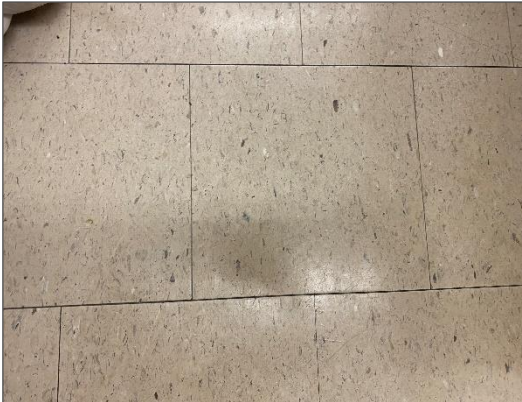
Material and Application	Asbestos Type	Photo
<p>Vinyl floor tiles (12"x12", various colours) are present in the building.</p>	<p>Presumed (tile) Presumed (mastic)</p>

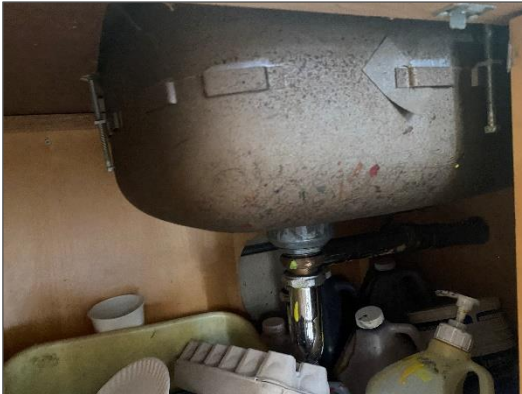
<p>Remaining vinyl floor tiles were presumed to be non-asbestos based on historical knowledge of the date of installation.</p> <p>Mastic underneath new flooring (laminates, vinyl floor tiles) is presumed to contain asbestos until further sampling proves otherwise.</p>	<p>None (tile) Presumed (mastic)</p>	
<p>Gold sink undercoating is present.</p>	<p>Presumed</p>

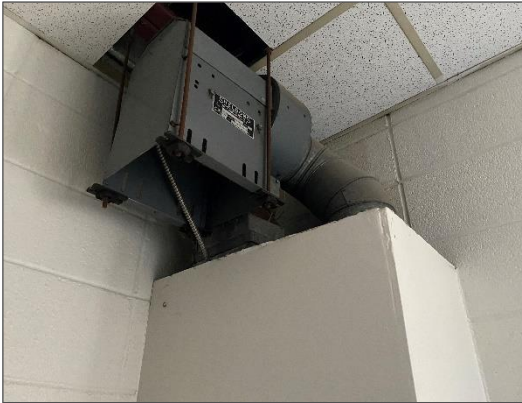
Material and Application	Asbestos Type	Photo
Duct expansion joint is present.	Presumed

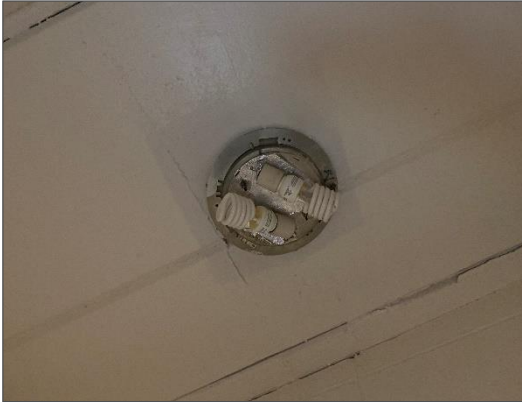
Paper heat shields are present.	Presumed

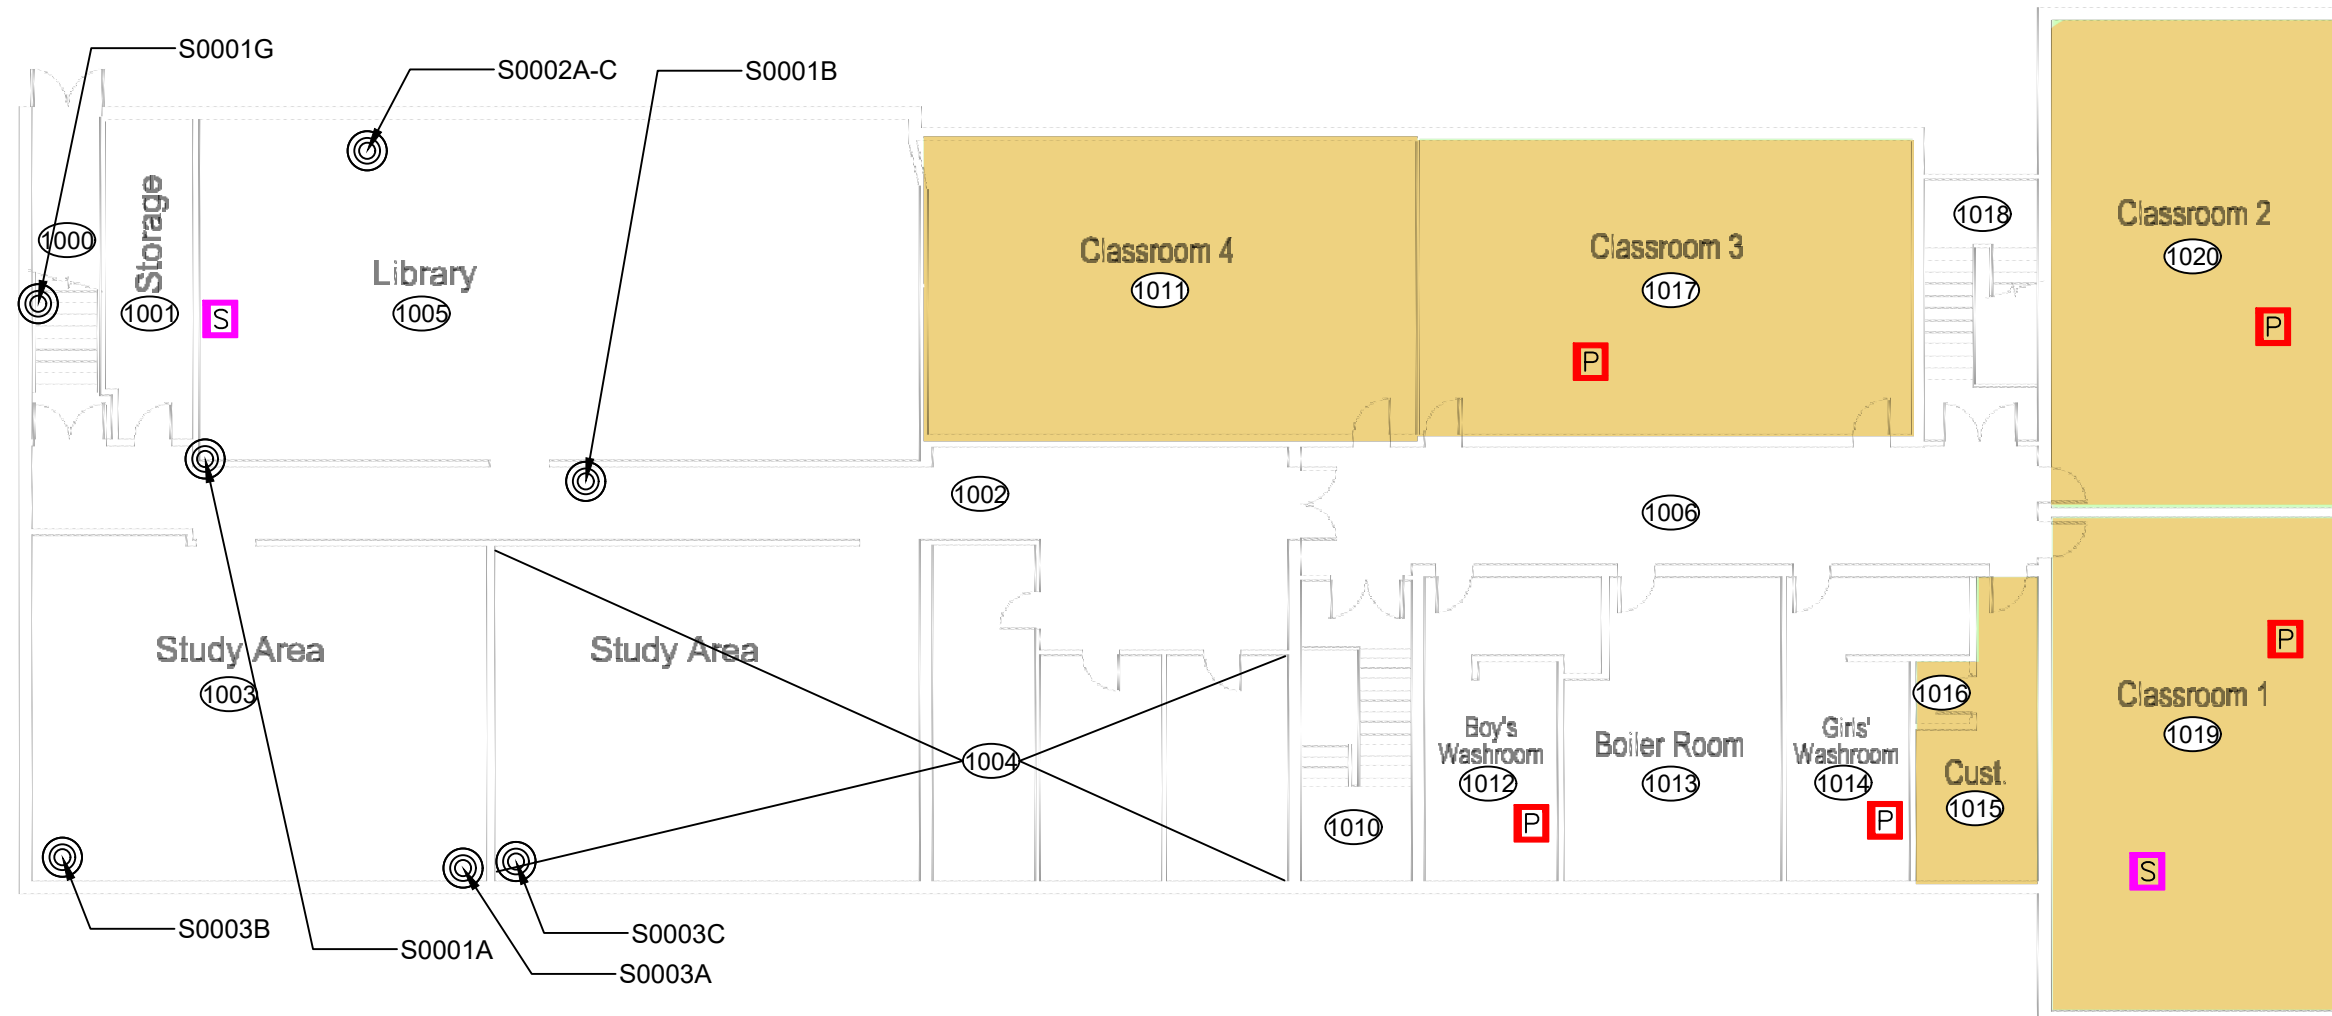
NOTE:  
ASBESTOS-CONTAINING DRYWALL IS PRESENT ON WALLS AND CEILING FINISHES THROUGHOUT THE BUILDING
