# Asbestos Assessment

Sacred Heart of Jesus  
5 Hamilton Ave, Hamilton, ON, L8V  
2SC

August 31, 2023

Pinchin File: 320582.004

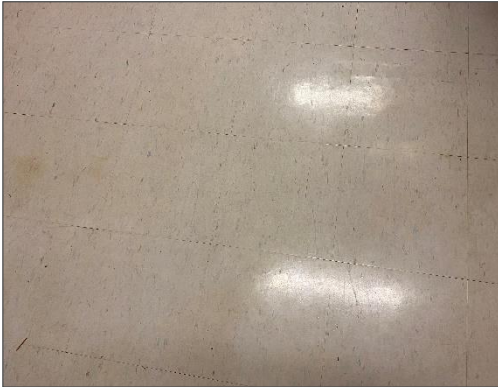
<p>Vinyl floor tiles, 12"x12", grey oatmeal, are present.</p>	<p>Presumed (tile) Presumed (mastic)</p>

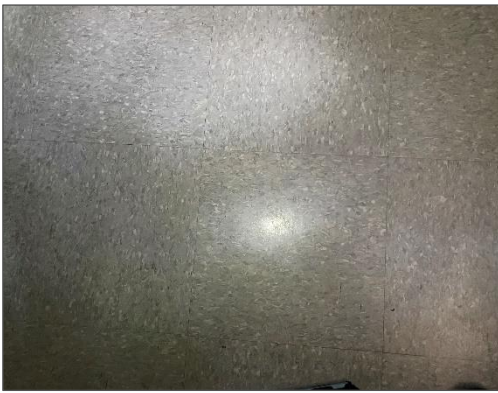
<p>Vinyl floor tiles, 12"x12", white with black specks, are present.</p>	<p>Presumed (tile) Presumed (mastic)</p>

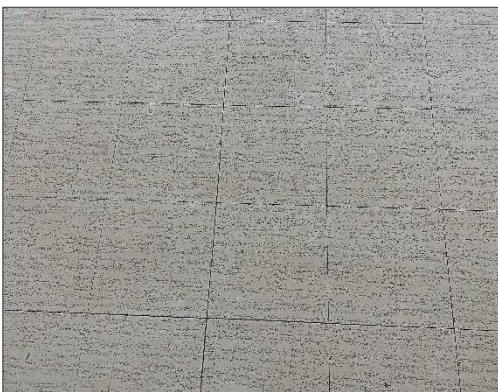
Material and Application	Asbestos Type	Photo
Vinyl floor tiles and mastic are presumed to be non-asbestos based on historical knowledge of the date of installation (2002).	None	
Gold sink undercoating is present.	Presumed
