# Asbestos Assessment

St. Agnes  
80 Colcrest Street, Hamilton, ON,  
L8E 3Y8

August 31, 2023

Pinchin File: 320582.004

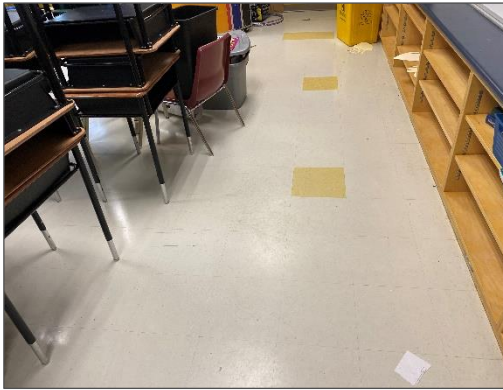
Material and Application	Asbestos Type	Photo
<p>Vinyl sheet flooring is presumed to be non-asbestos based on historical knowledge of the type of flooring (foam) or based on the lack of a paper backing layer (underpad).</p> <p>Mastic under non-asbestos vinyl sheet flooring is presumed to contain asbestos until further sampling is performed.</p>	<p>None (flooring)            Presumed (mastic)</p>	
<p>Vinyl floor tiles are presumed to be non-asbestos based on historical knowledge of the date of installation (2006).</p> <p>Mastic under non-asbestos tiles is presumed to contain asbestos until further sampling is performed.</p>	<p>None (tile)            Presumed (mastic)</p>
