Asbestos Assessment

St. Ann
24 Fiddlers Green Road, Ancaster,
ON, L9G 1W1

August 31, 2023

Pinchin File: 320582.004

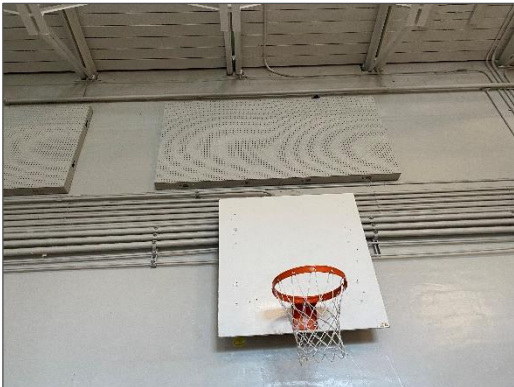
Material and Application	Asbestos Type	Photo
<p>Asbestos in drywall joint compound was banned in Canada in 1980. Drywall joint compound in the 1994 addition was installed after 1986 (1980 plus a reasonable non-compliance period based on our experience) and the drywall joint compound is assumed to contain no asbestos.</p>	<p>None</p>	
<p>Transite board is present as acoustic panels in the Gymnasium (Location 130).</p>	<p>Presumed</p>

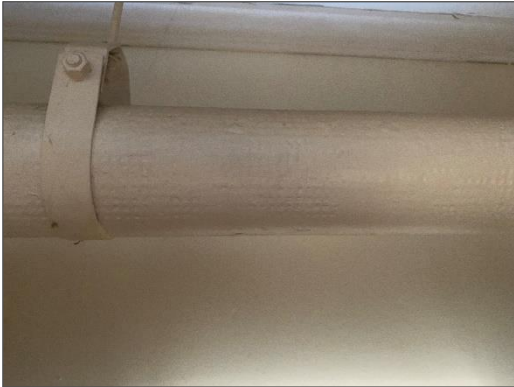
<p>Transite pipe is present as rainwater leaders.</p>	<p>Presumed</p>

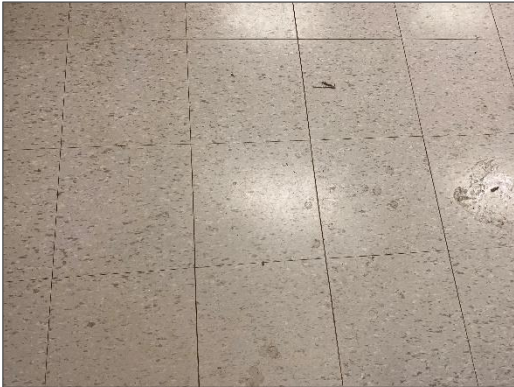
Material and Application	Asbestos Type	Photo
Vinyl floor tiles, 12"x12", various colours, are present.	Presumed (tile) Presumed (mastic)
