Asbestos Assessment

St. Ann (Hamilton)
15 St. Ann Street, Hamilton, ON,
L8L 0B8

August 31, 2023

Pinchin File: 320582.004

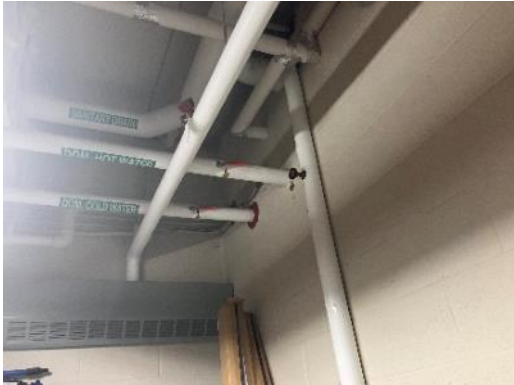
Material and Application	Asbestos Type	Photo
Pipes are either uninsulated or insulated with non-asbestos fibreglass or elastomeric insulation (Armaflex).	None

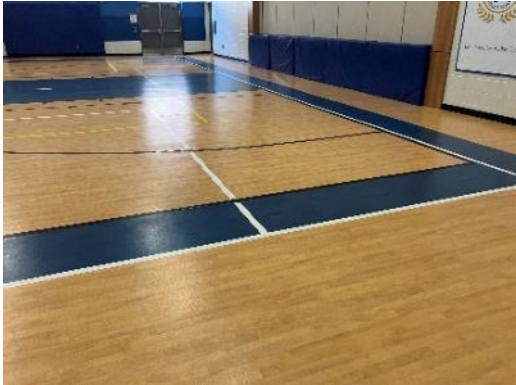
Material and Application	Asbestos Type	Photo
<p>Vinyl sheet flooring is presumed to be non-asbestos based on historical knowledge of the type of flooring (foam) or based on the lack of a paper backing layer (underpad).</p>	<p>None</p>

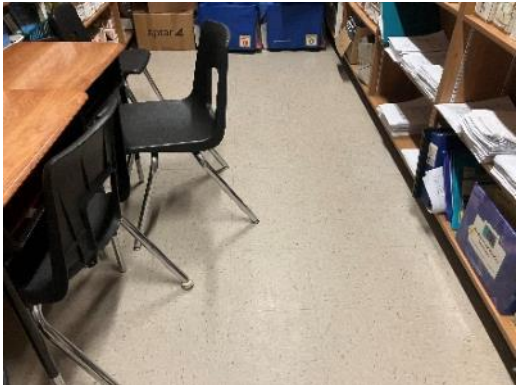
<p>Vinyl floor tiles and mastic were presumed to be non-asbestos based on historical knowledge of the date of installation.</p>	<p>None</p>
