Asbestos Assessment

St. Anthony Daniel
75 Anson Avenue, Hamilton, ON,
L8T 2X5

**Hamilton-Wentworth Catholic
District School Board**

August 31, 2023

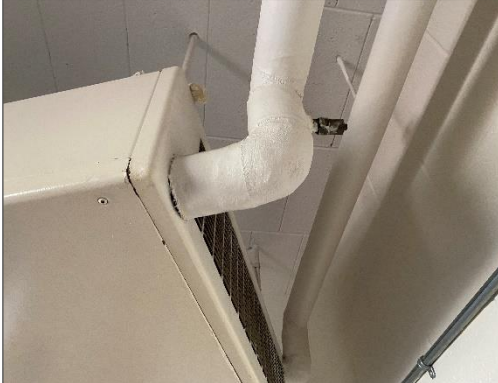
Material and Application	Asbestos Type	Photo
Texture finish is present on the concrete deck.	None	
Parging cement is present on pipe fittings (elbows, valves, tees, hangers etc.).	Chrysotile

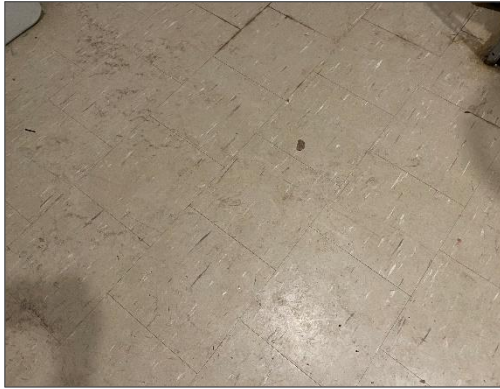
Material and Application	Asbestos Type	Photo
All ceiling tiles are non-asbestos from previous sampling, presumed to be non-asbestos based on the date of manufacture determined from the date stamp applied to the top of the tiles and the age of the materials determined from the age of the building.	None	
Plaster is present on walls and ceilings.	None	
Drywall joint compound is present on wall and ceiling finishes.	None	
Vinyl floor tiles, 12"x12" light brown with brown and white streaks are present.	Chrysotile (tile) Chrysotile (mastic)

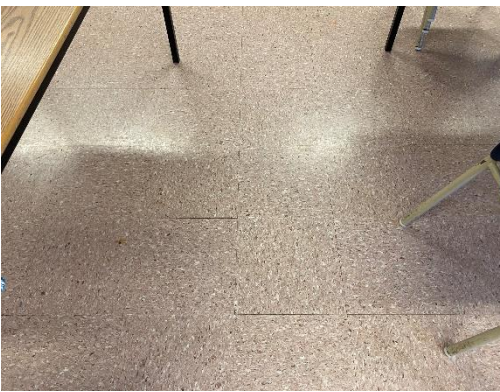
Vinyl floor tiles, 12"x12" pink oatmeal are present.	None (tile) Chrysotile (mastic)

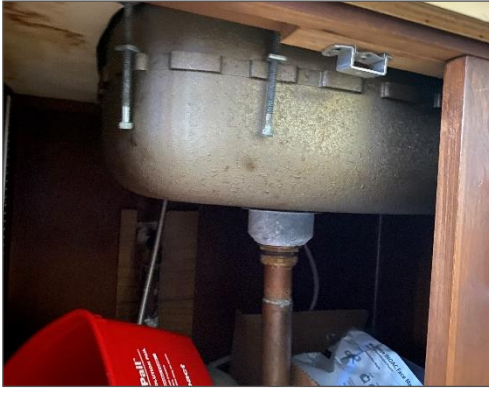
Material and Application	Asbestos Type	Photo
Gold sink undercoating is present.	Presumed
