Asbestos Assessment

St. Augustine
25 Alma Street, Dundas, ON, L9H
2C9

August 31, 2023

Pinchin File: 320582.004

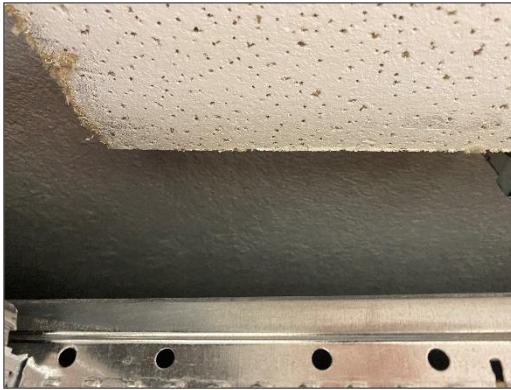
Material and Application	Asbestos Type	Photo
Fireproofing is present on structural steel including beams, trusses, joists, corrugated steel deck, concrete deck, columns.	None	
Texture finish is present on ceilings.	Chrysotile

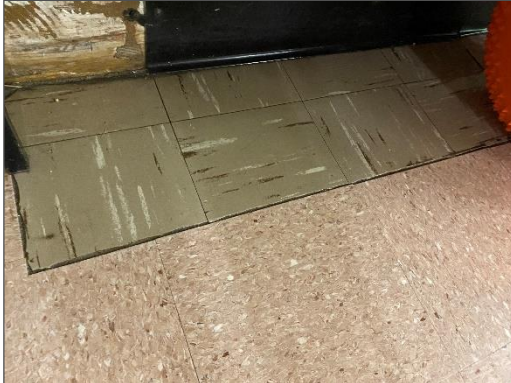
Material and Application	Asbestos Type	Photo
Mechanical equipment is either uninsulated or insulated with non-asbestos fibreglass.	None	
All ceiling tiles are non-asbestos from previous sampling, presumed to be non-asbestos based on the date of manufacture determined from the date stamp applied to the top of the tiles.	None	
Smooth plaster is present on walls and ceilings.	None	
Drywall joint compound is present on wall finishes.	None	
Asbestos in drywall joint compound was banned in Canada in 1980. The post-1990 addition was constructed after 1986 (1980 plus a reasonable non-compliance period based on our experience) and the drywall joint compound is assumed to contain no asbestos.	None	
Vinyl floor tiles, 12"x12", various colours, are present.	Presumed (tile) Presumed (mastic)

<p>Remaining vinyl floor tiles are presumed to be non-asbestos based on historical knowledge of the date of installation.</p> <p>Mastic under select non-asbestos tiles is presumed to contain asbestos until further sampling is performed.</p>	None (tile) Presumed (mastic)
