Asbestos Assessment

St. Charles Barlake
60 Barlake Avenue, Hamilton, ON,
L8E 1G7

**Hamilton-Wentworth Catholic
District School Board**

August 31, 2023

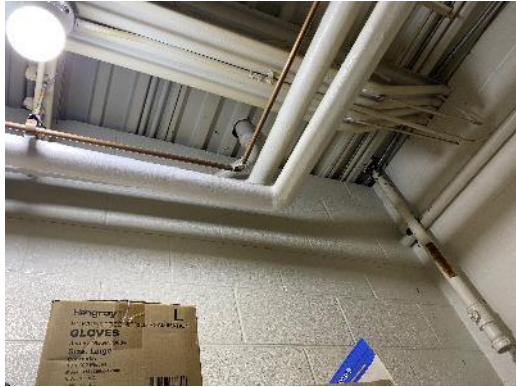
Material and Application	Asbestos Type	Photo
Parging cement is present on pipe fittings (elbows, valves, tees, hangers etc.).	Chrysotile

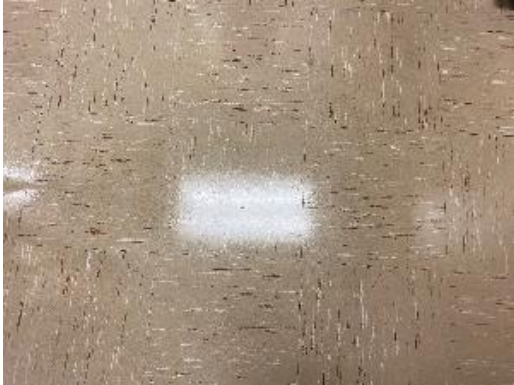
Material and Application	Asbestos Type	Photo
Drywall joint compound is present on wall and ceiling finishes.	None	
Vinyl floor tiles, 12"x12", beige with brown and white streaks, are present.	Chrysotile (tile) None (mastic)

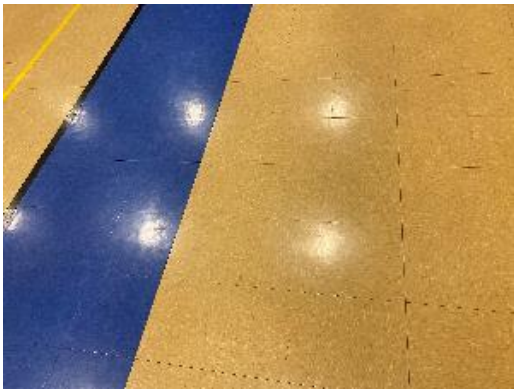
Vinyl floor tiles, 12"x12", beige dense fleck, are present.	None (tile) Presumed (mastic)

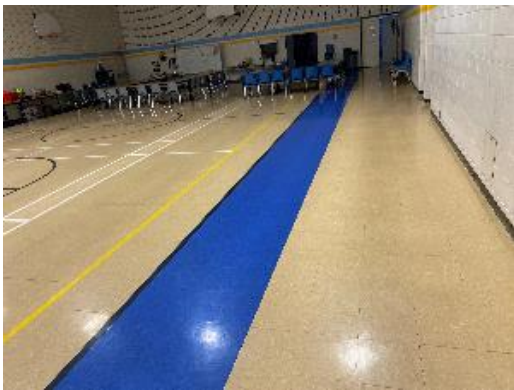
Vinyl floor tiles, 12"x12", blue dense fleck, are present.	None (tile) Presumed (mastic)

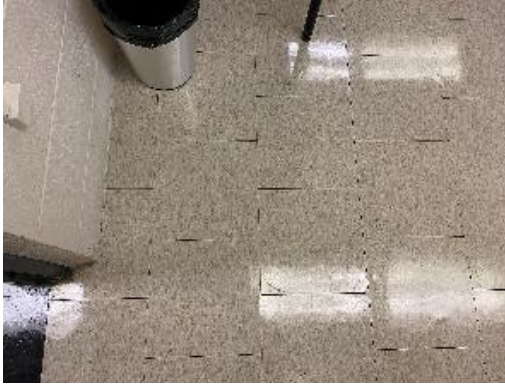
Material and Application	Asbestos Type	Photo
Vinyl floor tiles, 12"x12", light grey multi fleck, are present.	Presumed (tile) Presumed (mastic)

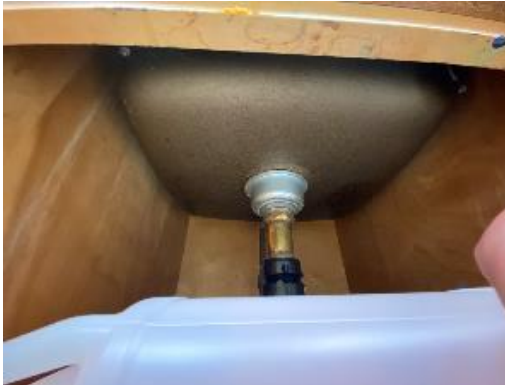
Gold mastic is present as a sink undercoating.	Presumed
