Asbestos Assessment

St. Charles Centre
45 Young Street, Hamilton, ON,
L8N 1V1

August 31, 2023

Pinchin File: 320582.004

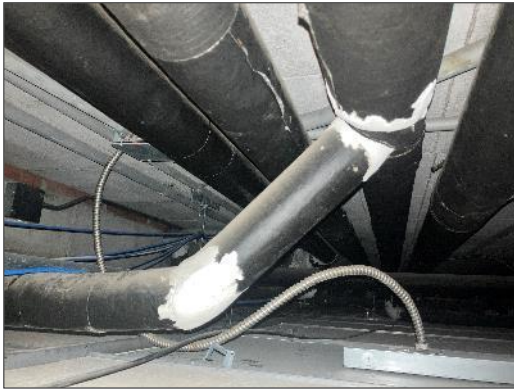
Material and Application	Asbestos Type	Photo
Parging cement is present on pipe fittings (elbows, valves, tees, hangers etc.).	Chrysotile

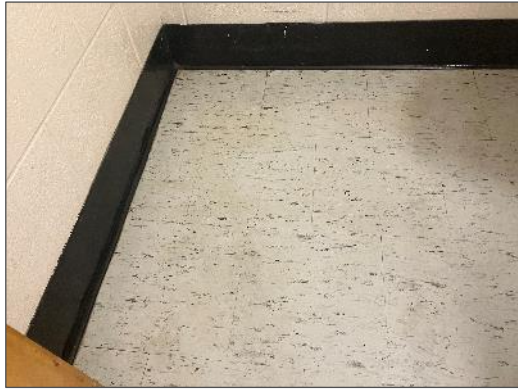
Material and Application	Asbestos Type	Photo
<p>Vinyl floor tiles, 9"x9" and 12"x12", various colours, are present.</p>	<p>Presumed (tile) Presumed (mastic)</p>

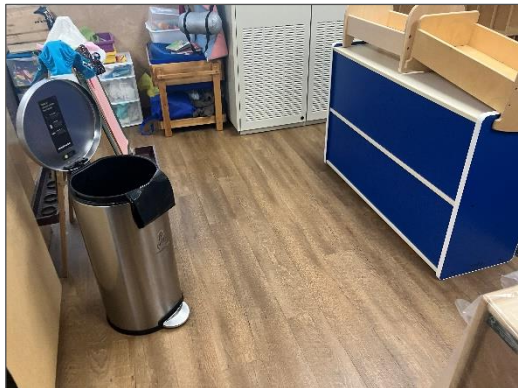
<p>Remaining vinyl floor tiles/vinyl plank flooring are presumed to be non-asbestos based on the material (rubber) and the historical knowledge of the date of installation.</p> <p>Mastic under non-asbestos tiles is presumed to contain asbestos until further sampling is performed.</p>	<p>None (tile) Presumed (mastic)</p>

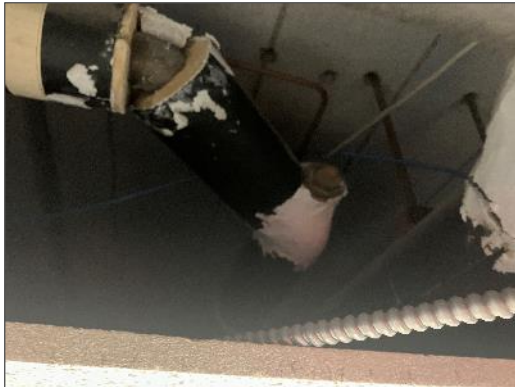
Photo 1

Material, Quantity, Condition, Photo #	Location (Location #)	Recommended Procedure
<p>Pipe insulation, 1 fitting, poor condition, Photo 1</p>	<p>Women's Washroom (Location 1008)</p>	<p>Asbestos precautions for work in ceiling space which may disturb asbestos in poor condition.</p>
