Asbestos Assessment

St. Charles Mountain
150 East 5th Street, Hamilton, ON,
L9A 2Z8

August 31, 2023

Pinchin File: 320582.004

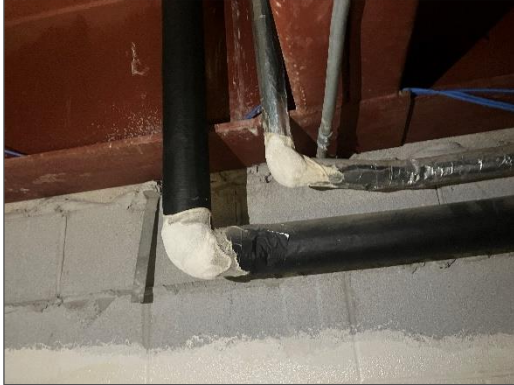
| Material and Application | Asbestos Type | Photo |
|---|---|---|
| Parging cement is present on pipe fittings (elbows, valves, tees, hangers etc.). | Chrysotile | |

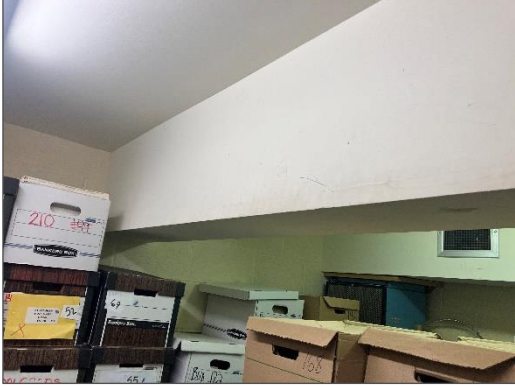
| Material and Application | Asbestos Type | Photo |
|---|--|--|
| Drywall joint compound is present on wall and ceiling finishes. | Chrysotile | |

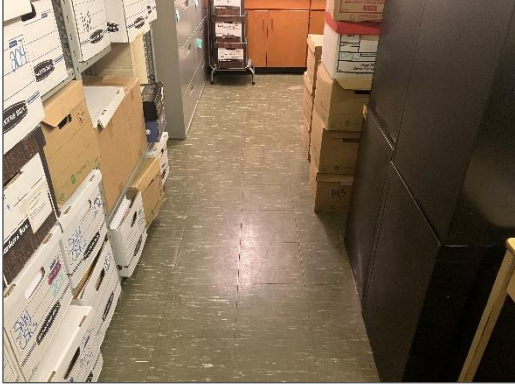
| Material and Application | Asbestos Type | Photo |
|---|--|--|
| Vinyl floor tiles, 12"x12", dark green with white streaks, are present. | Chrysotile (tile) Chrysotile (mastic) | |

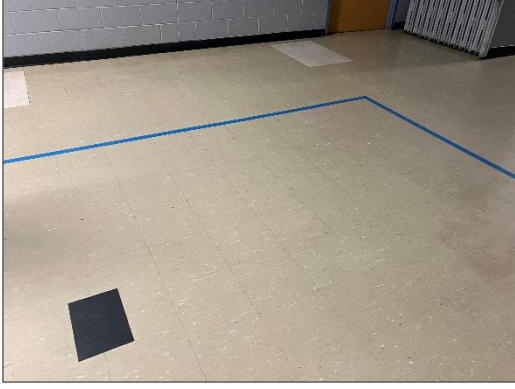
| Material and Application | Asbestos Type | Photo |
|---|--|--|
| Vinyl floor tiles, 12"x12", various colours, are present. | Presumed (tile) Presumed (mastic) | |

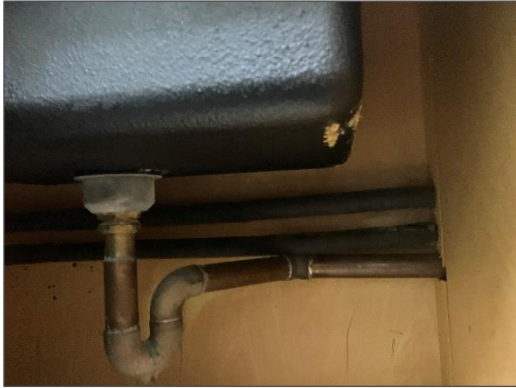
| Material and Application | Asbestos Type | Photo |
|--|---|--|
| Black and gold sink undercoating is present. | Presumed | |
