# Asbestos Reassessment

St. Clare of Assisi  
185 Glenashton Drive, Stoney  
Creek, Ontario

May 15, 2023

Pinchin File: 320582.001

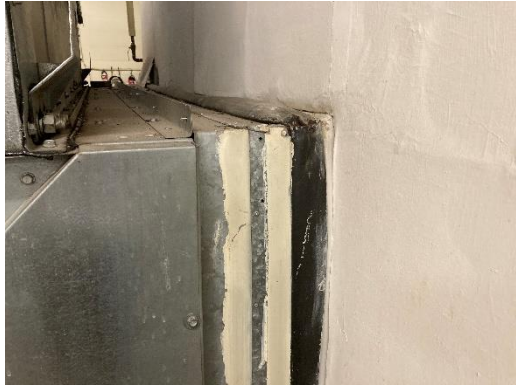
Material and Application	Asbestos Type	Photo
Pipes are either uninsulated or insulated with non-asbestos fibreglass or elastomeric insulation (Armaflex).	None	
Texture finish is present on the concrete soffit.	None Detected	
Ducts are either uninsulated or insulated with non-asbestos fibreglass (foil-faced or canvas).	None	
Vibration dampeners are present on HVAC equipment.	Presumed

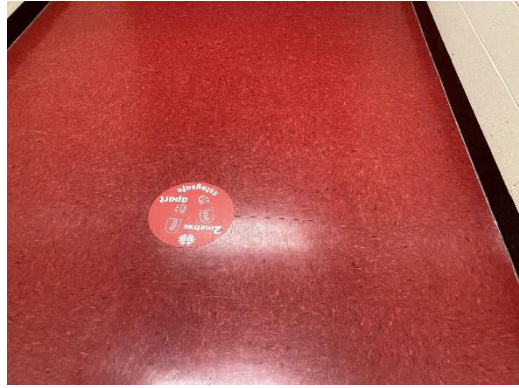
Material and Application	Asbestos Type	Photo
<p>Vinyl floor tiles and mastic, 12"x12" red, are present in the Gymnasium (Location 1006).</p>	<p>None (tile) Chrysotile (mastic)</p>

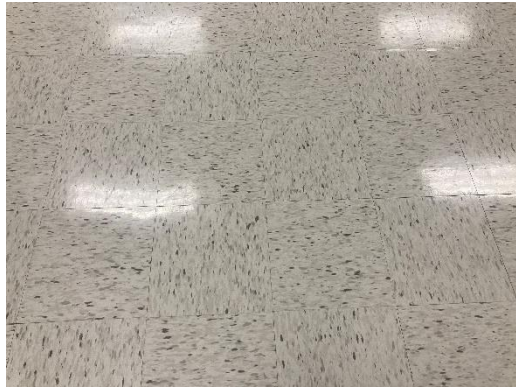
<p>Vinyl floor tiles throughout the building were presumed to be non-asbestos based on historical knowledge of the date of installation.</p> <p>Mastic under non-asbestos vinyl floor tiles is presumed to contain asbestos until further sampling can prove otherwise.</p>	<p>None (tile) Presumed (mastic)</p>

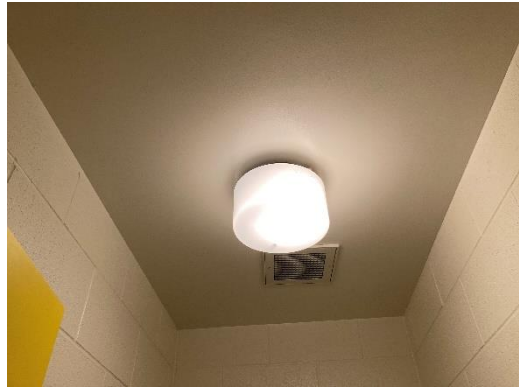
<p>Paper heat shields are present in light fixtures.</p>	<p>Presumed</p>

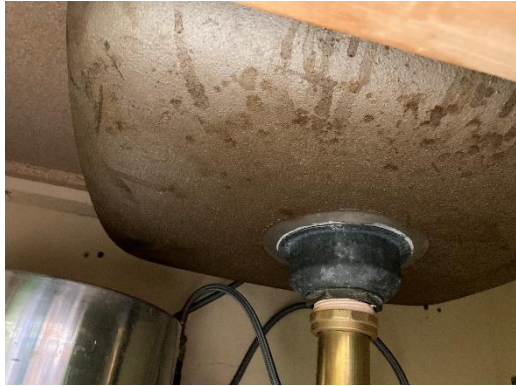
Material and Application	Asbestos Type	Photo
Gold sink undercoating is present.	Presumed
