Asbestos Assessment

St. David
33 Cromwell Crescent, Hamilton,
ON, L8G 2E9

**Hamilton-Wentworth Catholic
District School Board**

August 31, 2023

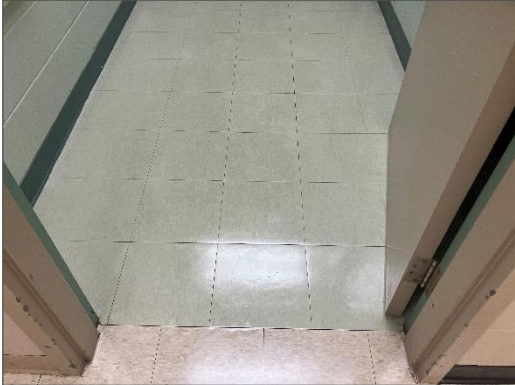
Material and Application	Asbestos Type	Photo
<p>Vinyl floor tiles, 12"x12" light green multi-fleck and 12"x12" green multi-fleck, are present.</p>	<p>None (tile) None (mastic)</p>

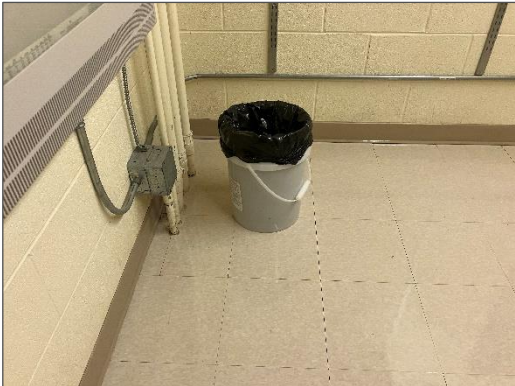
<p>Remaining vinyl floor tiles are presumed to be non-asbestos based on historical knowledge of the date of installation.</p> <p>Mastic under non-asbestos tiles is presumed to contain asbestos until further sampling is performed.</p>	<p>None (tile) Presumed (mastic)</p>
