## **Asbestos Assessment**

St. Eugene  
120 Parkdale Avenue South,  
Hamilton, ON, L8K 3P3

**Hamilton-Wentworth Catholic  
District School Board**

August 31, 2023

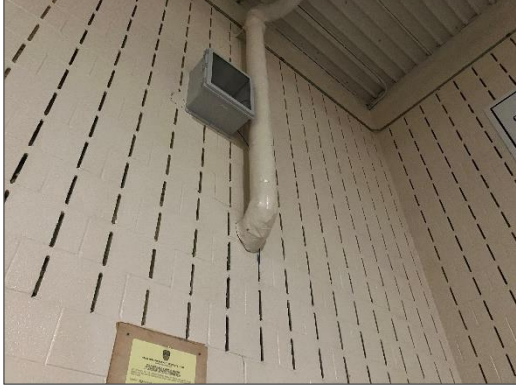
Material and Application	Asbestos Type	Photo
Non-asbestos texture finish was previously identified in the Entrance/Stairwell.	None	
Parging cement is present on pipe fittings (elbows, valves, tees, hangers etc.).	Chrysotile

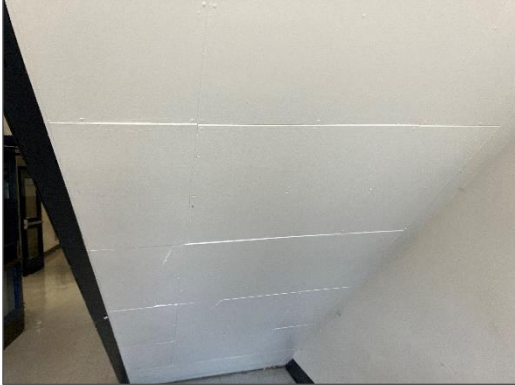
Material and Application	Asbestos Type	Photo
An intrusive investigation of accessible masonry block walls was conducted in 2020, and no vermiculite was present in locations investigated.	None	
All ceiling tiles are non-asbestos from previous sampling, presumed to be non-asbestos based on the date of manufacture determined from the date stamp applied to the top of the tiles and the age of the materials determined from the age of the building renovation.	None	
Plaster is present on walls and ceilings.	None	
Drywall joint compound is present on wall and ceiling finishes.	None	
Asbestos in drywall joint compound was banned in Canada in 1980. The building was constructed after 1986 (1980 plus a reasonable non-compliance period based on our experience) and the drywall joint compound is assumed to contain no asbestos.	None	
Transite board is present as a ceiling finish in stairwells.	Presumed

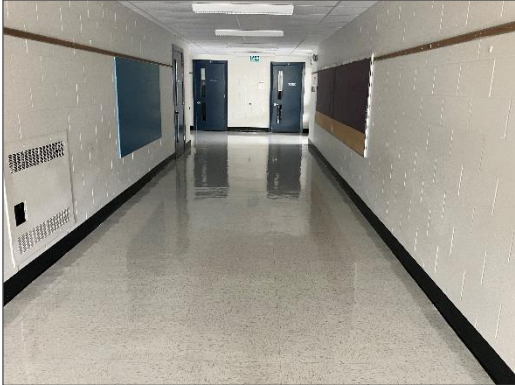
<p>Vinyl floor tiles, 9"x9", various colours, are presumed to be present and concealed under new non-asbestos tiles.</p>	<p>Chrysotile/Presumed (tile) Chrysotile/Presumed (mastic)</p>	
<p>Remaining vinyl floor tiles are presumed to be non-asbestos based on historical knowledge of the date of installation.</p> <p>Mastic under non-asbestos tiles or new rubber flooring is presumed to contain asbestos until further sampling is performed.</p>	<p>None (tile) Presumed (mastic)</p>	
<p>Textured paint/primer is present on walls.</p>	<p>None</p>	
<p>A coating/compound is underneath the paint in the Corridor (Location 4010). This coating/compound is presumed to be throughout the school until further sampling confirms otherwise.</p>	<p>Chrysotile</p>

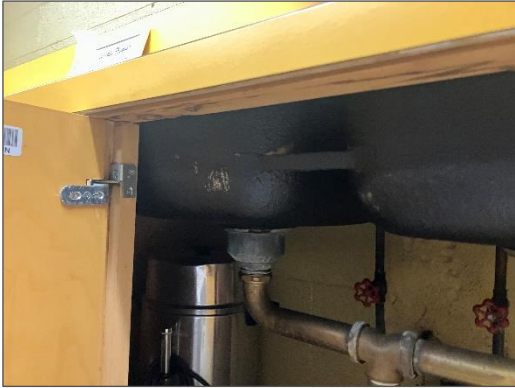
Material and Application	Asbestos Type	Photo
Black sink undercoating is present.	Chrysotile
