Asbestos Assessment

St. Francis Xavier
298 Highway 8, Stoney Creek, ON,
L8G 1E6

**Hamilton-Wentworth Catholic
District School Board**

August 31, 2023

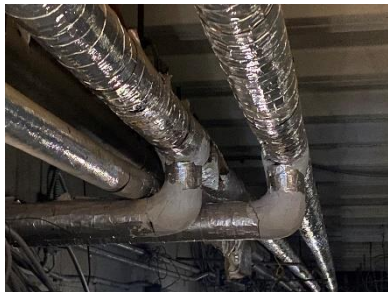
Material and Application	Asbestos Type	Photo
Non-asbestos fireproofing is present on structural steel including beams, trusses, joists, corrugated steel deck, concrete deck, columns.	None	N/A
Parging cement is present on pipe fittings (elbows, valves, tees, hangers etc.).	Chrysotile

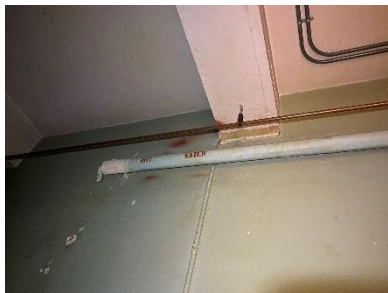
A white corrugated paper insulation (trade name Aircell), containing chrysotile asbestos, is present on straight sections of domestic water system pipes.	Chrysotile

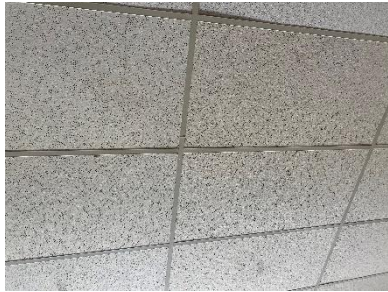
Material and Application	Asbestos Type	Photo
Ducts are either uninsulated or insulated with non-asbestos fibreglass (foil-faced or canvas).	None	N/A
Mechanical equipment is either uninsulated or insulated with non-asbestos fibreglass.	None	N/A
24"x48" lay-in ceiling tiles, with a honeycomb pattern, are present.	Amosite

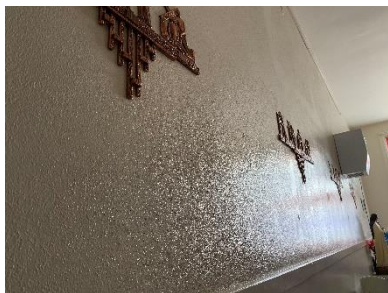
12"x12" lay-in ceiling tiles, with a long fissure random pinhole pattern, are present.	None	N/A
24"x48" lay-in ceiling tiles, with a small pinhole pattern, are present.	None	N/A
Remaining ceiling tiles are presumed to be non-asbestos based on the date of manufacture determined from the date stamp applied to the top of the tiles or the age of the materials determined from the age of the renovation.	None	N/A
Textured plaster, containing asbestos, is present on walls in Classroom 24 (Location 2007), Chapel (Location 2008) and Classroom 25 (Location 2009).	Chrysotile

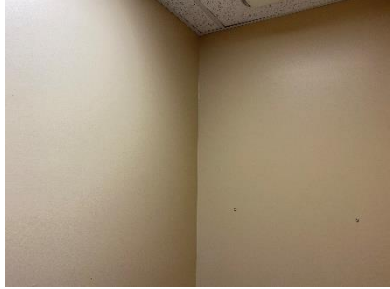
Material and Application	Asbestos Type	Photo
Drywall joint compound is present on wall and ceiling finishes throughout the building.	Chrysotile

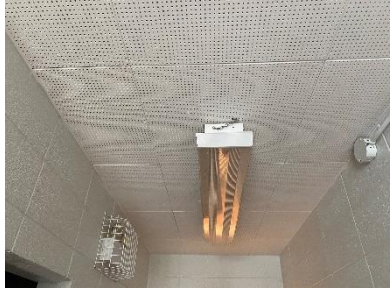
Non-asbestos drywall joint compound is present on remaining wall and ceiling finishes throughout the building.	None	N/A
Transite board is present as ceiling tiles.	Presumed

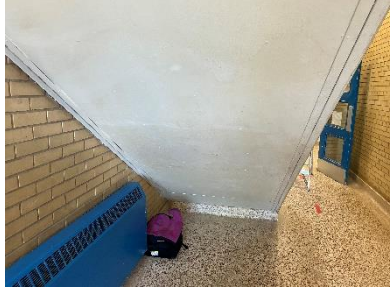
Transite board is present beneath the stairs in the Stairwell (Location 1028).	Presumed

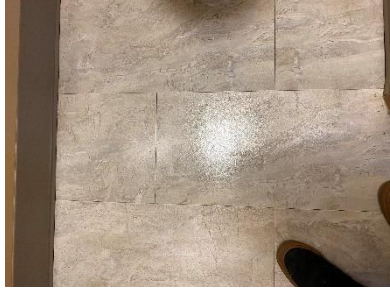
Vinyl sheet flooring, with a marbled pattern is present,	Presumed (sheet flooring) Presumed (mastic)

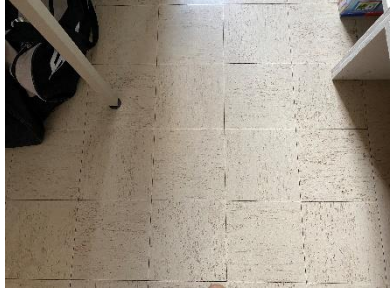
Material and Application	Asbestos Type	Photo
Vinyl floor tiles, 9"x9", cream with brown streaks, are present.	Presumed (tile) Presumed (mastic)

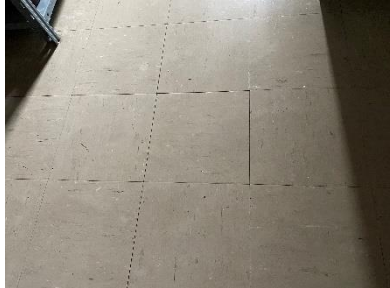
Vinyl floor tiles, 12"x12", beige with white and grey streaks, are present.	Presumed (tile) Presumed (mastic)

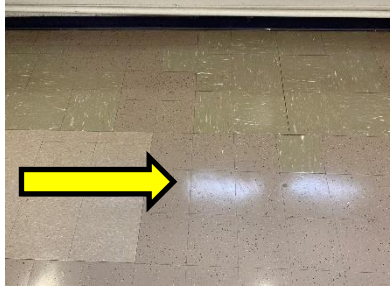
Vinyl floor tiles, 12"x12", white with black speck, are present.	Presumed (tile) Presumed (mastic)	N/A
Vinyl floor tiles, 9"x9", brown with green/red/blue spots, are present.	Presumed (tile) Presumed (mastic)

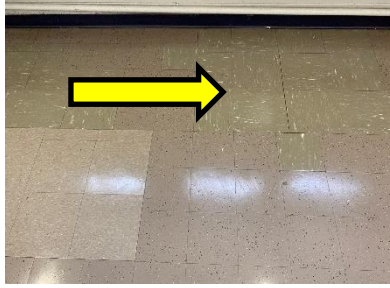
Vinyl floor tiles, 12"x12", green with streaks, are present.	Presumed (tile) Presumed (mastic)

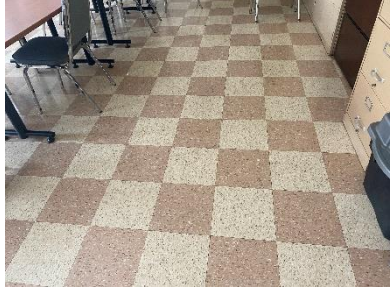
Material and Application	Asbestos Type	Photo
Vinyl floor tiles, 12"x12", pink marbled, are present.	None (tile) Presumed (mastic)
