Asbestos Assessment

St. Gabriel
1361 Barton St, Stoney Creek, ON
L8E 5L1

August 31, 2023

Pinchin File: 320582.004

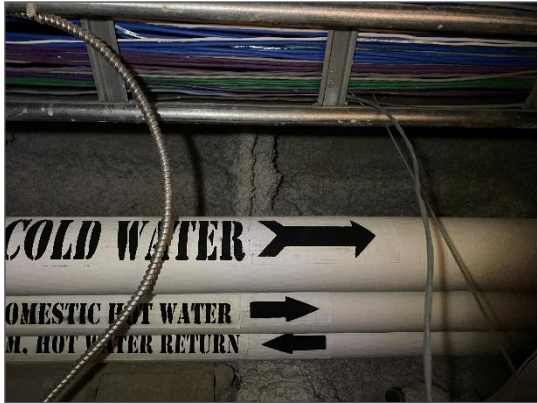
Material and Application	Asbestos Type	Photo
<p>Pipes are either uninsulated or insulated with non-asbestos fibreglass or elastomeric insulation (Armaflex).</p>	<p>None</p>

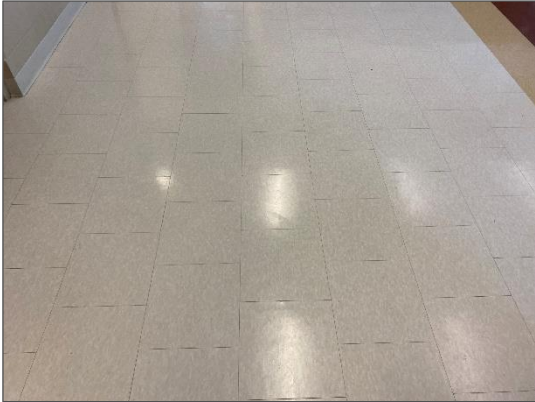
Material and Application	Asbestos Type	Photo
Vinyl floor tiles and mastic were presumed to be non-asbestos based on historical knowledge of the date of installation.	None
