## **Asbestos Assessment**

St. Jean de Brebeuf  
200 Acadia Drive, Hamilton, ON,  
L8W 1B8

**Hamilton-Wentworth Catholic  
District School Board**

August 31, 2023

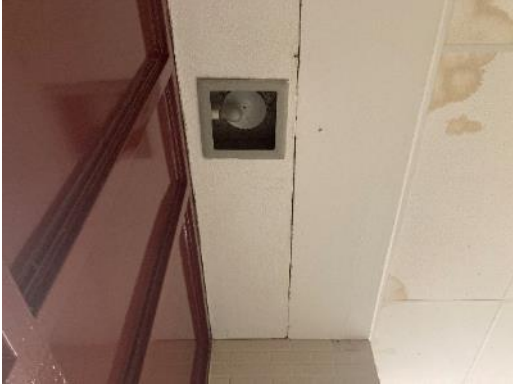
Material and Application	Asbestos Type	Photo
Fireproofing is present on structural steel including beams, trusses, joists, corrugated steel deck, concrete deck, columns.	None	
<p>Texture finish is present on plaster ceilings in the Chapel (Location 1055).</p> <p>Texture finish is also present on the soffit in the Hallway (Location 1041).</p> <p>Overspray from the asbestos-containing texture coat is presumed to be present above the ceiling at light fixture openings, on the deck, ducts and within junction boxes.</p>	Chrysotile

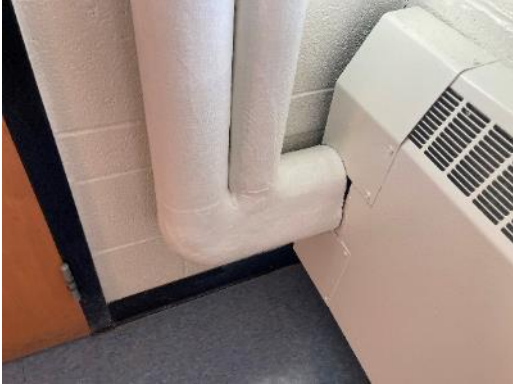
Material and Application	Asbestos Type	Photo
<p>Parging cement is present on pipe fittings (elbows, valves, tees, hangers etc.) and over sweatwrap on pipe straights.</p>	<p>Chrysotile</p>

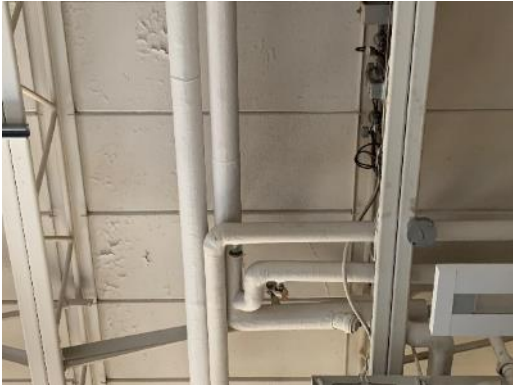
<p>A white corrugated paper insulation (trade name Aircell), containing chrysotile asbestos, is present on straight sections of domestic water and heating system pipes.</p>	<p>Chrysotile</p>

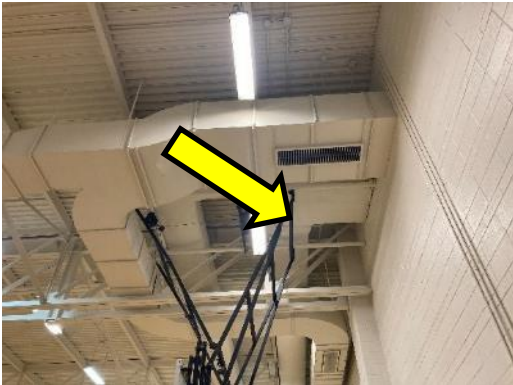
<p>Ducts are presumed to be insulated with fiberglass and parging cement in the Gymnasium (Location 1100) but were not confirmed due to the elevated height of the material.</p>	<p>Presumed</p>

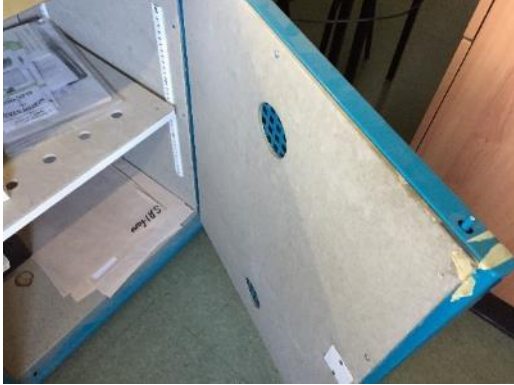
Material and Application	Asbestos Type	Photo
Mechanical equipment is either uninsulated or insulated with non-asbestos fibreglass.	None	
All ceiling tiles are non-asbestos from previous sampling or presumed to be non-asbestos based on the date of manufacture determined from the date stamp applied to the top of the tiles.	None	
Smooth plaster is present on walls and ceilings.	None	
Drywall joint compound is present on wall and ceiling finishes.	None	
Asbestos in drywall joint compound was banned in Canada in 1980. The 2018 addition was constructed after 1986 (1980 plus a reasonable non-compliance period based on our experience) and the drywall joint compound is assumed to contain no asbestos.	None	
Transite pipe is present as rain water leaders.	Presumed	
Transite board is present in fume hoods and acid/base storage cabinets.	Presumed

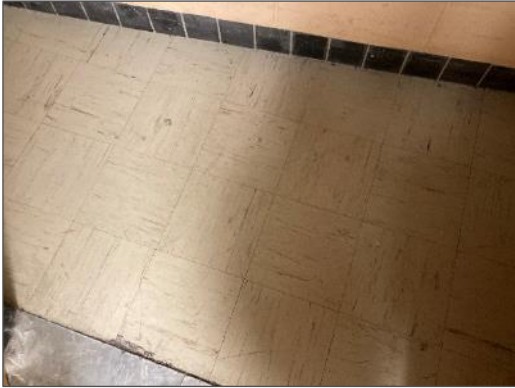
Material and Application	Asbestos Type	Photo
<p>Vinyl floor tiles, 9"x9" and 12"x12", various colours, are present.</p>	<p>Presumed (tile) Chrysotile/Presumed (mastic)</p>

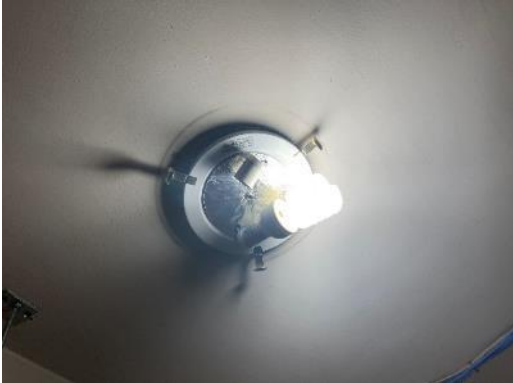
<p>Remaining vinyl floor tiles are presumed to be non-asbestos based on historical knowledge of the date of installation or confirmed non-asbestos based on previous sampling.</p> <p>Mastic under non-asbestos tiles is presumed to contain asbestos until further sampling is performed.</p>	<p>None (tile) Presumed (mastic)</p>	
<p>Vinyl floor tiles and mastic in the 2018 addition are presumed to be non-asbestos based on historical knowledge of the date of installation.</p>	<p>None</p>	
<p>Foil faced heat shield paper is present in incandescent light fixtures.</p>	<p>Chrysotile</p>

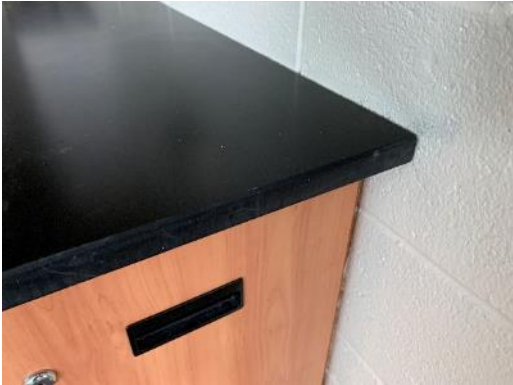
Material and Application	Asbestos Type	Photo
Bakelite is present as sinks and countertops.	Presumed

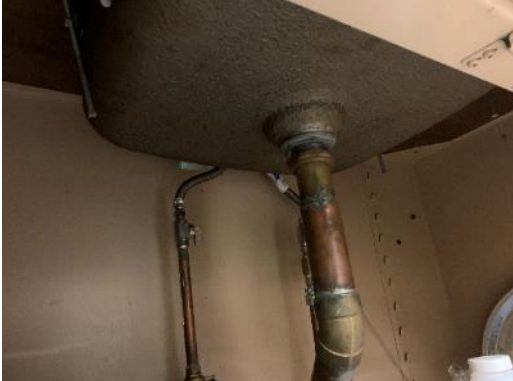
Caulking, in various colours, is present throughout the exterior of the building around window frames, louvers, and expansion joints.	Chrysotile	
Gold mastic is present as a sink undercoating.	Presumed

- Caulking was collected and analyzed during a project-specific assessment. Remaining caulking in the building was not included in this assessment due to limitations in scope and methodology. Where present, other caulking not sampled is assumed to contain asbestos until otherwise proven by sampling and analysis.
