Asbestos Assessment

St. Joachim
75 Concerto Crescent, Ancaster,
ON, L9G 4V6

**Hamilton-Wentworth Catholic
District School Board**

August 31, 2023

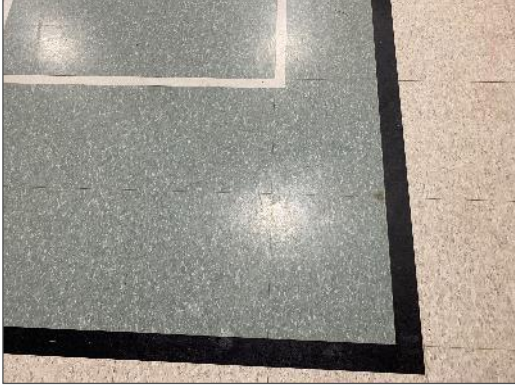
Material and Application	Asbestos Type	Photo
<p>Remaining vinyl floor tiles and mastic are presumed to contain asbestos until sampling proves otherwise.</p>	<p>Presumed (tile) Presumed (mastic)</p>

Sample presumed ACM prior to alteration or maintenance work if the presumed ACM may be disturbed by the work.

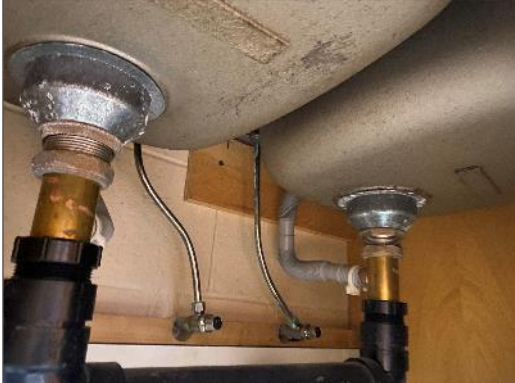
<p>Gold sink undercoating is present.</p>	<p>Chrysotile</p>

Remove asbestos-containing materials (ACM) prior to alteration or maintenance work if ACM may be disturbed by the work. Follow appropriate asbestos precautions for the classification of work being performed.
