Asbestos Assessment

St. John Henry Newman
127 Grays Road, Stoney Creek,
ON, L8G 3V3

August 31, 2023

Pinchin File: 320582.004

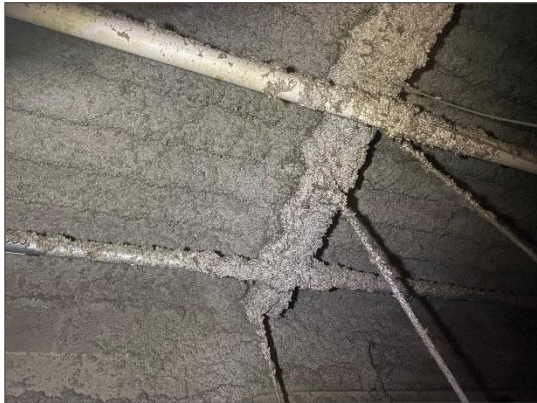
Material and Application	Asbestos Type	Photo
<p>Fireproofing is present on structural steel including beams, trusses, joists, corrugated steel deck, concrete deck, columns and is non-asbestos based on the date of construction.</p>	<p>None</p>

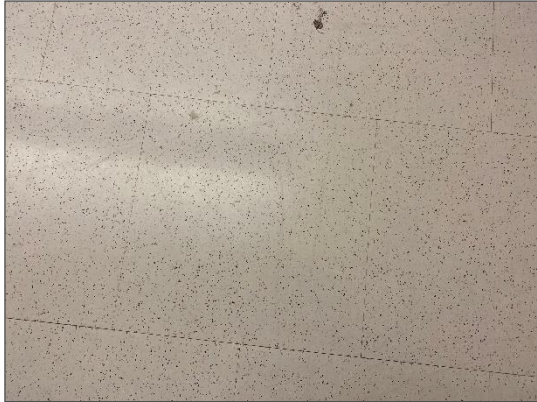
Material and Application	Asbestos Type	Photo
<p>Vinyl floor tiles and mastic were presumed to be non-asbestos based on historical knowledge of the date of installation.</p>	<p>None</p>
