Asbestos Assessment

St. John the Baptist
115 London Street South, Hamilton,
ON, L8K 2G6

Hamilton-Wentworth Catholic District School Board

August 31, 2023

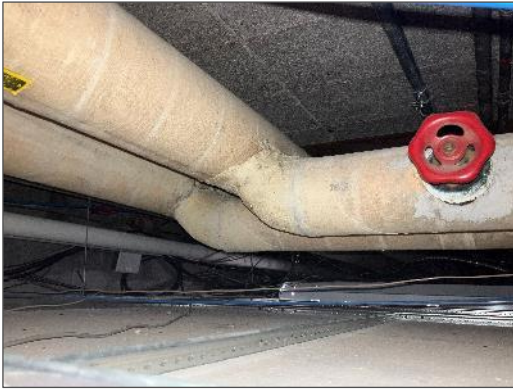
Material and Application	Asbestos Type	Photo
Fireproofing is present on structural steel including beams, trusses, joists, corrugated steel deck, concrete deck, columns.	None	
Parging cement is present on pipe fittings (elbows, valves, tees, hangers etc.).	Chrysotile

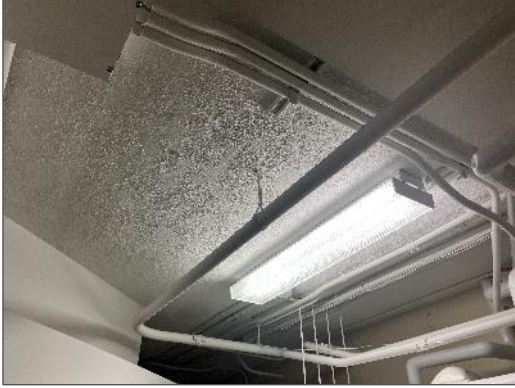
Material and Application	Asbestos Type	Photo
All ceiling tiles are non-asbestos from previous sampling or presumed to be non-asbestos based on the date of manufacture determined from the date stamp applied to the top of the tiles.	None	
Textured plaster is present as a ceiling finish.	Chrysotile

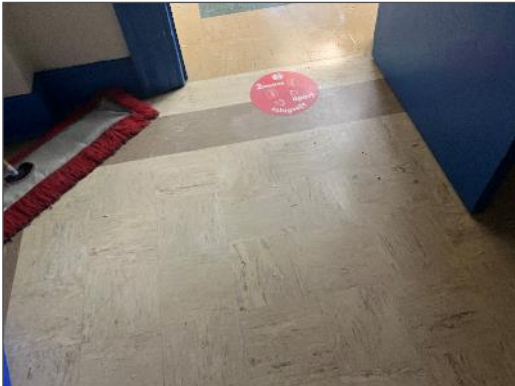
Vinyl floor tiles, 9"x9", golden with red, are present.	Chrysotile (tile) None (mastic)

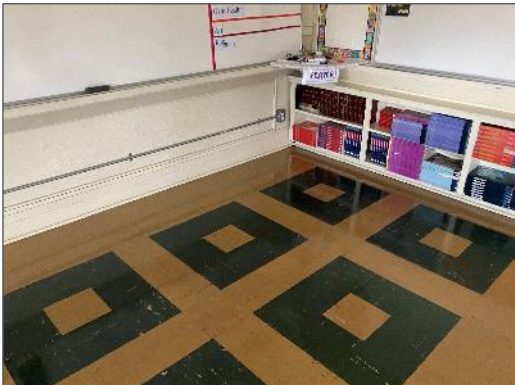
Vinyl floor tiles, 9"x9" and 12"x12", various colours, and mastic are present.	Presumed (tile) Presumed (mastic)
