## **Asbestos Assessment**

St. Joseph  
270 Locke Street South, Hamilton,  
ON L8P 4C1

**Hamilton-Wentworth Catholic  
District School Board**

August 31, 2023

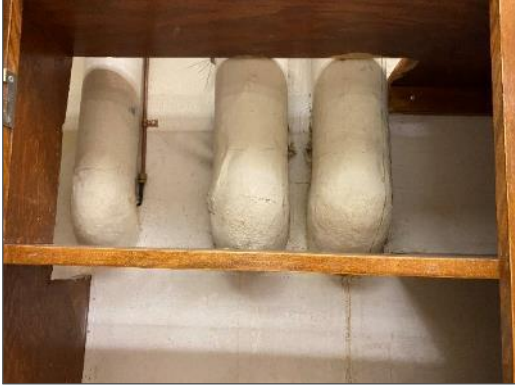
Material and Application	Asbestos Type	Photo
Parging cement is present on pipe fittings (elbows, valves, tees, hangers etc.).	Chrysotile

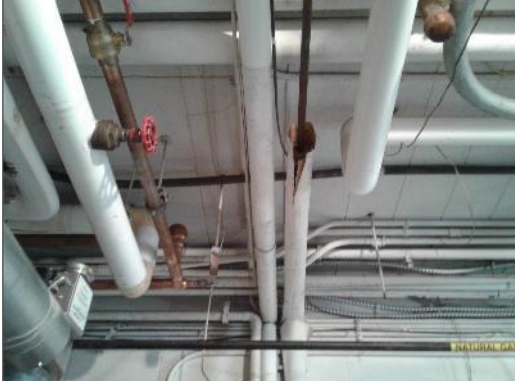
A white corrugated paper insulation (trade name Aircell), containing chrysotile asbestos, is present on straight sections of pipes.	Chrysotile

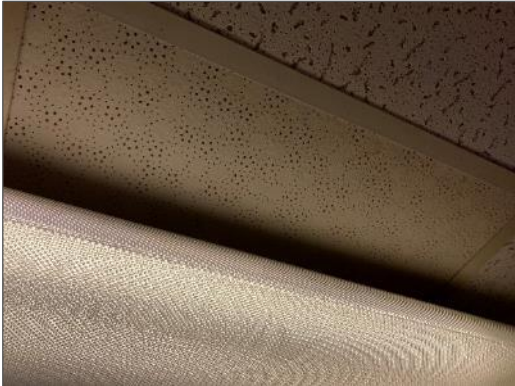
Material and Application	Asbestos Type	Photo
Remaining pipes are either uninsulated or insulated with non-asbestos fibreglass or elastomeric insulation (Armaflex).	None	
Ducts are either uninsulated or insulated with non-asbestos fibreglass (foil-faced or canvas).	None	
Mechanical equipment is either uninsulated or insulated with non-asbestos fibreglass.	None	
Vermiculite is present as insulation in perimeter masonry block walls.	Libby Amphibole	
24"x24" lay-in ceiling tiles, with a honeycomb pinhole pattern are present.	Amosite

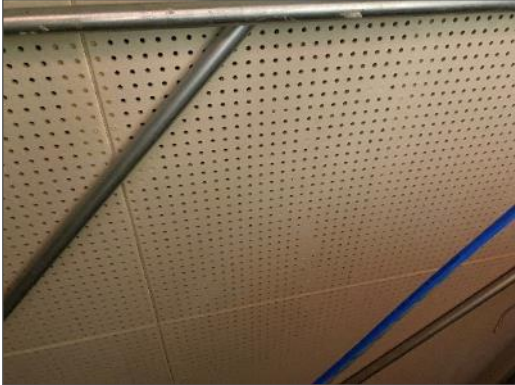
Transite (asbestos cement) is present as acoustic ceiling tiles.	Presumed

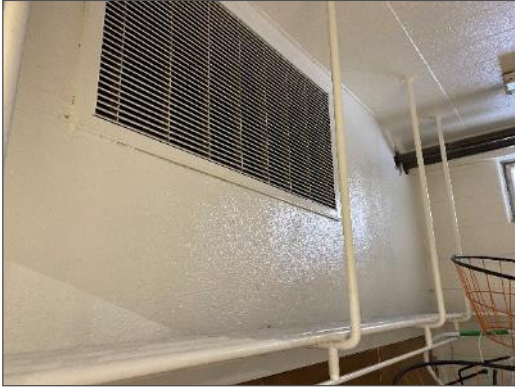
Material and Application	Asbestos Type	Photo
<p>Remaining ceiling tiles are non-asbestos from previous sampling or presumed to be non-asbestos based on the date of manufacture determined from the date stamp applied to the top of the tiles and the age of the materials determined from the age of the building.</p>	<p>None</p>	
<p>Textured plaster, containing asbestos in the finish layer, is present on walls and ceilings.</p>	<p>Chrysotile</p>

- Textured plaster is present as a wall and ceiling finish throughout the building. A total of 5 samples of textured plaster were collected (samples S0019A-E, lab reference no. 71922395) and it was found that two samples contained chrysotile asbestos. The asbestos-positive results indicate that textured plaster in the building should be presumed to contain asbestos until further sampling proves otherwise. Further sampling may be considered in an attempt to delineate asbestos-containing textured plaster from non-asbestos textured plaster.

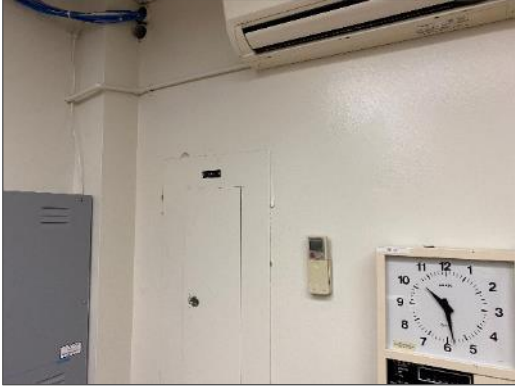
<p>Smooth plaster is present on walls and ceilings.</p>	<p>None</p>	
<p>Drywall joint compound is present on wall and ceiling finishes.</p>	<p>Chrysotile</p>

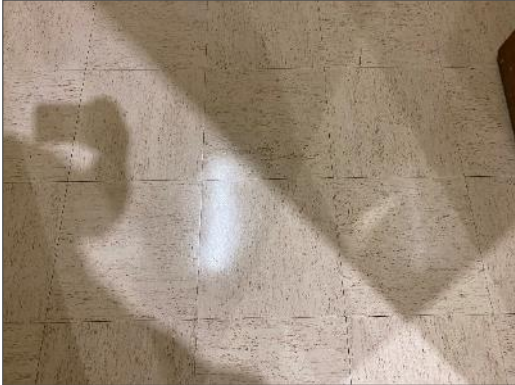
Material and Application	Asbestos Type	Photo
<p>Vinyl floor tiles, 9"x9" and 12"x12", various colours, are present.</p>	<p>Presumed (tile) Presumed (mastic)</p>

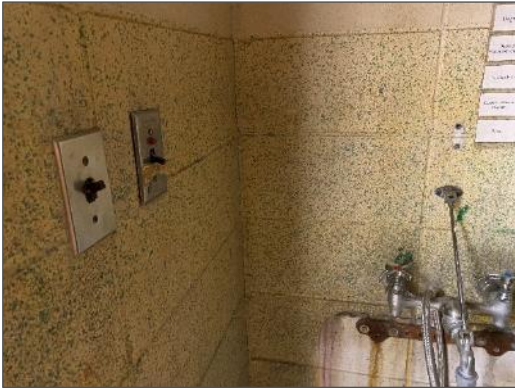
<p>Remaining vinyl floor tiles are presumed to be non-asbestos based on historical knowledge of the date of installation.</p> <p>Mastic under non-asbestos tiles is presumed to contain asbestos until further sampling is performed.</p>	<p>None (tile) Presumed (mastic)</p>	
<p>Textured paint on concrete block walls is present.</p>	<p>Chrysotile</p>

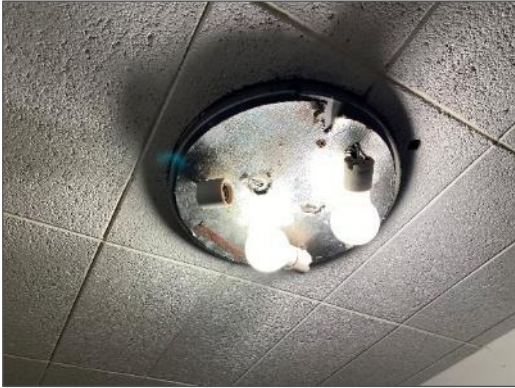
Material and Application	Asbestos Type	Photo
Paper heat shields are present in light fixtures.	Presumed
