Asbestos Reassessment

St. Kateri Tekakwitha
22 Queensbury Drive, Hamilton,
Ontario

**Hamilton-Wentworth Catholic
District School Board**

May 15, 2023

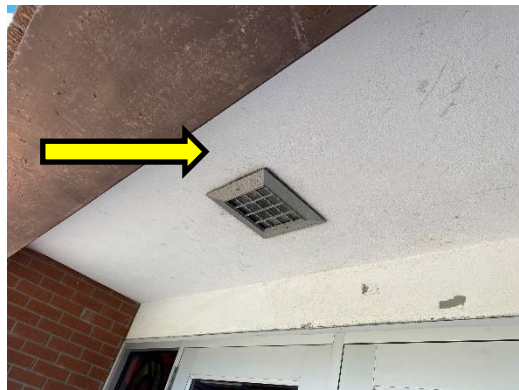
Material and Application	Asbestos Type	Photo
Pipes are either uninsulated or insulated with non-asbestos fibreglass or elastomeric insulation (Armaflex).	None	
Ducts are either uninsulated or insulated with non-asbestos fibreglass.	None	
Mechanical equipment is either uninsulated or insulated with non-asbestos fibreglass.	None	
All ceiling tiles are presumed to be non-asbestos based on the date of manufacture determined from the date stamp applied to the top of the tiles (2007).	None	
Textured plaster is present as a ceiling/soffit finish	Chrysotile

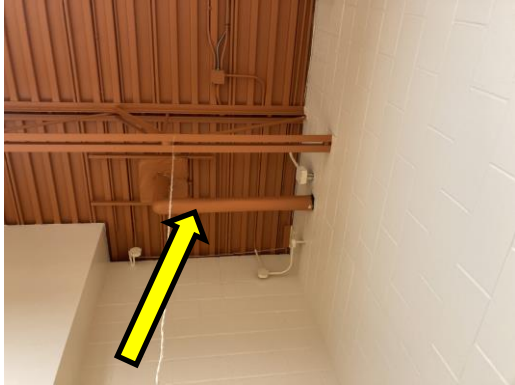
Material and Application	Asbestos Type	Photo
Transite pipe is present as rainwater leaders.	Presumed

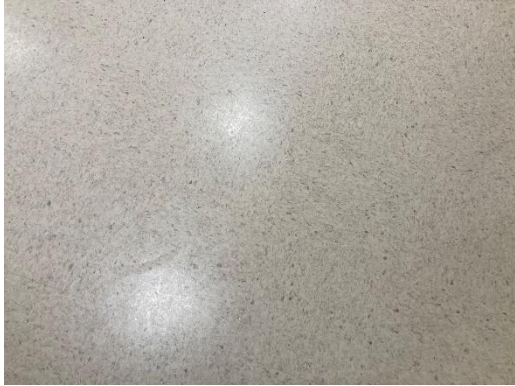
Vinyl floor tiles, 12"x12", cream with purple streaks are present.	Chrysotile (tile) None Detected (mastic)

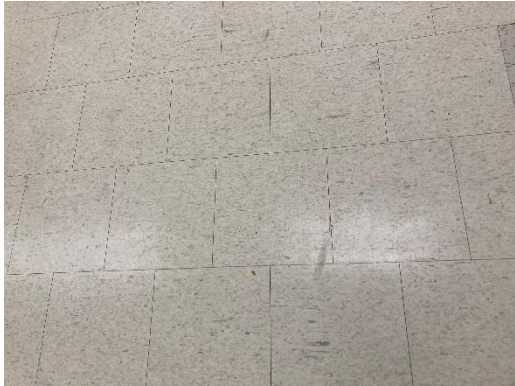
Vinyl floor tiles, 12"x12", white with grey streaks are present.	Presumed (tile) Presumed (mastic)

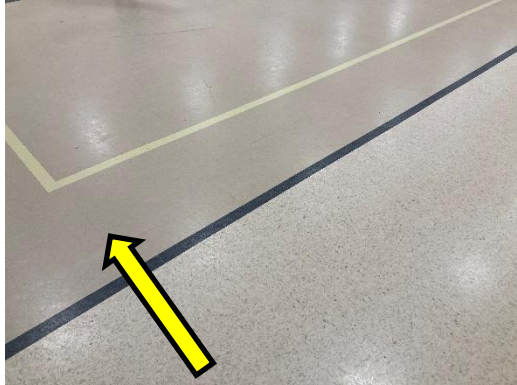
Material and Application	Asbestos Type	Photo
<p>Vinyl floor tiles, 12"x12", beige are present.</p>	<p>Chrysotile (tile) None Detected (mastic)</p>

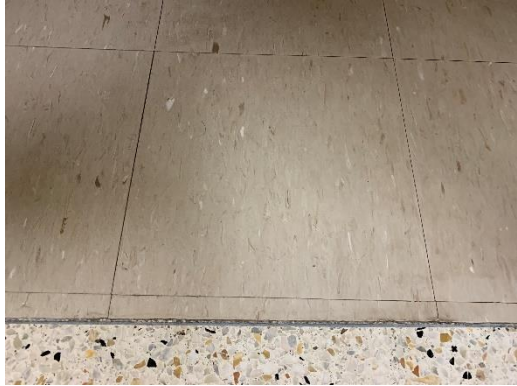
<p>Remaining vinyl floor tiles are either non-asbestos based on previous sampling or by the date of installation as reported by the Client.</p> <p>Mastic under non-asbestos vinyl floor tiles is presumed to contain asbestos under sample analysis proves otherwise.</p>	<p>None (tile) Presumed (mastic)</p>

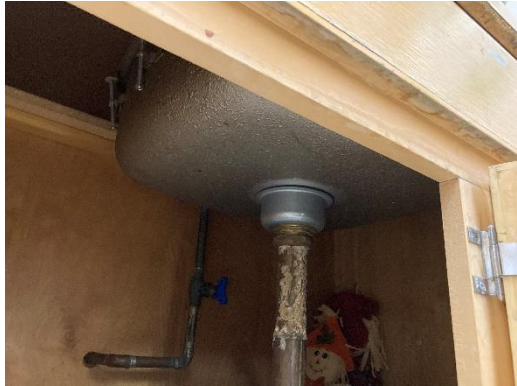
<p>Gold mastic is present as a sink undercoating.</p>	<p>Presumed</p>

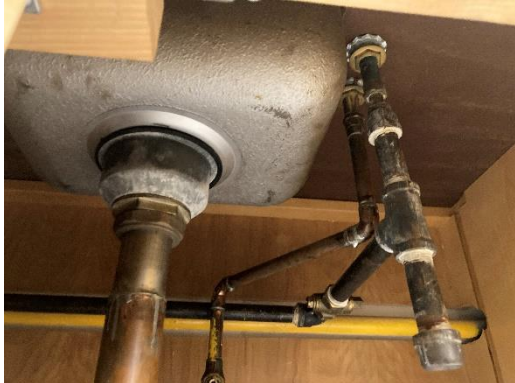
Material and Application	Asbestos Type	Photo
Silver mastic is present as a sink undercoating.	Presumed

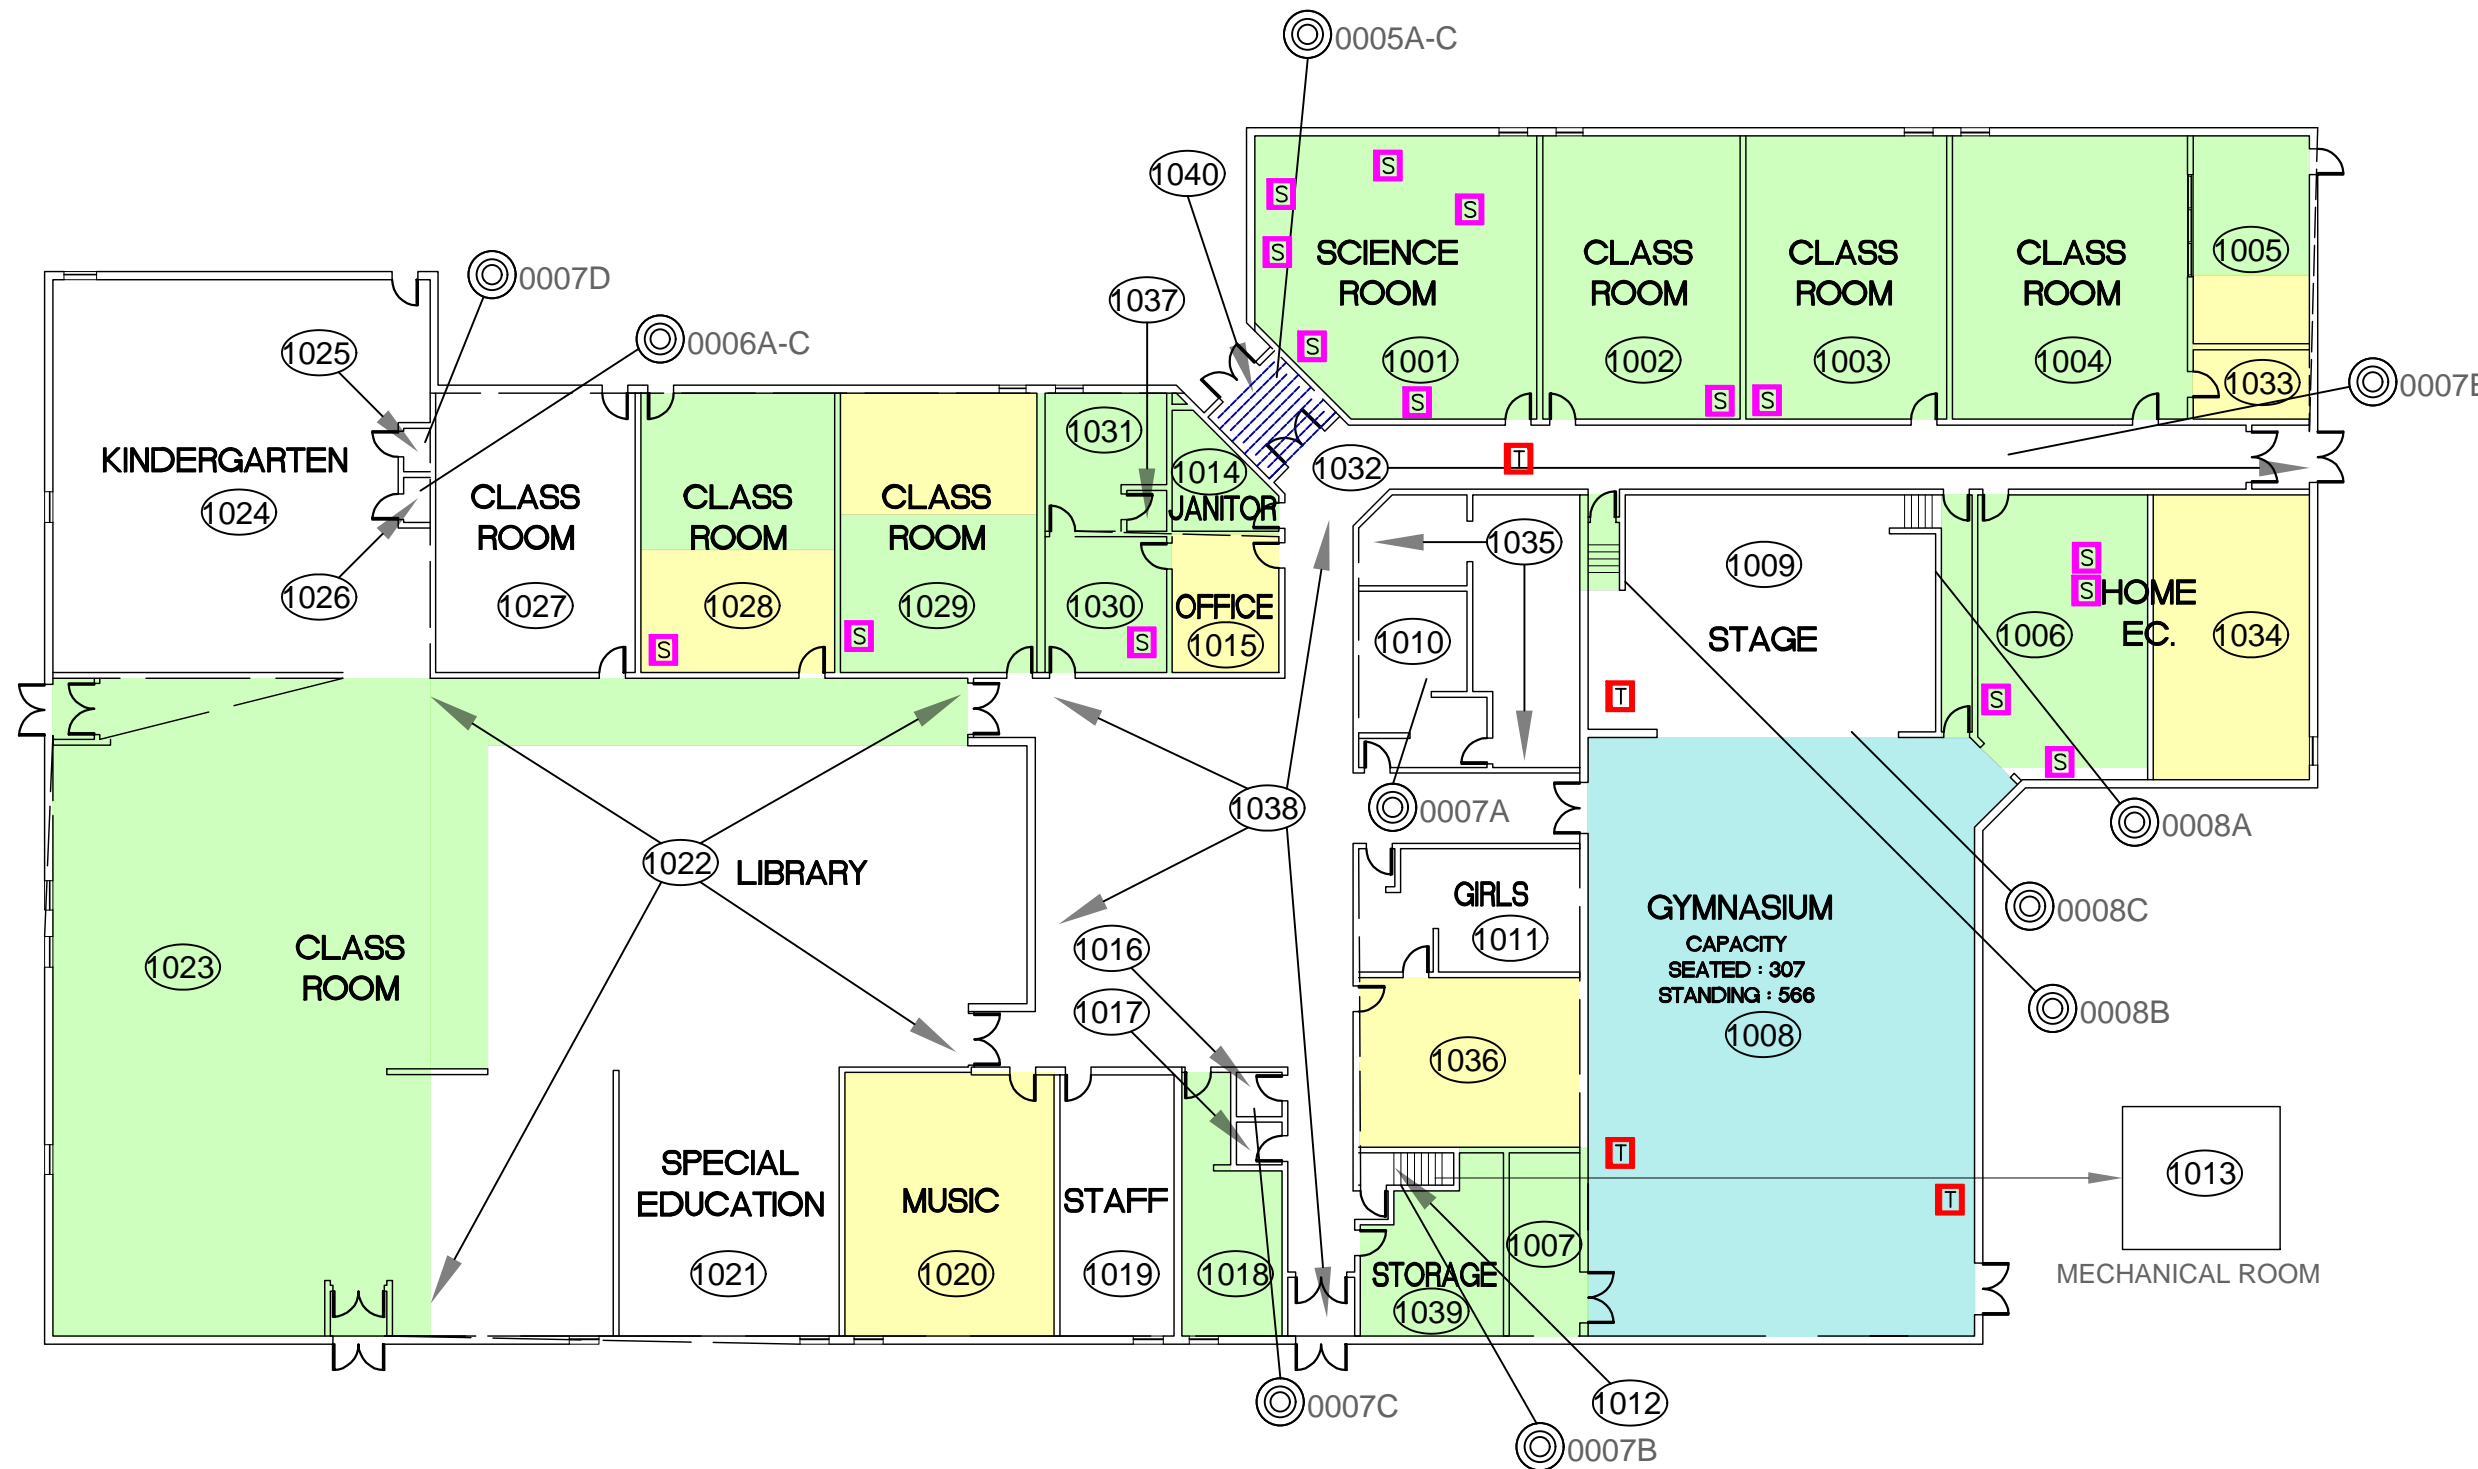
ASBESTOS-CONTAINING MATERIALS:

- (T) TRANSITE PIPE
- (S) SINK UNDERCOATING
- VINYL FLOOR TILES & MASTIC
- MASTIC UNDER VINYL FLOOR TILE
- VINYL FLOOR TILES
- TEXTURE FINISH
