Asbestos Assessment

St. Lawrence
88 Macaulay Street East, Hamilton,
ON, L8L 3X3

**Hamilton-Wentworth Catholic
District School Board**

August 31, 2023

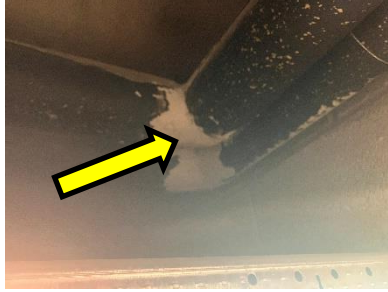
Material and Application	Asbestos Type	Photo
Non-asbestos fireproofing is present on structural steel including beams, trusses, joists, corrugated steel deck in Custodian Storage (Location 1009) and Electrical Room (Location 1010).	None	N/A
Non-asbestos fireproofing is present on structural steel in Classroom 2 (Location 1001).	None	N/A
Parging cement is present on pipe fittings (elbows, valves, tees, hangers etc.).	Chrysotile

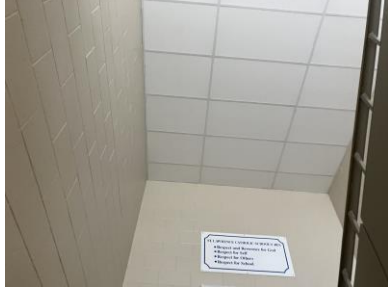
Material and Application	Asbestos Type	Photo
24"x48" lay-in ceiling tiles, with a textured pinhole pattern are present.	Amosite

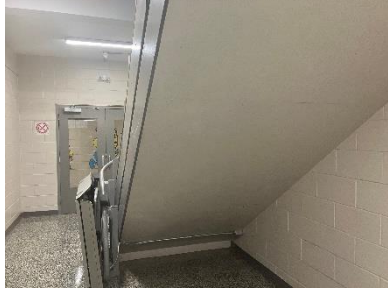
All remaining ceiling tiles were determined to be non-asbestos by sample analysis or are presumed to be non-asbestos based on the date of manufacture determined from the date stamp applied to the top of the tiles or the age of the materials determined from the age of the building addition (2010).	None	N/A
Plaster present on walls and ceilings does not contain asbestos.	None	N/A
Non-asbestos drywall joint compound is present on wall and ceiling finishes.	None	N/A
Asbestos in drywall joint compound was banned in Canada in 1980. Drywall joint compound in the 2010 addition was installed after 1986 (1980 plus a reasonable non-compliance period based on our experience) and is assumed to contain no asbestos.	None	N/A
Transite board is present as a ceiling finish underneath stairs.	Presumed

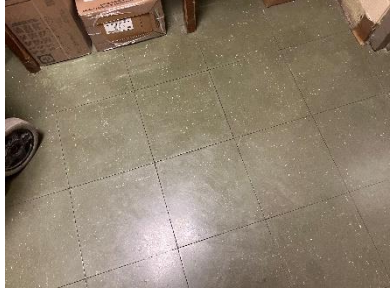
Material and Application	Asbestos Type	Photo
Vinyl floor tiles, 12"x12", dark green with white, are present.	Chrysotile (tile) Presumed (mastic)

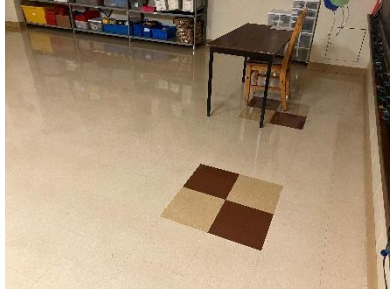
<p>Remaining vinyl floor tiles were presumed to be non-asbestos based on historical knowledge of the date of installation (2010).</p> <p>Mastic underneath new flooring is presumed to contain asbestos until sampling proves otherwise, with the exception of mastic in the addition which is non-asbestos based on the date of construction.</p>	None (tile) Presumed (mastic)

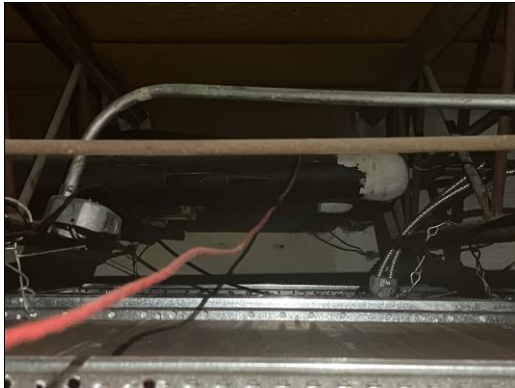
Material, Quantity, Condition, Photo #	Location (Location #)	Recommended Procedure
Parging cement pipe insulation, 2 fittings, fair condition, Photo 1	Room 11, Location 1012	Repair following Type 2 procedures
Parging cement pipe insulation, 2 fittings, fair condition, Photo 2	Boys Washroom, Location 1017	Repair following Type 2 procedures
