Asbestos Assessment

St. Luke
345 Albright Road, Hamilton, ON,
L8K 6N3

August 31, 2023

Pinchin File: 320582.004

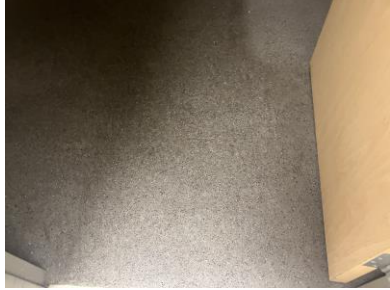
Material and Application	Asbestos Type	Photo
Vinyl sheet flooring, grey with green and red flecks pattern, is present.	Presumed

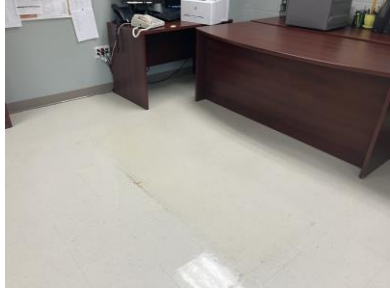
Vinyl floor tiles, 12"x12", white with grey flecks, are present.	<0.5% Chrysotile (tile) None (mastic)
