# Asbestos Assessment

St. Margaret Mary  
25 Brentwood Drive, Hamilton, ON,  
L8T 3V9

August 31, 2023

Pinchin File: 320582.004

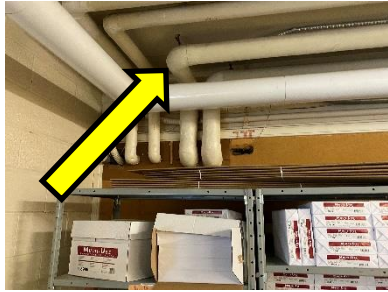
Material and Application	Asbestos Type	Photo
Parging cement is present on pipe fittings (elbows, valves, tees, hangers etc.).	Chrysotile

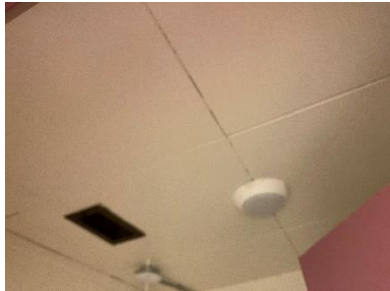
Material and Application	Asbestos Type	Photo
ceilings does not contain asbestos.		
Non-asbestos drywall joint compound is present as a wall finish.	None	N/A
Transite board is present as a ceiling finish and as acoustic wall panels.	Presumed

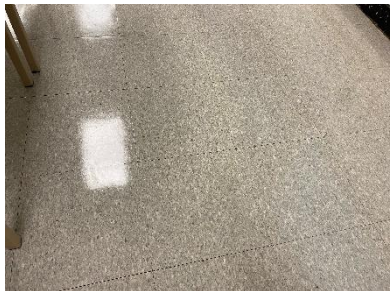
Vinyl floor tiles, 12"x12", light grey multi-fleck, are present.	Presumed (tile) Presumed (mastic)

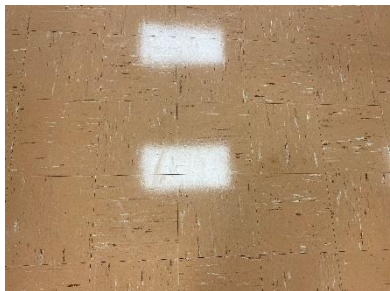
Vinyl floor tiles, 9"x9", pink with white and brown streak, are present.	Presumed (tile) Presumed (mastic)

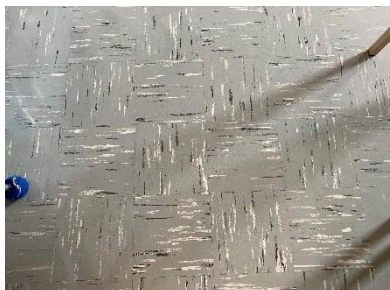
Vinyl floor tiles, 9"x9", green with white streaks, are present.	Presumed (tile) Presumed (mastic)	N/A
Vinyl floor tiles, 9"x9", grey with white and black streaks, are present.	Presumed (tile) Presumed (mastic)

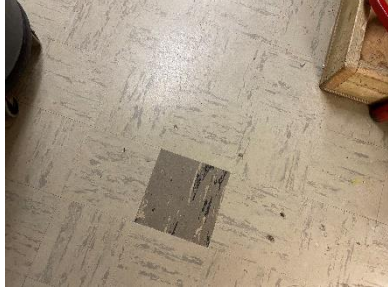
Material and Application	Asbestos Type	Photo
<p>Vinyl floor tiles, 9"x9", white with grey streaks, are present.</p>	<p>Presumed (tile) Presumed (mastic)</p>

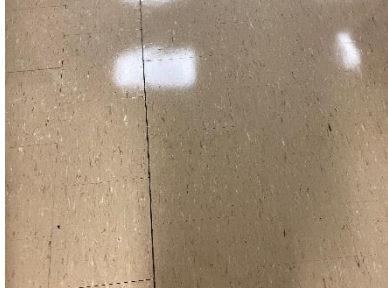
<p>Vinyl floor tiles, 12"x12", brown with white and black streaks, are present.</p>	<p>Presumed (tile) Presumed (mastic)</p>

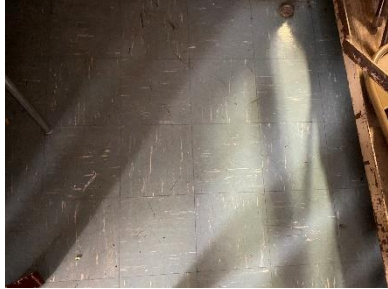
<p>Vinyl floor tiles, 12"x12", grey with white and black streaks, are present.</p>	<p>Presumed (tile) Presumed (mastic)</p>	<p>N/A</p>
<p>Vinyl floor tiles, 9"x9", blue with white streaks, are present.</p>	<p>Presumed (tile) Presumed (mastic)</p>

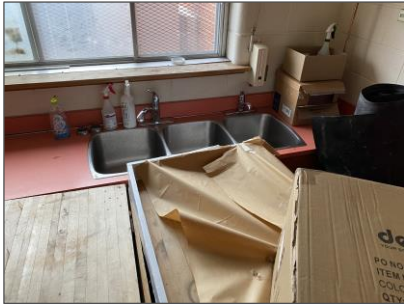
Material and Application	Asbestos Type	Photo
Gold mastic is present as a sink undercoating.	Presumed
