Asbestos Assessment

St. Mark
43 Whitedeer Road, Stoney Creek,
ON, L8J 2V8

**Hamilton-Wentworth Catholic
District School Board**

August 31, 2023

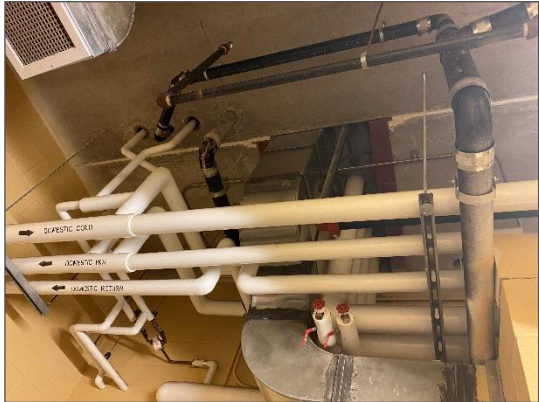
Material and Application	Asbestos Type	Photo
Pipes are either uninsulated or insulated with non-asbestos fibreglass or elastomeric insulation (Armaflex).	None
