Asbestos Reassessment

St. Martin of Tours
60 Grays Road, Stoney Creek,
Ontario

May 15, 2023

Pinchin File: 320582.001

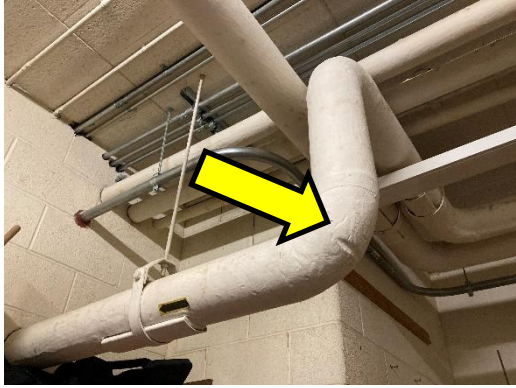
Material and Application	Asbestos Type	Photo
Parging cement is present on pipe fittings (elbows, valves, tees, hangers etc.)	Chrysotile

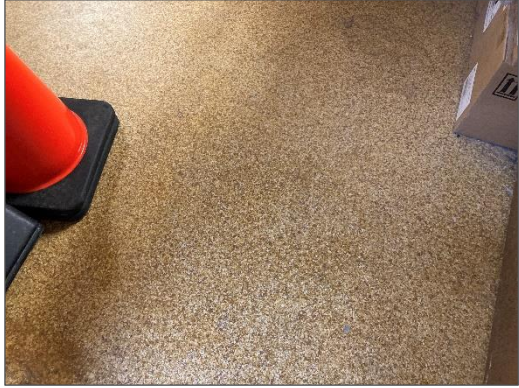
Material and Application	Asbestos Type	Photo
All ceiling tiles are presumed to be non-asbestos based on the date of manufacture determined from the date stamp applied to the top of the tiles or the age of the materials determined from the age of the building renovation.	None	
Textured plaster present on walls and ceilings does not contain asbestos.	None Detected	
Rough plaster present on the structure does not contain asbestos.	None Detected	
Vinyl sheet flooring, with a brown speckled pattern, is present.	None (flooring) Presumed (mastic)

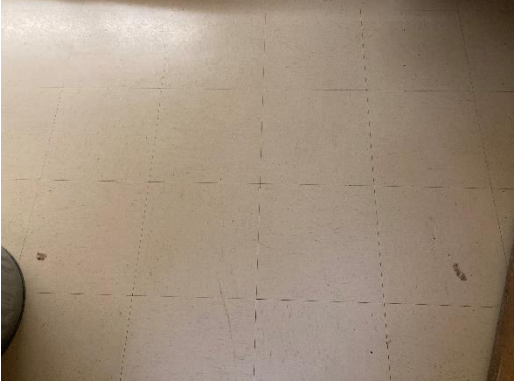
Vinyl floor tiles, 12"x12" beige with dark streak, are present.	Chrysotile (tile) Chrysotile (mastic)

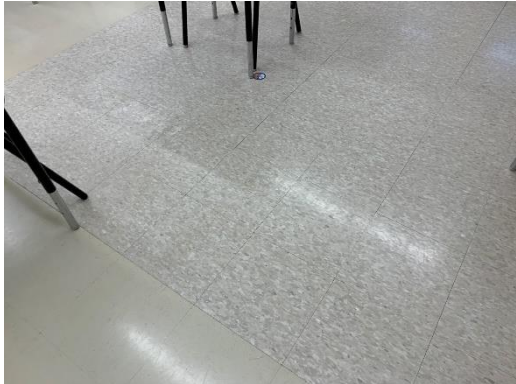
Material and Application	Asbestos Type	Photo
<p>Vinyl floor tiles, 12"x12" grey oatmeal, are present.</p>	<p>Presumed (tile) Presumed (mastic)</p>

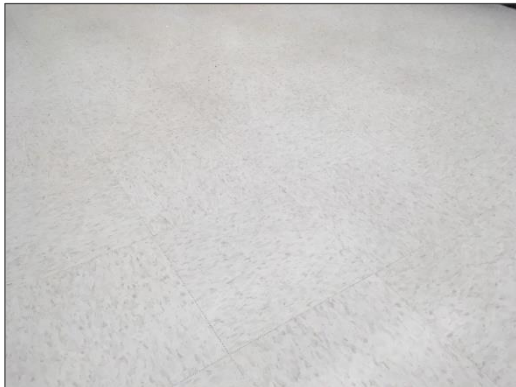
<p>Vinyl floor tiles, 12"x12" brown oatmeal, are present.</p>	<p>None Detected (tile) Presumed (mastic)</p>

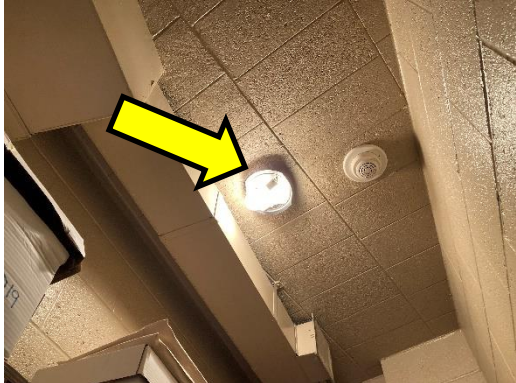
Material and Application	Asbestos Type	Photo
Paper heat shields are present.	Presumed

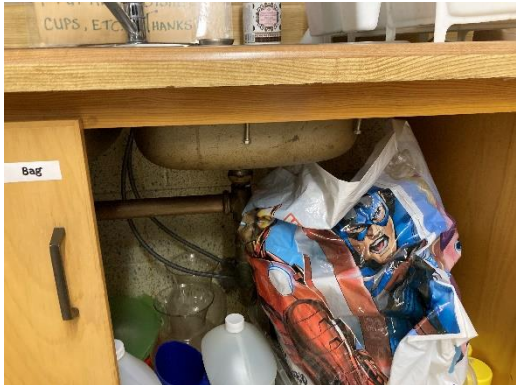
Gold mastic is present as a sink undercoating.	Presumed
