Asbestos Assessment

St. Mary Catholic ERC
209 MacNab Street, Hamilton, ON,
L8R1B5

August 31, 2023

Pinchin File: 320582.004

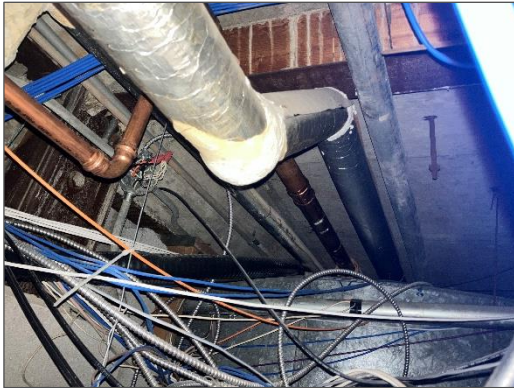
Material and Application	Asbestos Type	Photo
Parging cement is present on pipe fittings (elbows, valves, tees, hangers etc.).	Chrysotile

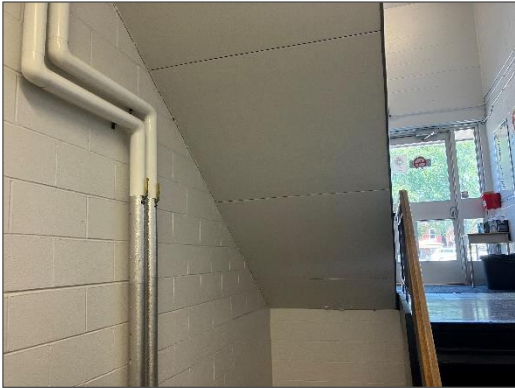
Material and Application	Asbestos Type	Photo
All ceiling tiles are non-asbestos from previous sampling, presumed to be non-asbestos based on the date of manufacture determined from the date stamp applied to the top of the tiles and the age of the materials determined from the age of the building.	None	
Drywall joint compound is present on wall and ceiling finishes.	None	
Asbestos in drywall joint compound was banned in Canada in 1980. The building was constructed after 1986 (1980 plus a reasonable non-compliance period based on our experience) and the drywall joint compound is assumed to contain no asbestos.	None	
Transite board is present underneath stairs.	Presumed

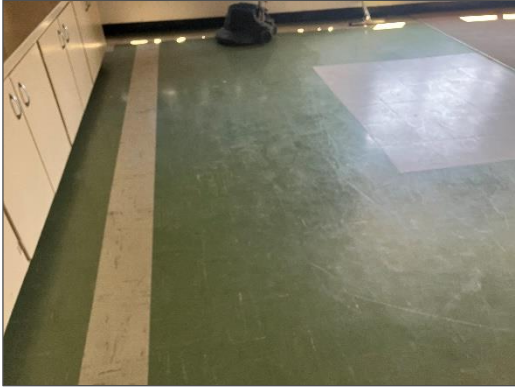
Vinyl floor tiles, 9"x9" and 12"x12", various colours, are present.	Chrysotile/Presumed (tile) Presumed (mastic)

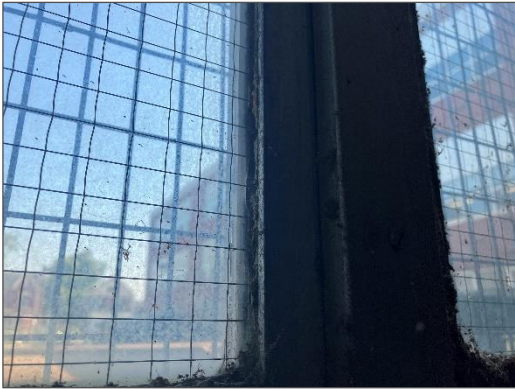
Material and Application	Asbestos Type	Photo
<p>Remaining vinyl floor tiles are presumed to be non-asbestos based on historical knowledge of the date of installation.</p> <p>Mastic under non-asbestos tiles is presumed to contain asbestos until further sampling is performed.</p>	<p>None (tile) Presumed (mastic)</p>	
<p>Grey caulking is present around window frames.</p>	<p>Chrysotile</p>

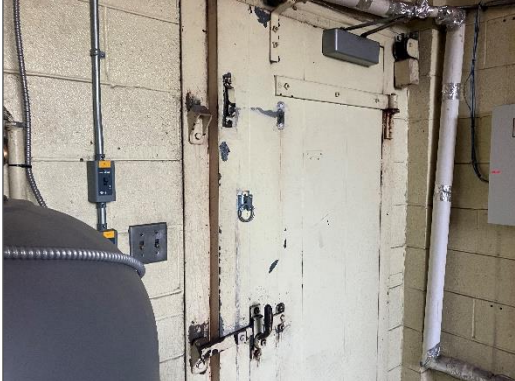
<p>Paper heat shields are present in light fixtures.</p>	<p>Presumed</p>	
<p>A fire door is present in the Boiler Room (Location 1016). Interior components are presumed to contain asbestos.</p>	<p>Presumed</p>
