# Asbestos Reassessment

St. Michael  
135 Hester Street, Hamilton,  
Ontario

May 15, 2023

Pinchin File: 320582.001

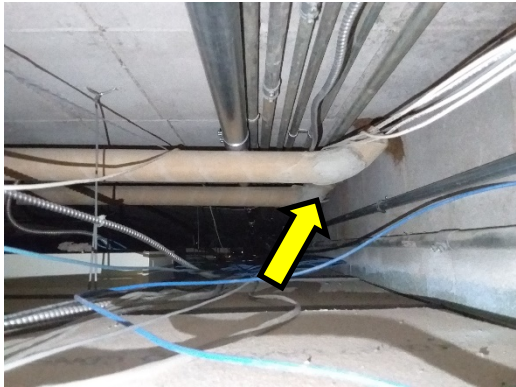
Material and Application	Asbestos Type	Photo
Parging cement is present on pipe fittings (elbows, valves, tees, hangers etc.)	Chrysotile

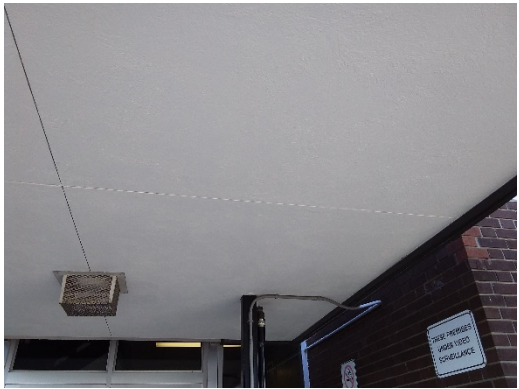
Material and Application	Asbestos Type	Photo
<p>All ceiling tiles are determined to be non-asbestos based on previous sampling, the material (gypsum) or presumed to be non-asbestos based on the date of manufacture determined from the date stamp applied to the top of the tiles or the age of the materials determined from the age of the building addition.</p>	<p>None</p>	
<p>Textured plaster is present as an exterior soffit finish.</p>	<p>Chrysotile</p>

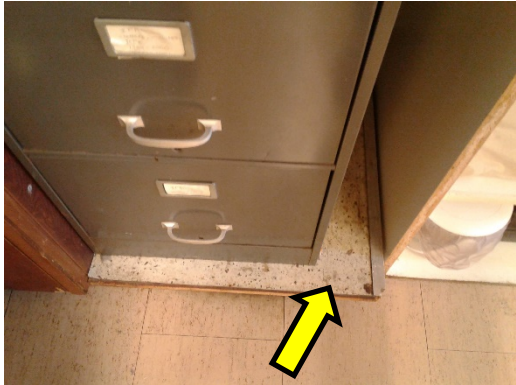
Material and Application	Asbestos Type	Photo
<p>Asbestos in drywall joint compound was banned in Canada in 1980. Drywall joint compound in the 2005 addition was installed after 1986 (1980 plus a reasonable non-compliance period based on our experience) and is assumed to contain no asbestos.</p>	<p>None</p>	
<p>Vinyl sheet flooring, with an off-white with dark flecks pattern is present under filing cabinets.</p>	<p>Presumed</p>

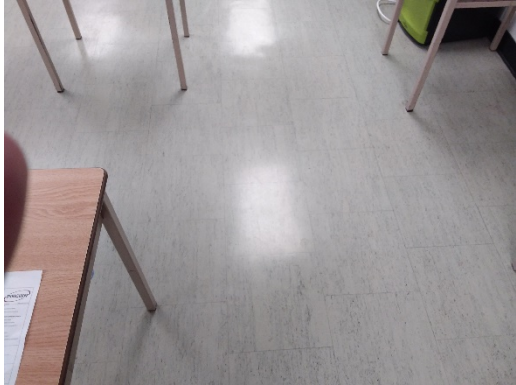
<p>Vinyl floor tiles, 12"x12", mint with grey fleck, are present.</p>	<p>Presumed (tile) Presumed (mastic)</p>

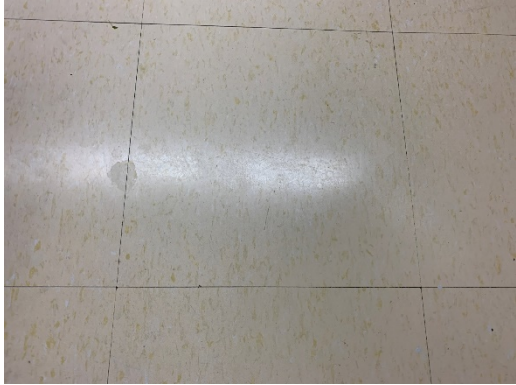
<p>Vinyl floor tiles, 12"x12", beige with orange flecks, are present.</p>	<p>Presumed (tile) Presumed (mastic)</p>

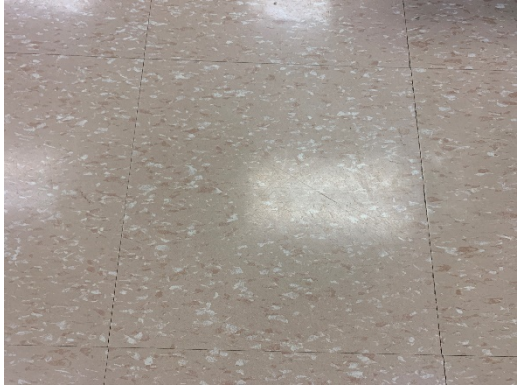
Material and Application	Asbestos Type	Photo
<p>Vinyl floor tiles, 12"x12", salmon with white flecks, are present.</p>	<p>Presumed (tile) Presumed (mastic)</p>

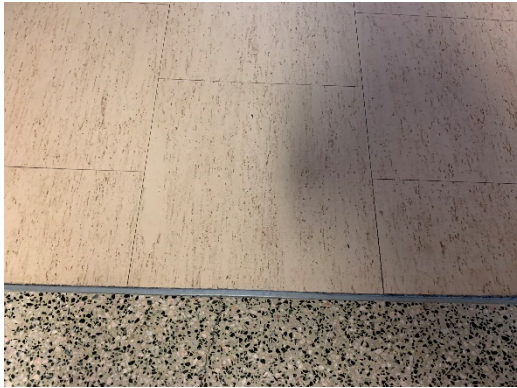
<p>Vinyl floor tiles, 12"x12", salmon with brown streaks, are present.</p>	<p>Presumed (tile) Presumed (mastic)</p>

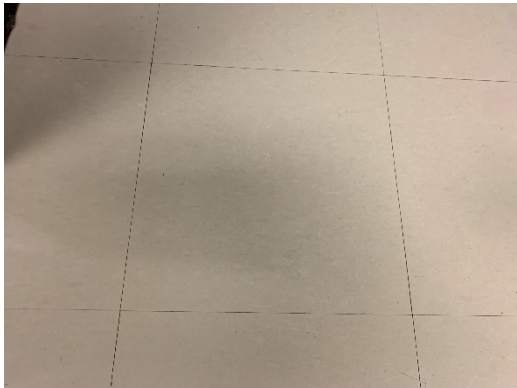
<p>Vinyl floor tiles, 12"x12", beige with yellow flecks, are present.</p>	<p>Presumed (tile) Presumed (mastic)</p>

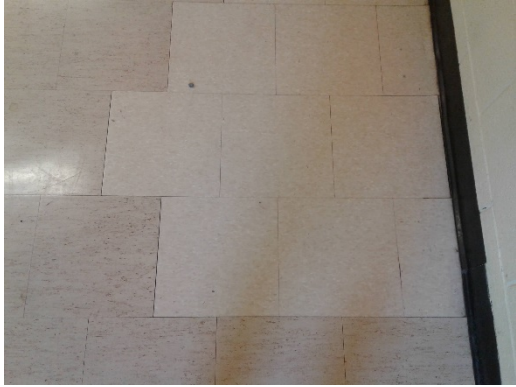
Material and Application	Asbestos Type	Photo
<p>Vinyl floor tiles, 12"x12", tan with brown streaks, are present.</p>	<p>Presumed (tile) Presumed (mastic)</p>

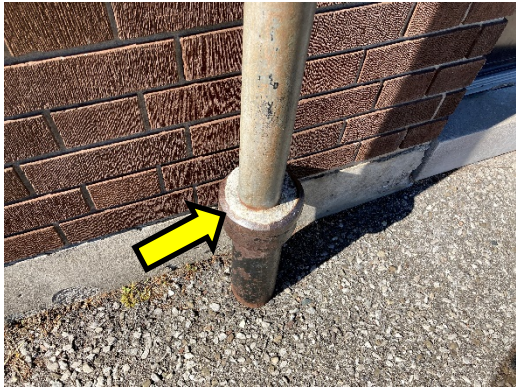
<p>Remaining vinyl floor tiles were presumed to be non-asbestos based on historical knowledge of the date of installation.</p> <p>Mastic underneath new vinyl floor tiles (excluding the 2005 addition) is presumed to contain asbestos until sampling proves otherwise.</p>	<p>None (tile) Presumed (mastic)</p>	
<p>Pipe packing material is present in an exterior bell and spigot fitting.</p>	<p>Amosite and Chrysotile</p>

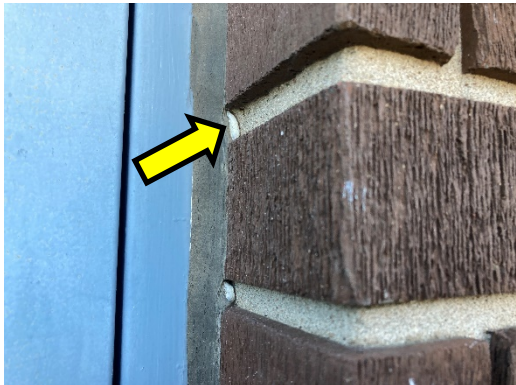
<p>White caulking is present under new non-asbestos caulking around an exterior door.</p>	<p>Chrysotile</p>
