Asbestos Assessment

St. Patrick
24 Smith Avenue, Hamilton, ON,
L8L 5P1

**Hamilton-Wentworth Catholic
District School Board**

August 31, 2023

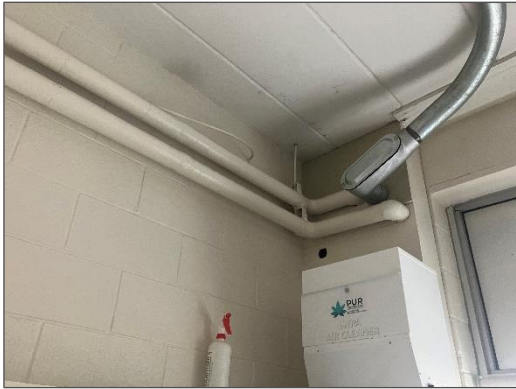
Material and Application	Asbestos Type	Photo
Parging cement is present on pipe fittings (elbows, valves, tees, hangers etc.).	Chrysotile

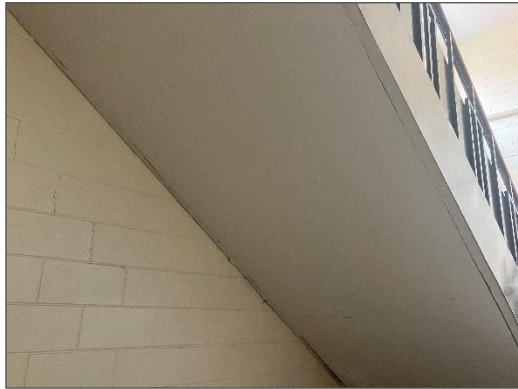
Material and Application	Asbestos Type	Photo
Texture finish is present on concrete.	None	
Smooth plaster is present on walls and ceilings.	None	
Drywall joint compound is present on wall and ceiling finishes.	None	
Transite board is present as a ceiling finish underneath stairs.	Presumed

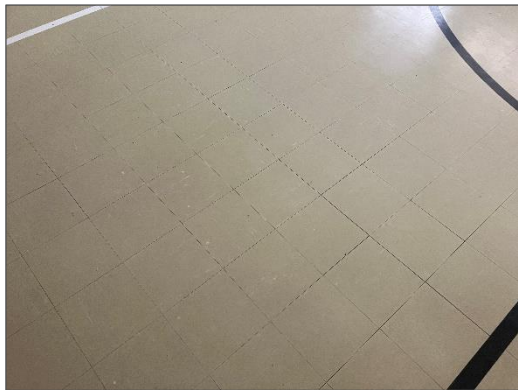
Vinyl floor tiles, 12"x12", various colours, are present.	Presumed (tile) Presumed (mastic)
