Asbestos Assessment

St. Paul
24 Amberwood Street, Stoney
Creek, ON, L8J 2H9

**Hamilton-Wentworth Catholic
District School Board**

August 31, 2023

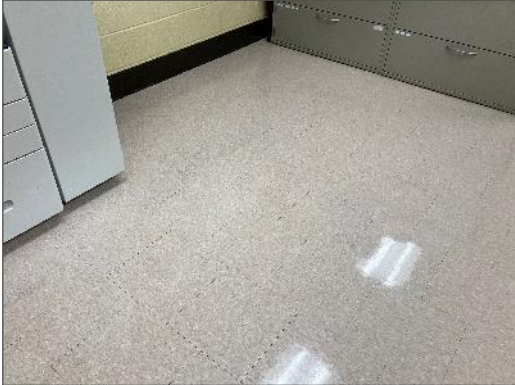
Material and Application	Asbestos Type	Photo
Vinyl floor tiles, 12"x12", various colours, are present.	Presumed (tile) Presumed (mastic)

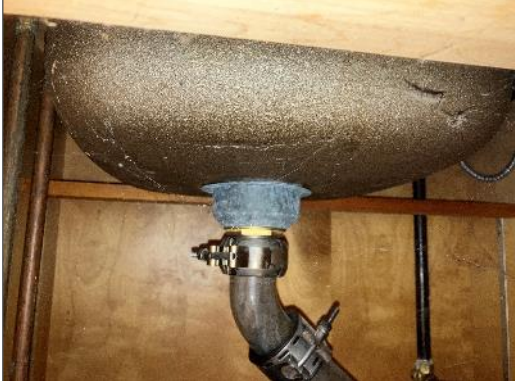
Gold and silver sink undercoating is present.	Presumed
