Asbestos Reassessment

St. Teresa of Avila
171 San Remo Drive, Hamilton,
Ontario

May 15, 2023

Pinchin File: 320582.001

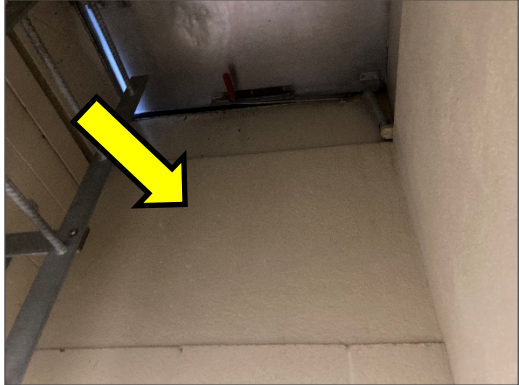
Material and Application	Asbestos Type	Photo
Pipes are either uninsulated or insulated with non-asbestos fibreglass or elastomeric insulation (Armaflex).	None	
Ducts are either uninsulated or insulated with non-asbestos fibreglass (foil-faced or canvas).	None	
Mechanical equipment is either uninsulated or insulated with non-asbestos fibreglass.	None	
Textured plaster is present as a wall finish on the east side of the Custodian Office (Location 116) and Electrical Room (Location 117).	Chrysotile

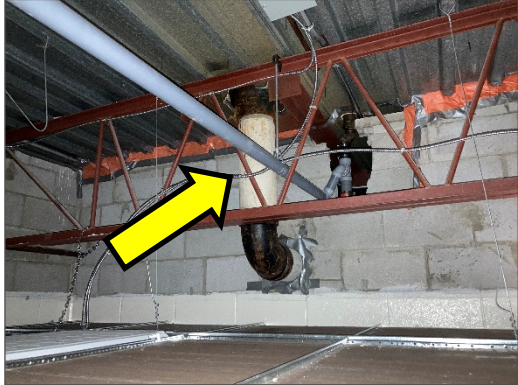
Material and Application	Asbestos Type	Photo
<p>All ceiling tiles were determined to be non-asbestos by sample analysis or are presumed to be non-asbestos based on the date of manufacture determined from the date stamp applied to the top of the tiles or the age of the materials determined from the age of the building renovation.</p>	<p>None</p>	
<p>Transite pipes are present as rainwater leaders.</p>	<p>Presumed</p>

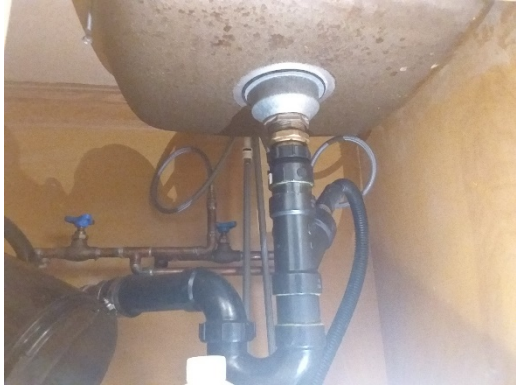
<p>Vinyl floor tiles and mastic were determined to be non-asbestos by sample analysis or were presumed to be non-asbestos based on historical knowledge of the date of installation.</p>	<p>None Detected (tile) None Detected (mastic)</p>	
<p>Gold mastic is present as a sink undercoating.</p>	<p>Presumed</p>
