Asbestos Assessment

St. Thomas More
1045 Upper Paradise Rd, Hamilton,
ON, L9B 2N4

August 31, 2023

Pinchin File: 320582.004

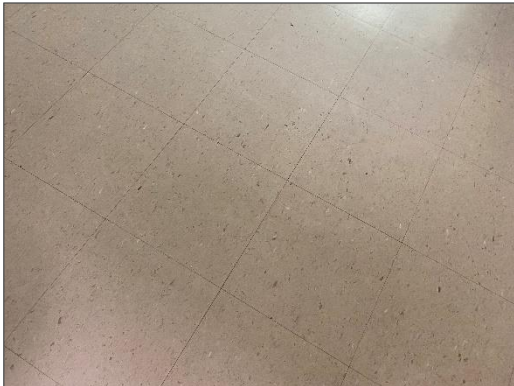
Vinyl floor tiles and mastic are present.	None Detected (tile) None Detected (mastic)
