Asbestos Assessment

St. Thomas the Apostle
170 Skinner Road, Waterdown, ON,
L8B 1C7

August 31, 2023

Pinchin File: 320582.004

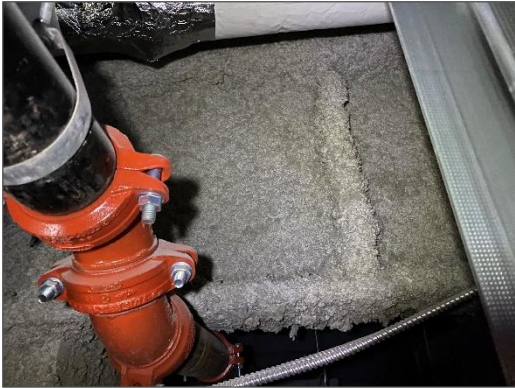
Material and Application	Asbestos Type	Photo
<p>Fireproofing is present on structural steel including beams, trusses, joists, corrugated steel deck, concrete deck, columns.</p>	<p>None</p>
