Asbestos Assessment

St. Vincent De Paul
295 Greencedar Drive, Hamilton,
ON, L9C 7M9

**Hamilton-Wentworth Catholic
District School Board**

August 31, 2023

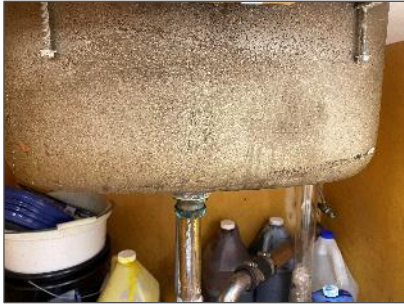
Material and Application	Asbestos Type	Photo
Pipes are either uninsulated or insulated with non-asbestos fibreglass or elastomeric insulation (Armaflex).	None	
Brown duct mastic is present.	None	
Ducts are either uninsulated or insulated with non-asbestos fibreglass (foil-faced or canvas).	None	
Mechanical equipment is either uninsulated or insulated with non-asbestos fibreglass.	None	
All ceiling tiles are presumed to be non-asbestos based on the age of the materials determined from the age of the building.	None	
Asbestos in drywall joint compound was banned in Canada in 1980. The building was constructed after 1986 (1980 plus a reasonable non-compliance period based on our experience) and the drywall joint compound is assumed to contain no asbestos.	None	
Vinyl floor tiles and mastic present are non-asbestos based on previous sampling.	None (tile) None (mastic)	
Gold sink undercoating is present.	Chrysotile

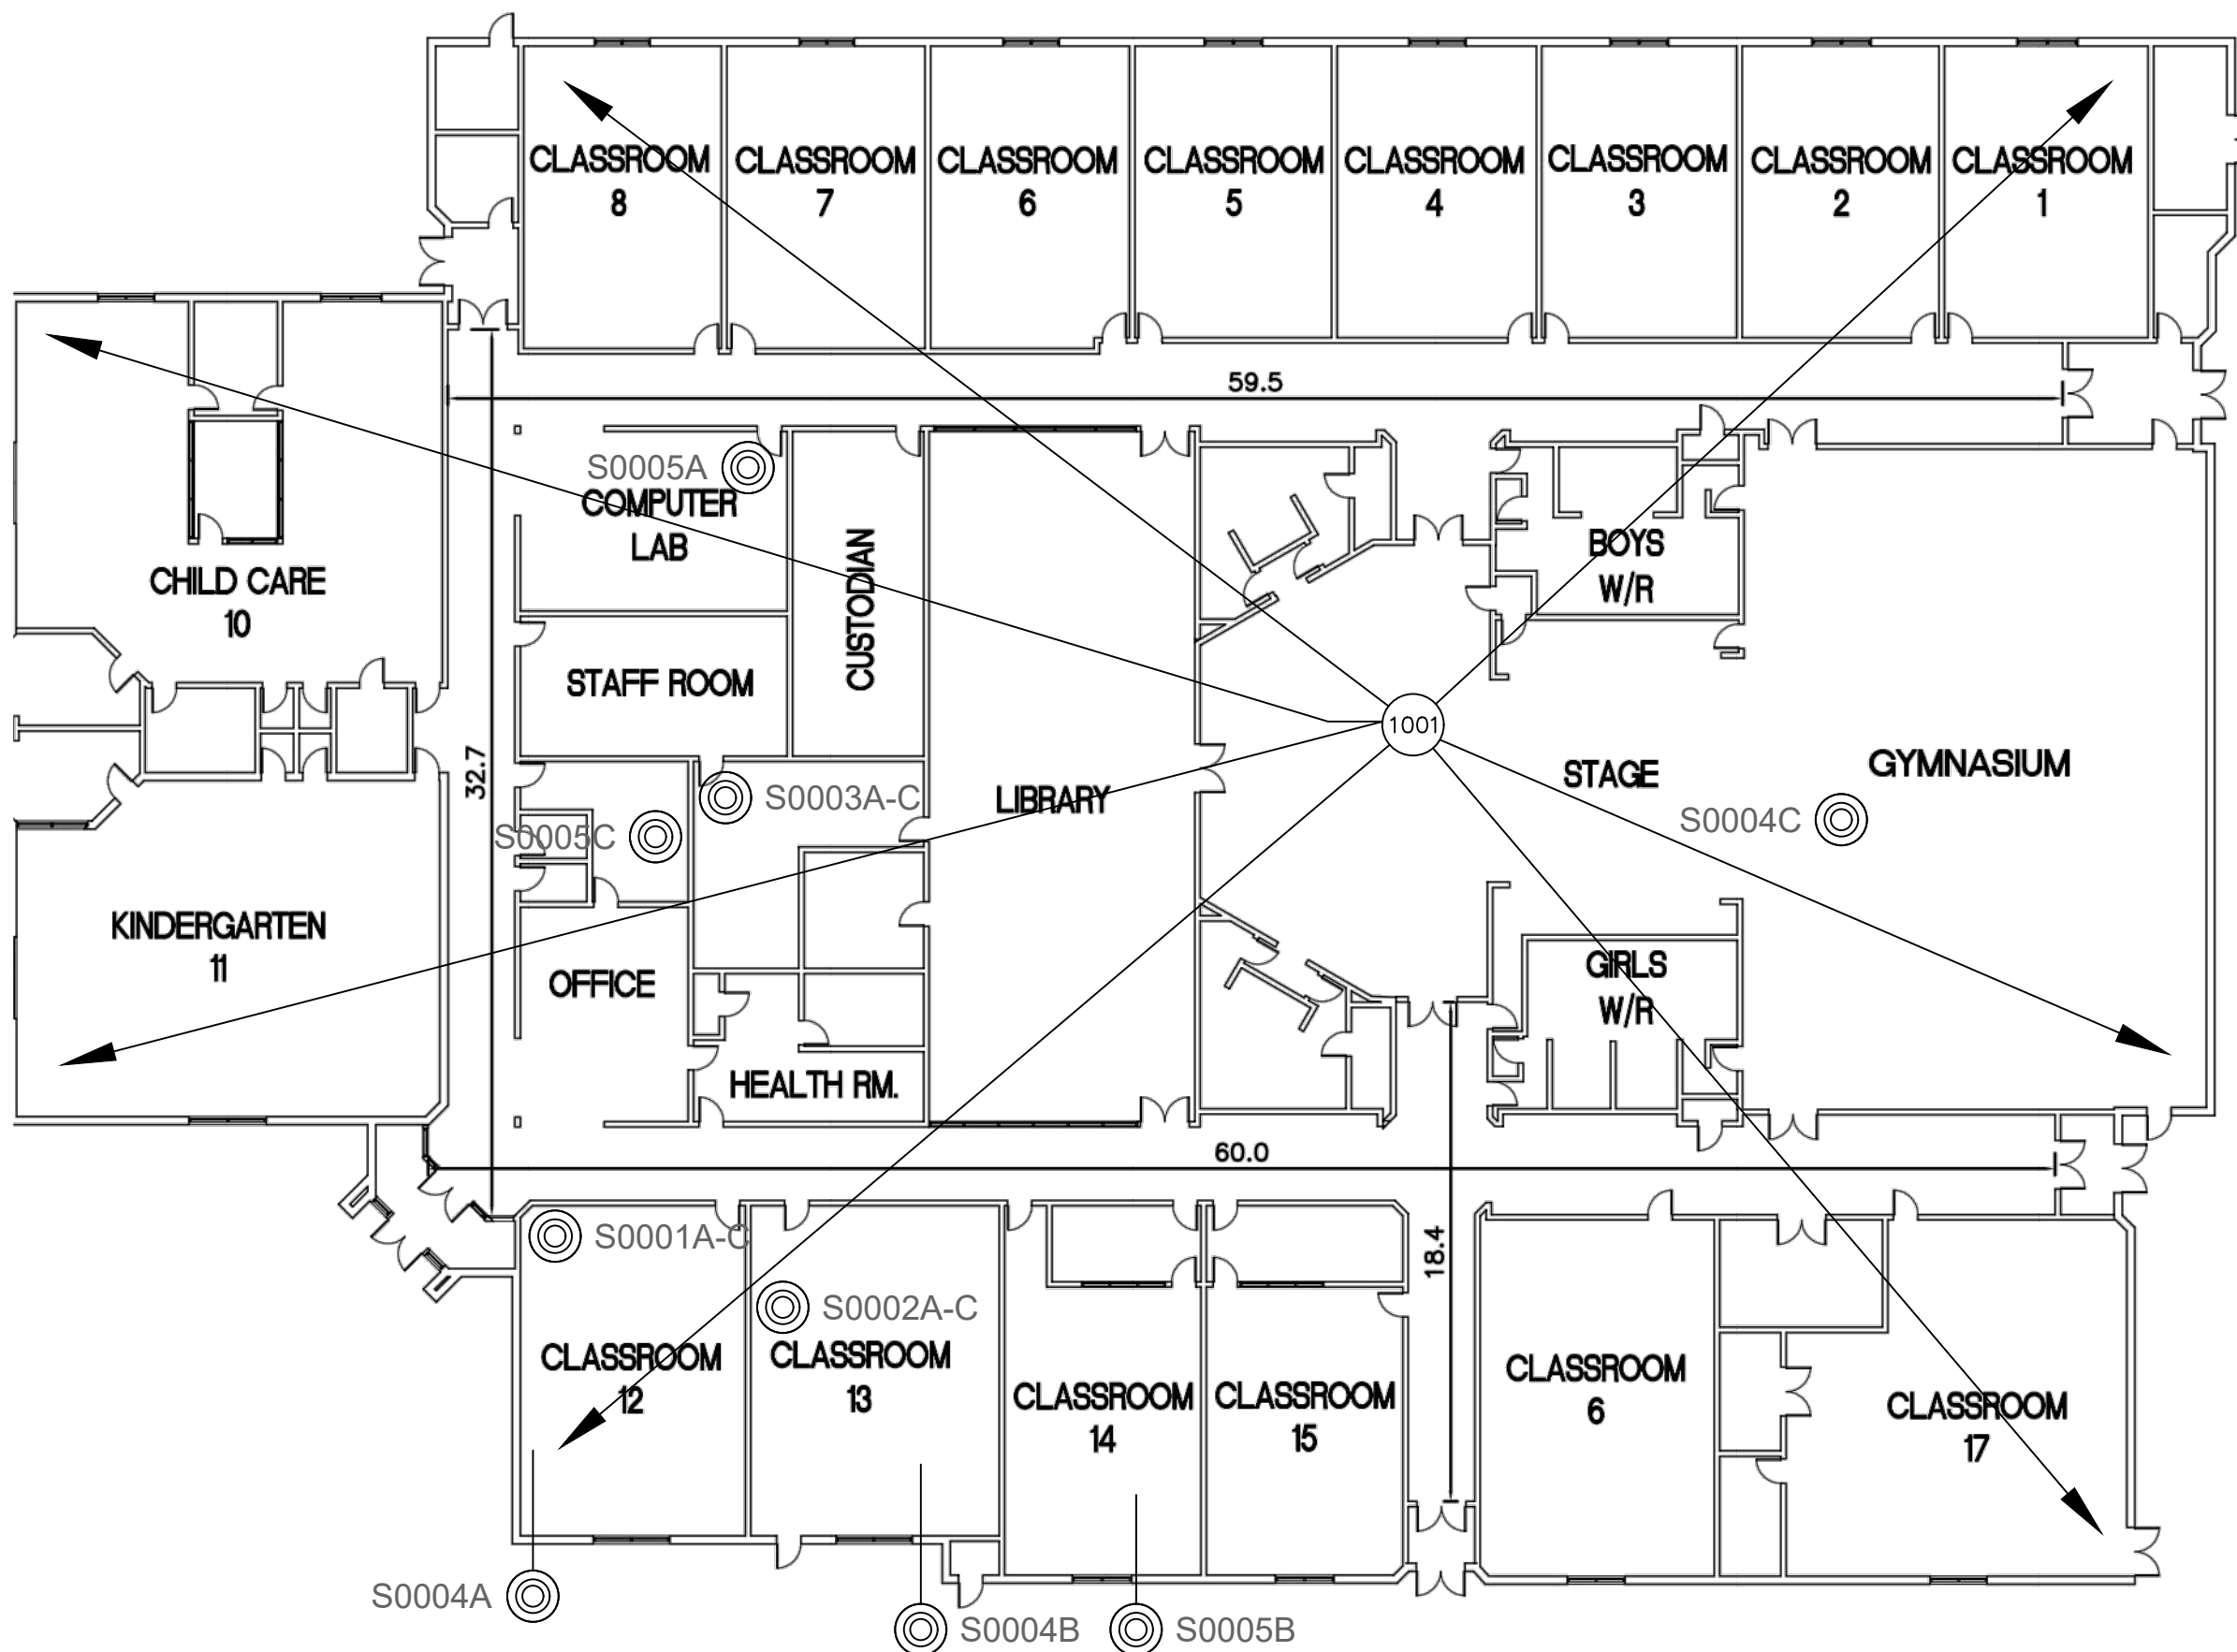
ASBESTOS ASSESSMENT
FLOOR LEVEL 1

ASBESTOS-CONTAINING GOLD MASTIC UNDERCOATING IS PRESENT SPORADICALLY ON SINKS WITHIN THE BUILDING.
