Asbestos Assessment

St. Peter and Paul
49 Fennell Avenue East, Hamilton,
ON, L9A 1R5

August 31, 2023

Pinchin File: 320582.004

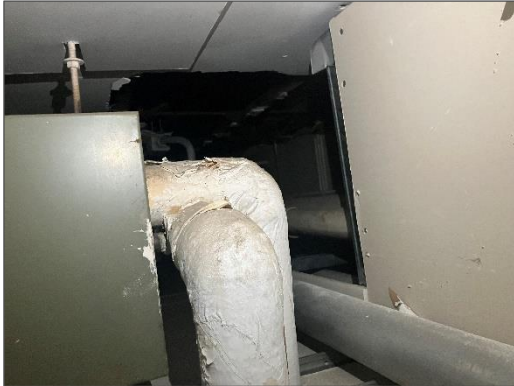
Material and Application	Asbestos Type	Photo
Parging cement is present on pipe fittings (elbows, valves, tees, hangers etc.).	Chrysotile

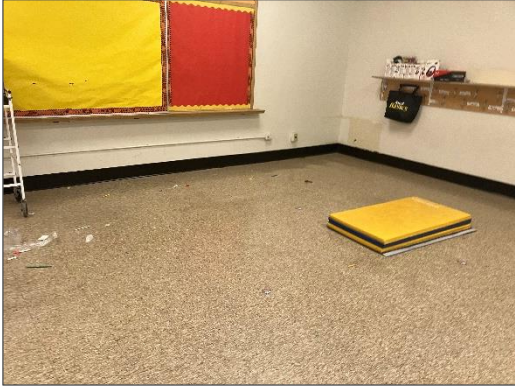
Material and Application	Asbestos Type	Photo
Vinyl sheet flooring, with a brown pebble pattern is present.	Chrysotile (flooring) Chrysotile (mastic)	
Vinyl floor tiles, 9"x9" and 12"x12", various colours, are present.	Chrysotile/Presumed (tile) Chrysotile/Presumed (mastic)	 
<p>Remaining vinyl floor tiles are presumed to be non-asbestos based on historical knowledge of the date of installation.</p> <p>Mastic under non-asbestos tiles is presumed to contain asbestos until further sampling is performed.</p>	None (tile) Presumed (mastic)
